April 2, 2019

RE: Post-Demo Biological Survey Results for a Fuel Tank Demolition Project at 3300 Panorama Drive, Morro Bay, California.

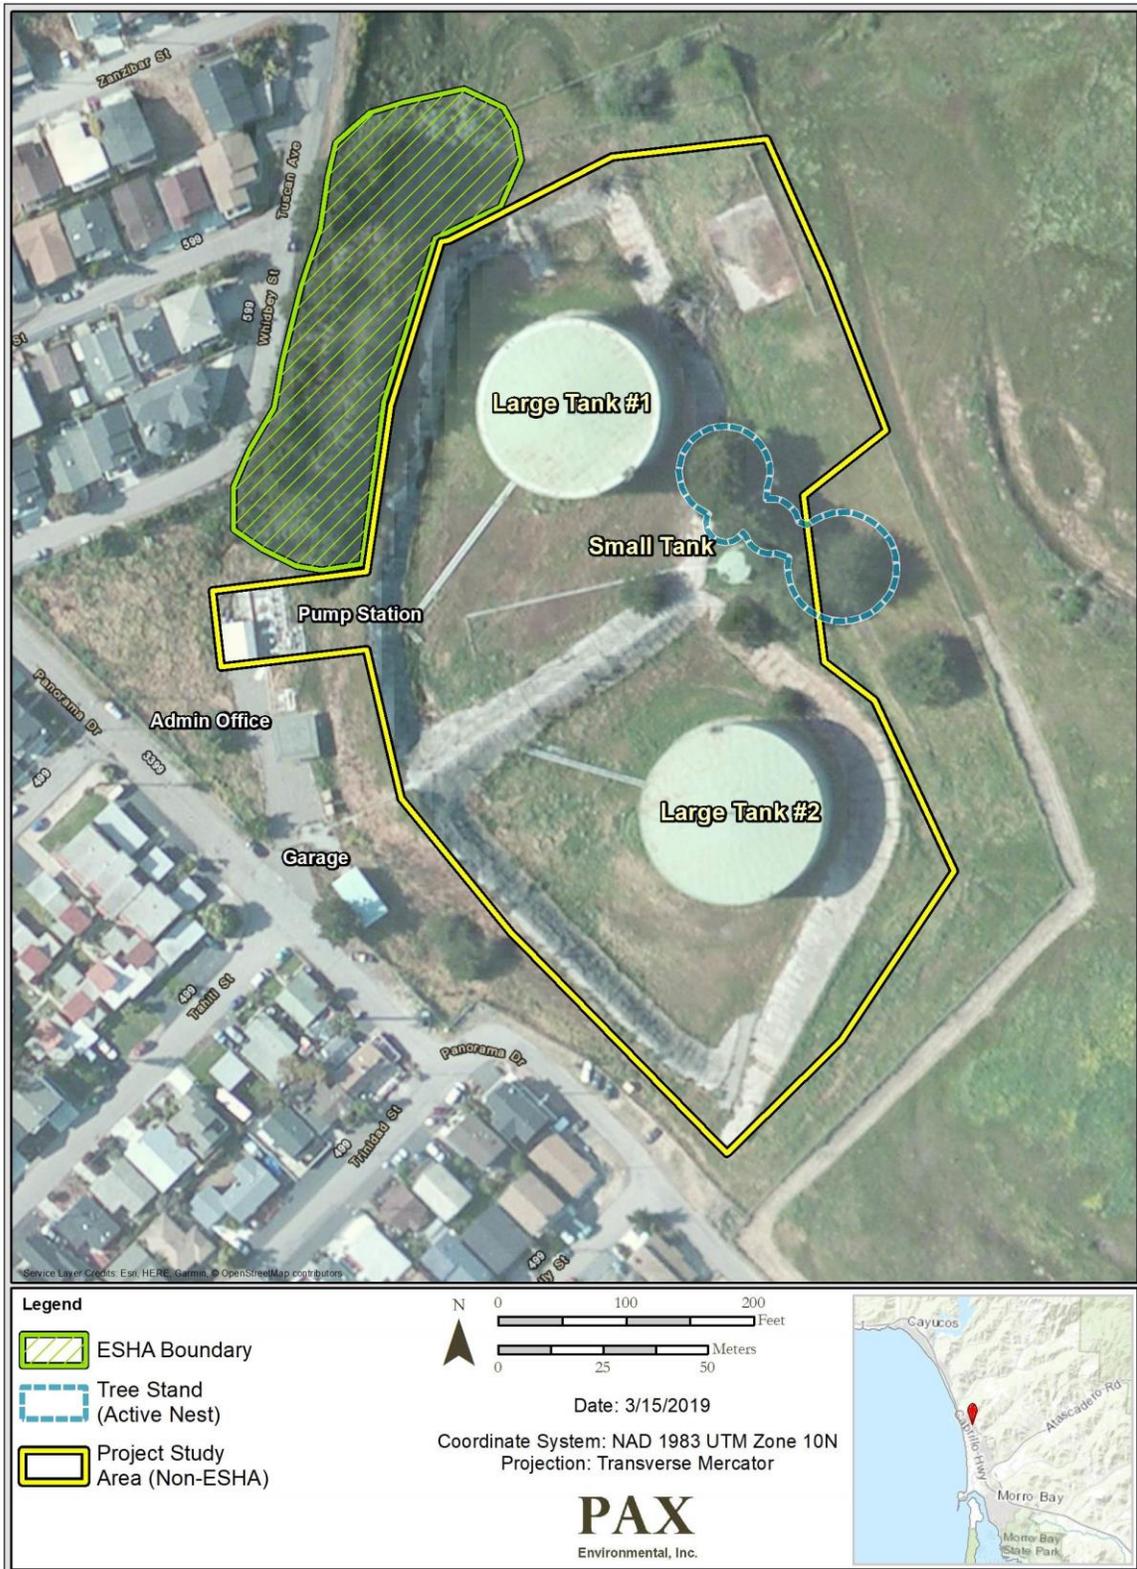
In the east side of the project area where the water tanks are located, one active nest (i.e., nests containing eggs or chicks) was observed in the stand of Monterey cypress. A great horned owl nest was observed in the crotch of one of the trees (Figure 3). Limbs on that tree were cut prior to construction in September/February to expose the shotcrete for removal (Photo 4). Both owls were observed, one roosting on the branches of the tree, the other flushed from the crotch of the tree. This species natural history indicates only the female incubates eggs, while the male roosts nearby in the tree¹. The eggs were not visible in the nest from the ground. Based on the observed behaviors, the pair is likely nesting. Additionally, based on the timing of nesting for this species, they likely began nesting in February and are incubating eggs. In the southern extent of this species range, incubation typically begins as early as mid-February. Pellets and white wash were observed near the base of the tree.

Figure 3: Project site, ESHA boundary, and active nesting area.

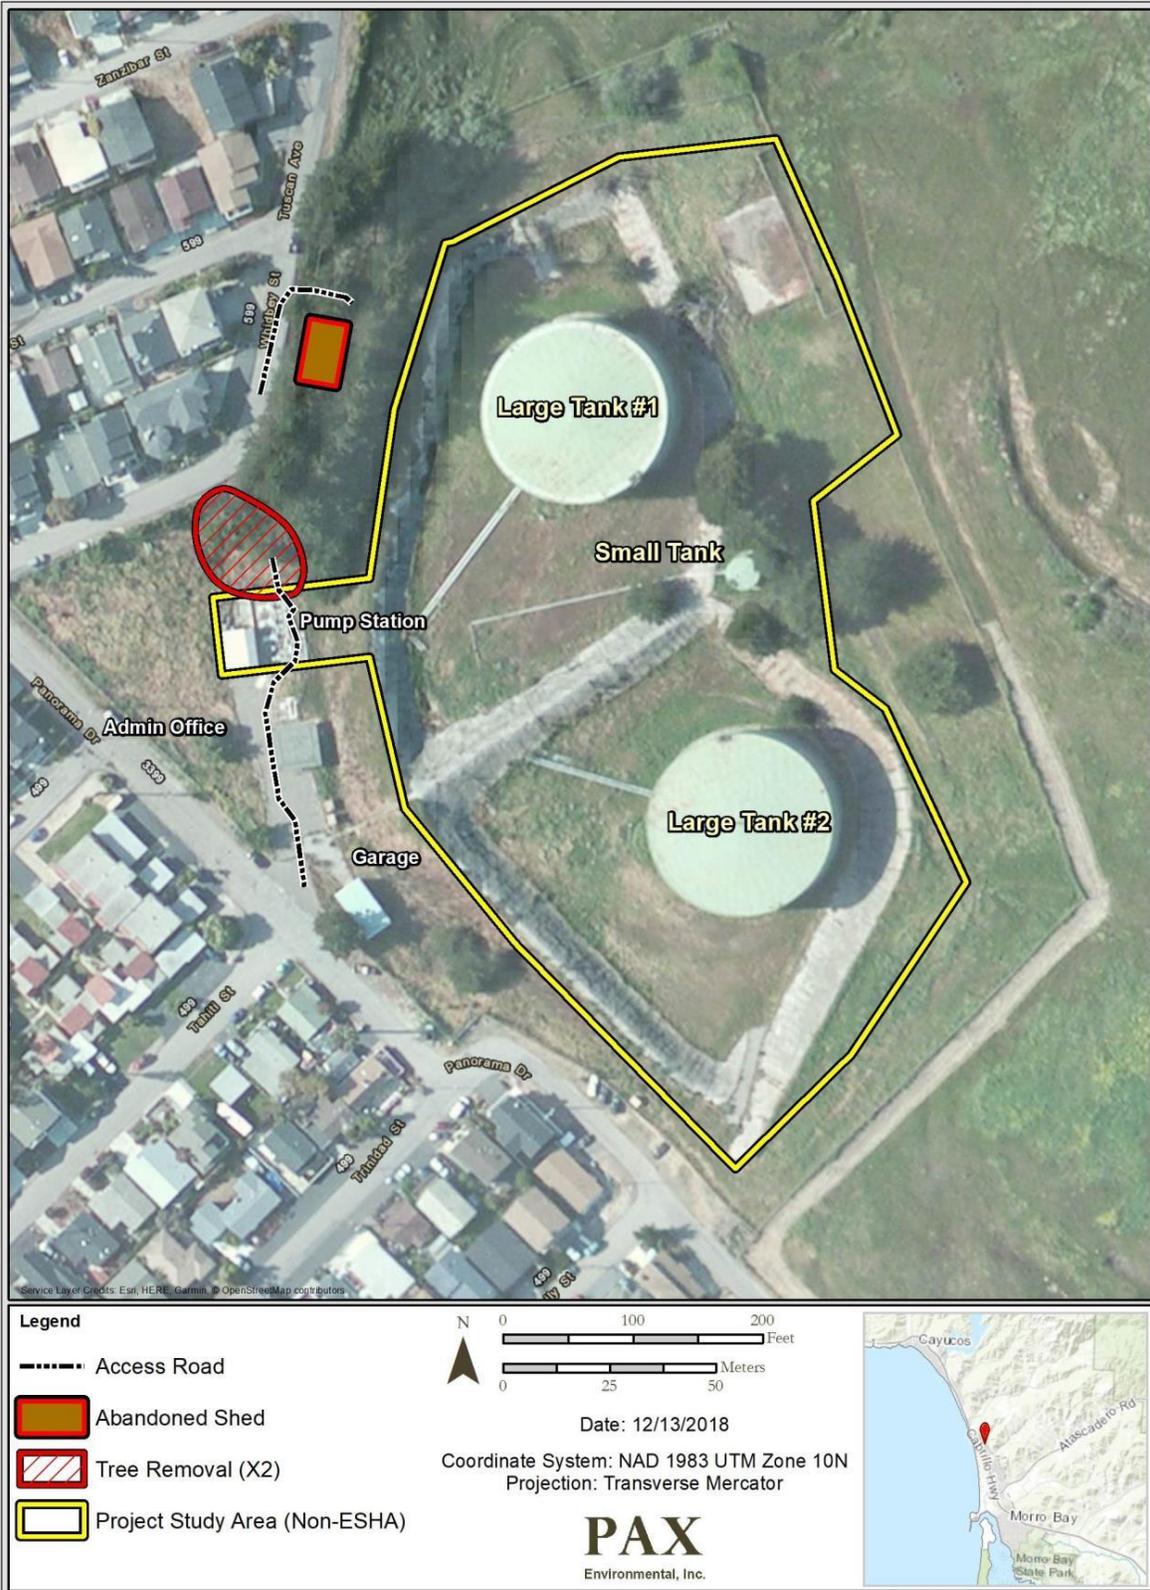
In the ESHA zone, there was no significant impacts to vegetation or soil within the woodland. The creek was flowing during the site visit. Where the shed was removed, in the west central section of the ESHA, the recommended access route was used through the existing gate, and minimum soil and vegetation impacts were observed, the concrete foundation remains (Figure 4, Photo 7). Where the 6 inch pipeline was removed, the soil is compacted, however the vegetation is re-growing. The fallen Monterey cypress was removed that fell south over the creek and the dead pine on the top of the north bank, crews used the recommended access route to limit impact to the water course (Photo 6). Some debris remains within the creek; however, this debris was present prior to any work activities beginning. There was no construction related impacts

Figure 4: Tree and shed removal area with recommended access route.

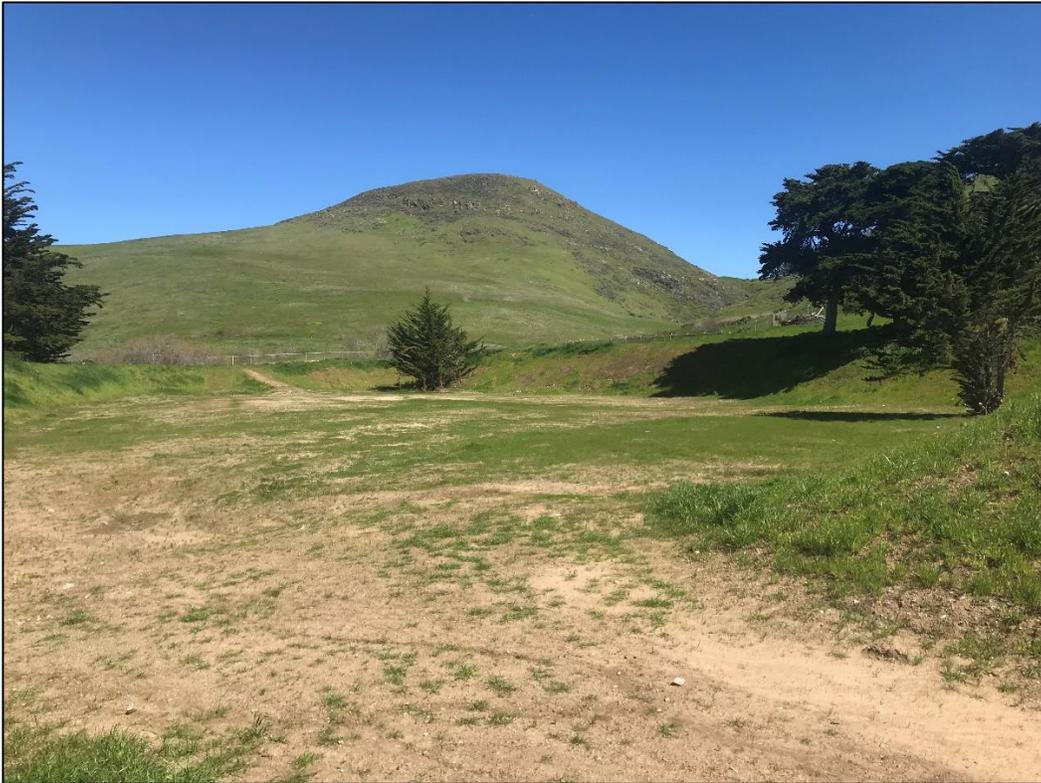
Photo 1: Fuel tank 1 removed, facing northeast.

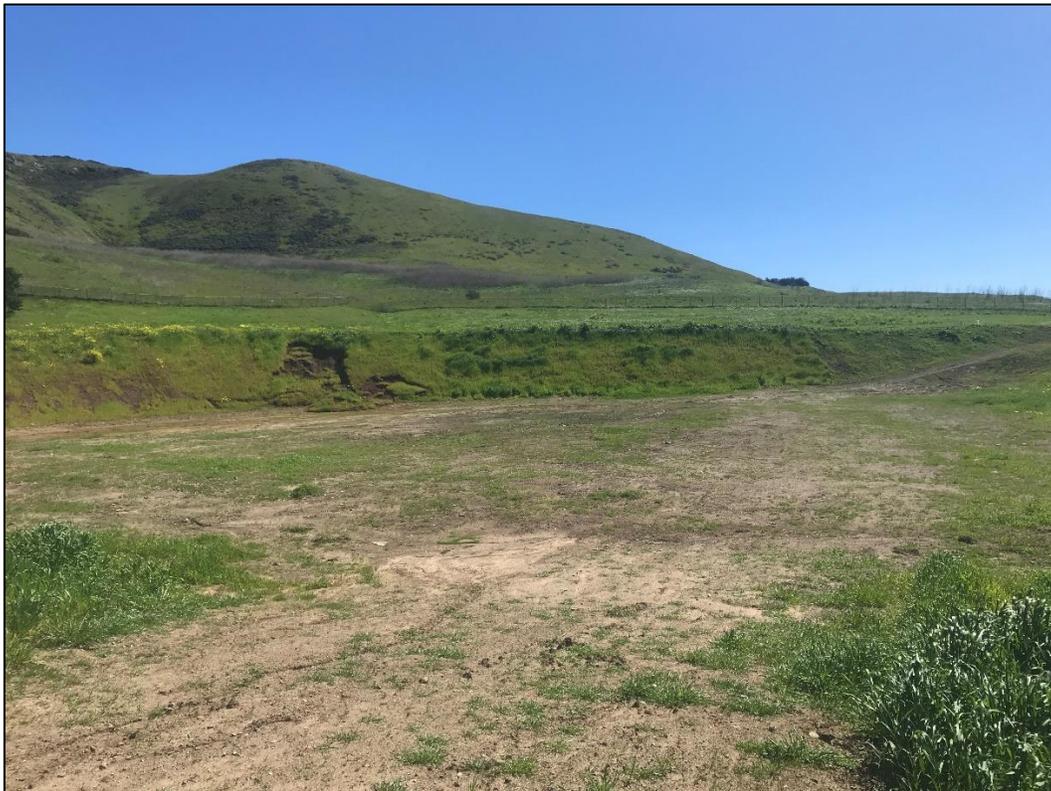
Photo 2: Fuel tank 2 removed, facing southeast.

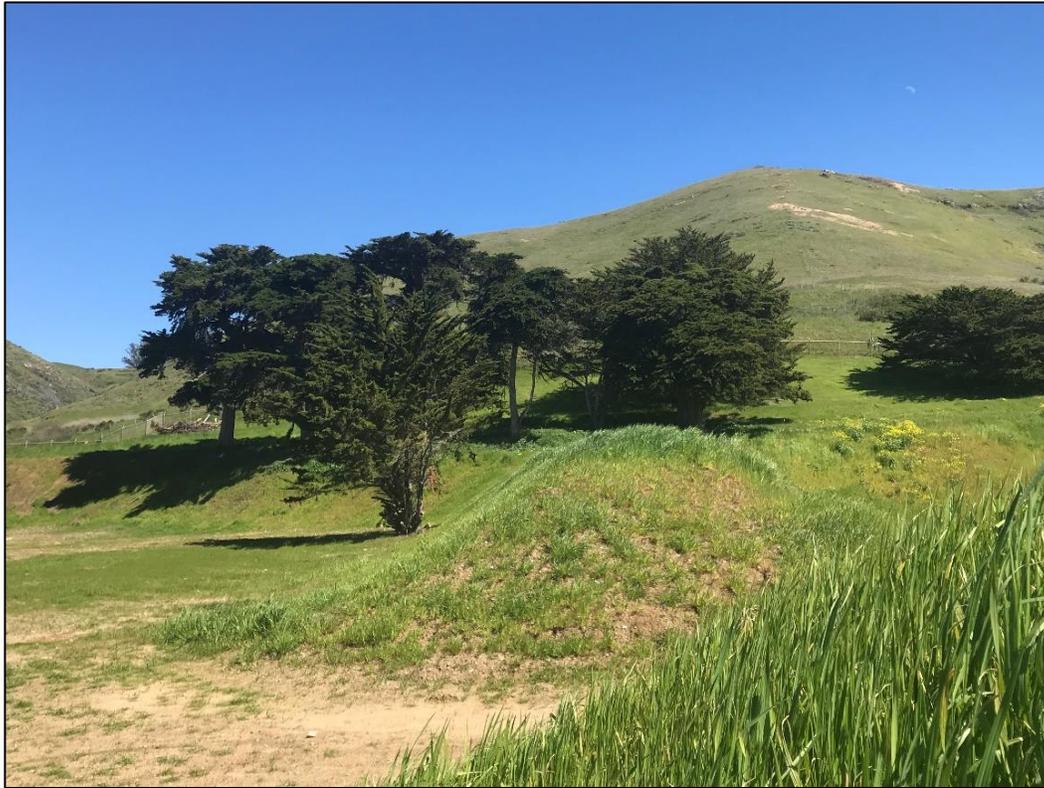
Photo 3: Small water tank removed, facing east.

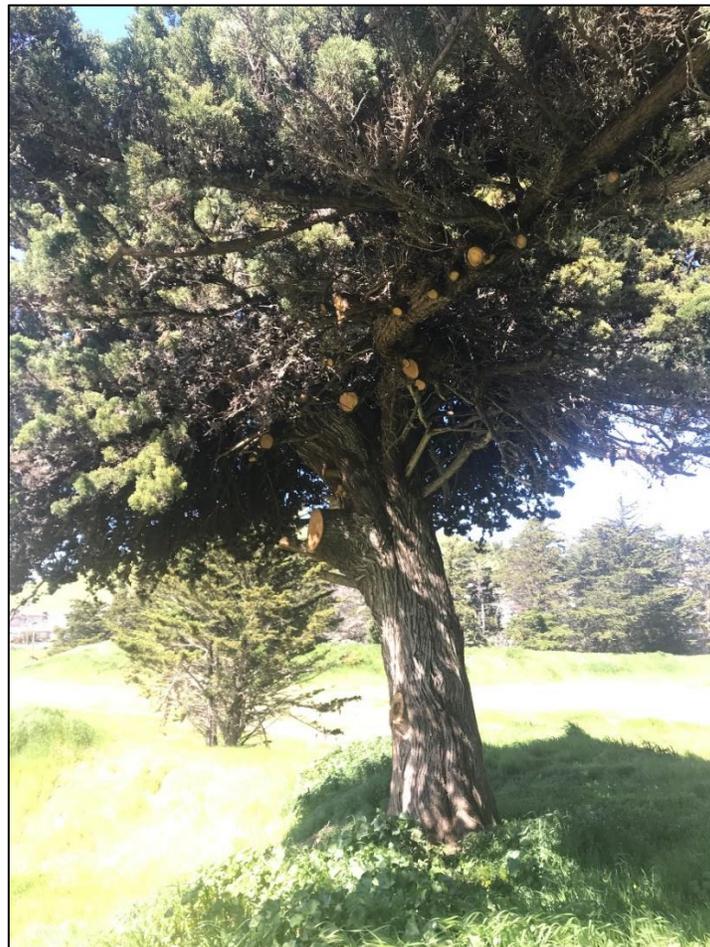
Photo 4: Trimmed Monterey cypress facing north.

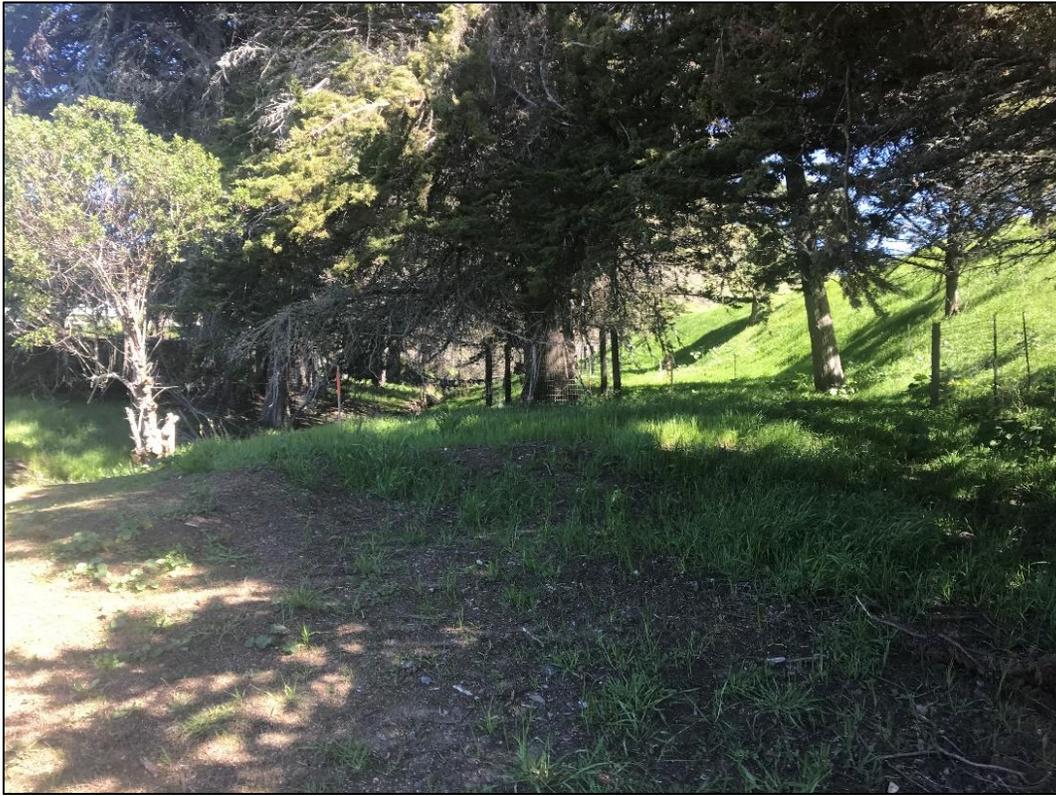
Photo 5: Removal of 6" pipeline, facing east.

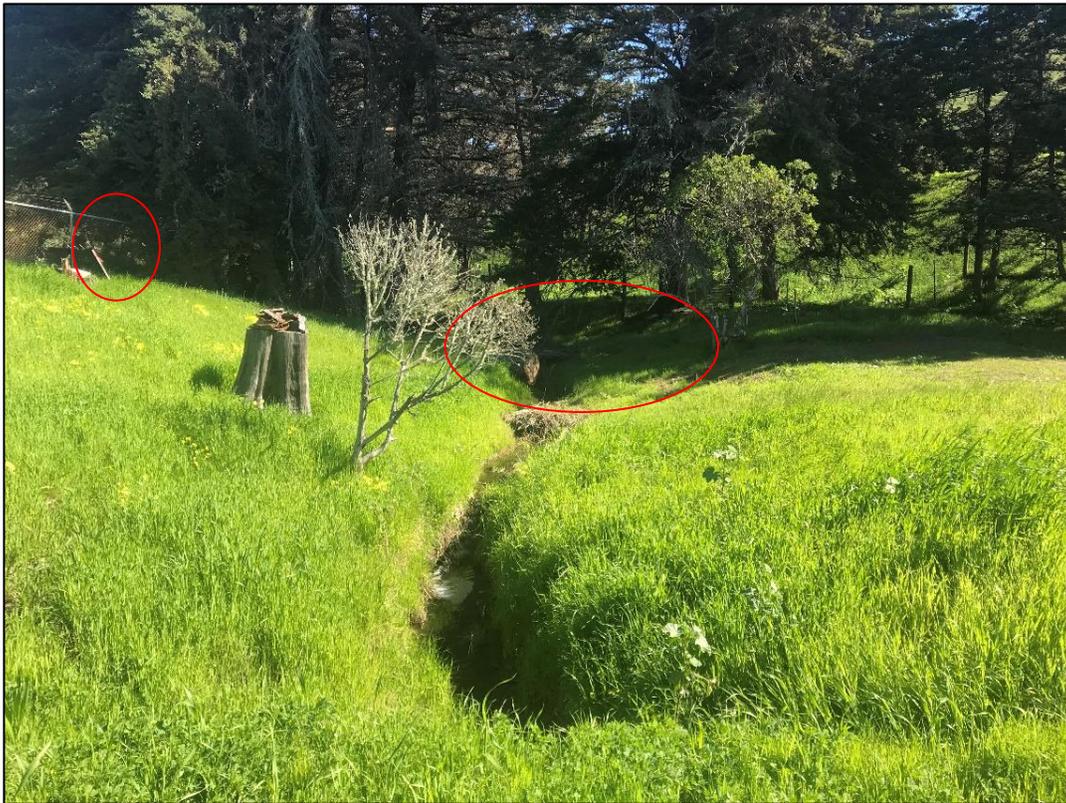
Photo 6: Creek with flowing water, wo trees removed (circled in red) west of ESHA, facing east.

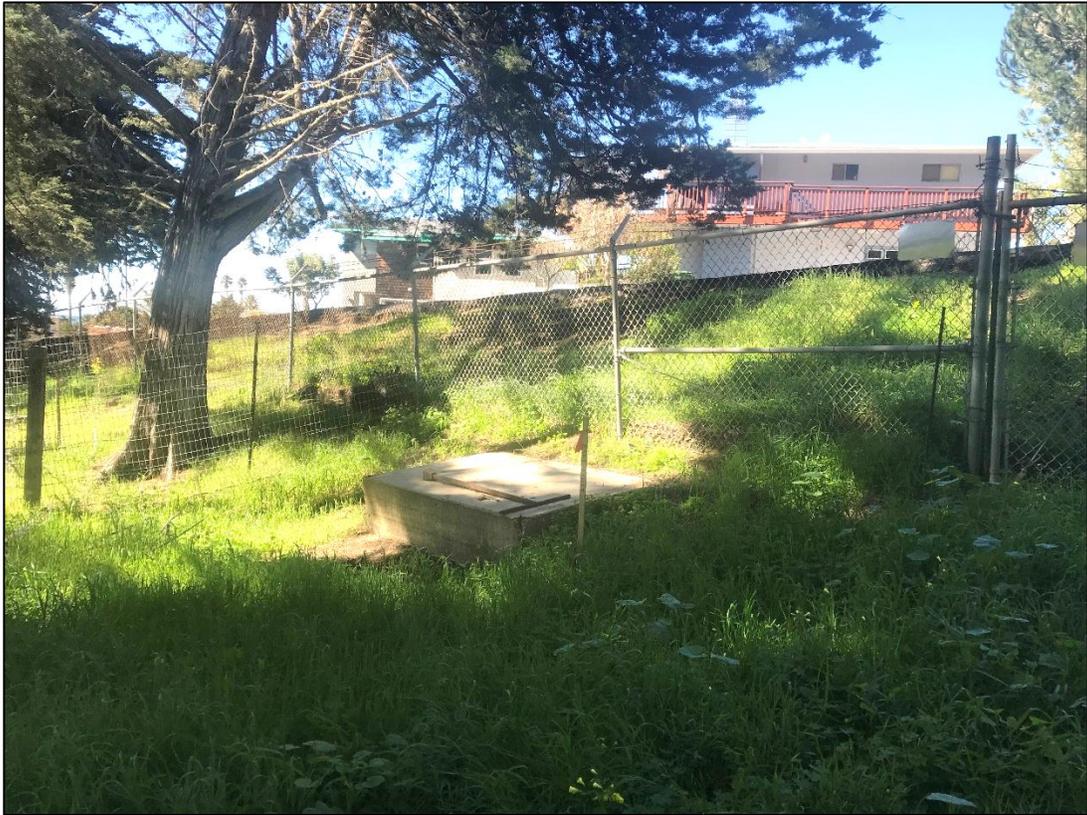
Photo 7: Shed and fire hydrants removed on edge of ESHA, facing northwest.
