# Morro Bay Revetments and Seawalls

# SCOPE OF WORK SUMMARY

# Seawall and Revetments – BACKGROUND

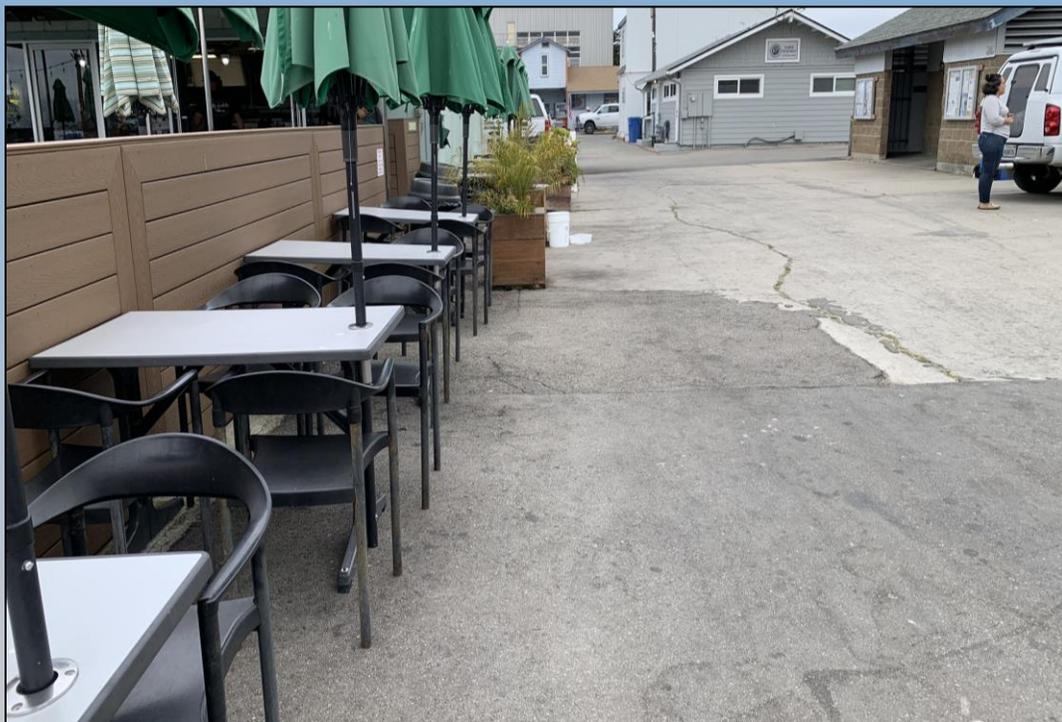
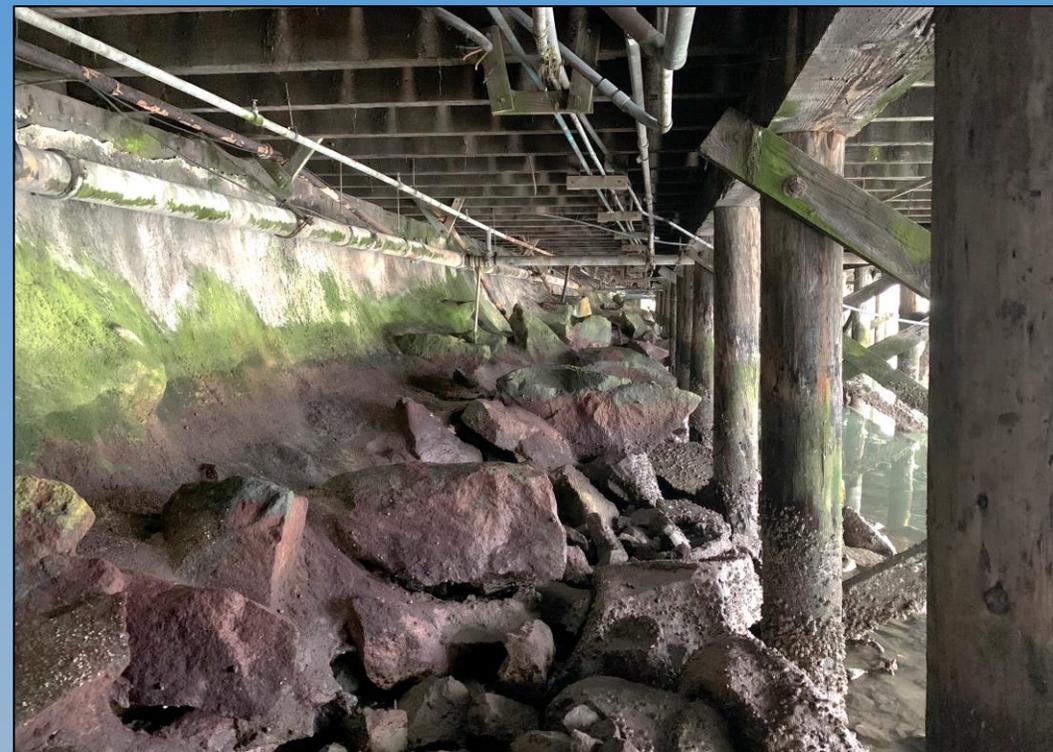
- ◆ Starts at the south side of the North-T Pier, following Revetment 3, and continues 87 feet under Tognazzini's Dockside wharf which supports a building and outdoor dining area.

- ◆ The wall is covered with a layer of shotcrete in *fair* condition, however further investigation is required to properly assign a condition to the tie-back wall structure.

- ◆ **Seawall 1:** Further investigation needed
- ◆ **Seawalls 2 and 3:** Replace in-kind or build new revetment.

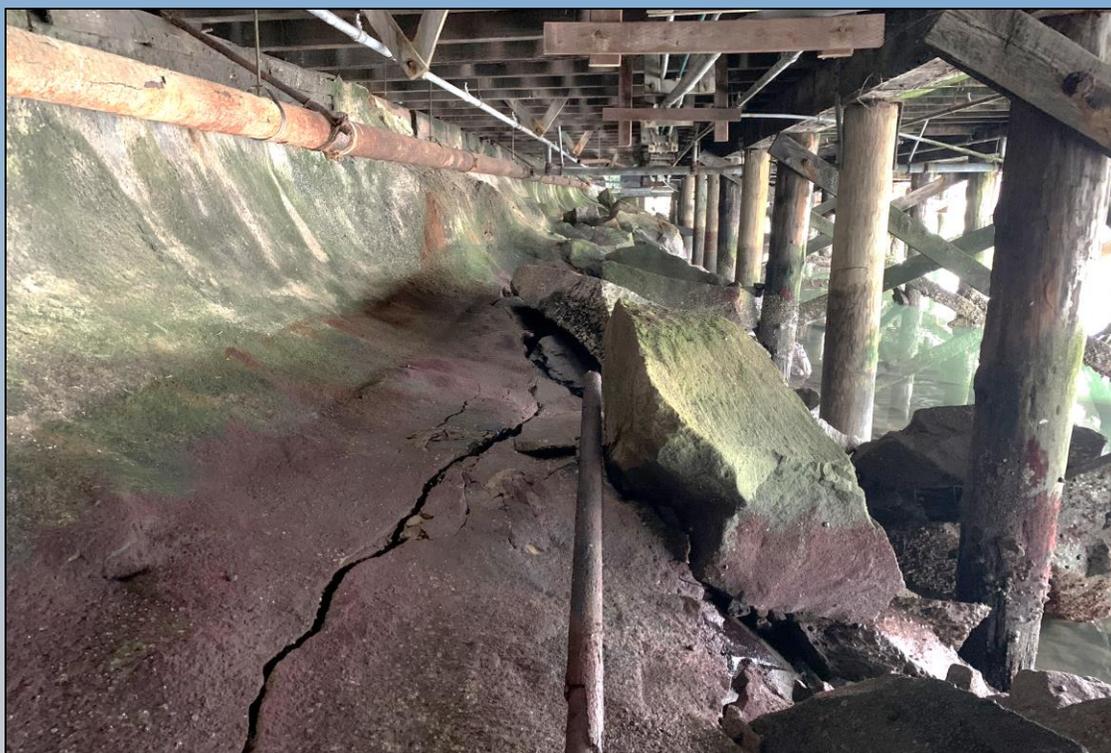
- ◆ Cracks in the shotcrete layer were typical (see left).

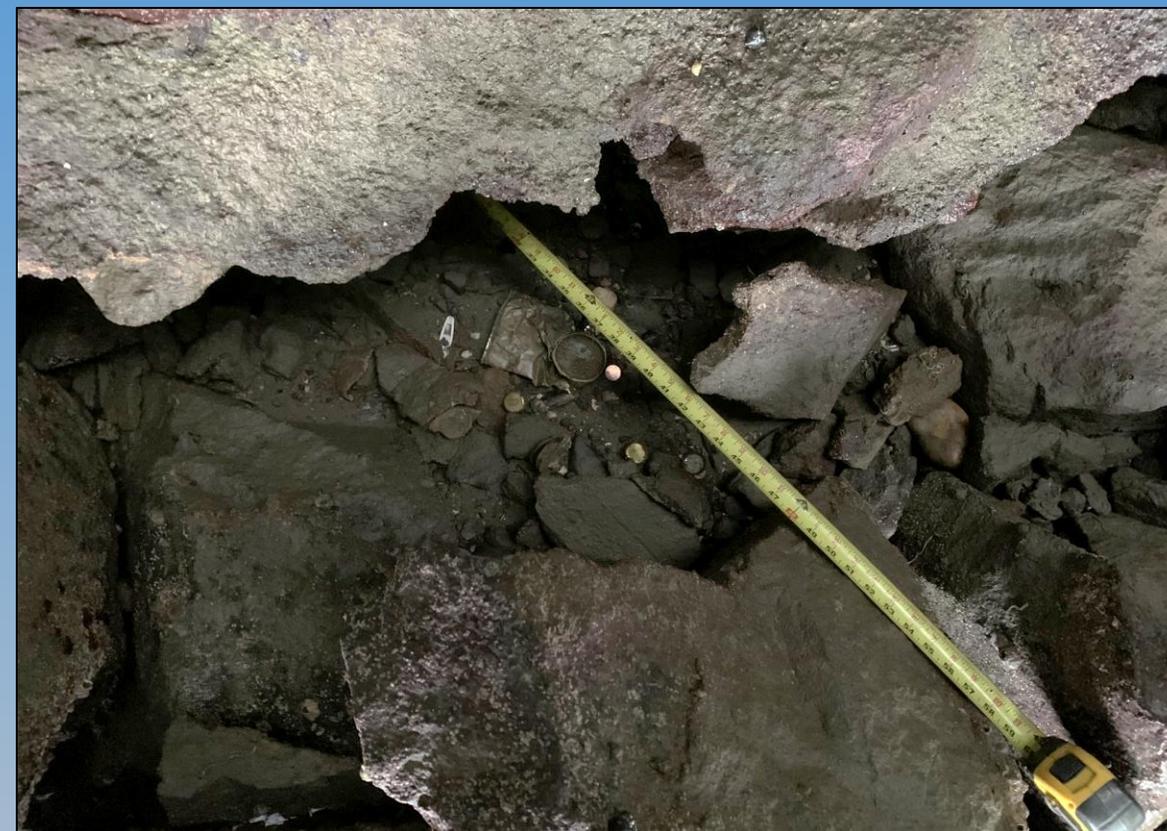
- ◆ Undermining of the shotcrete layer placed in front of the seawall was typical (see right).

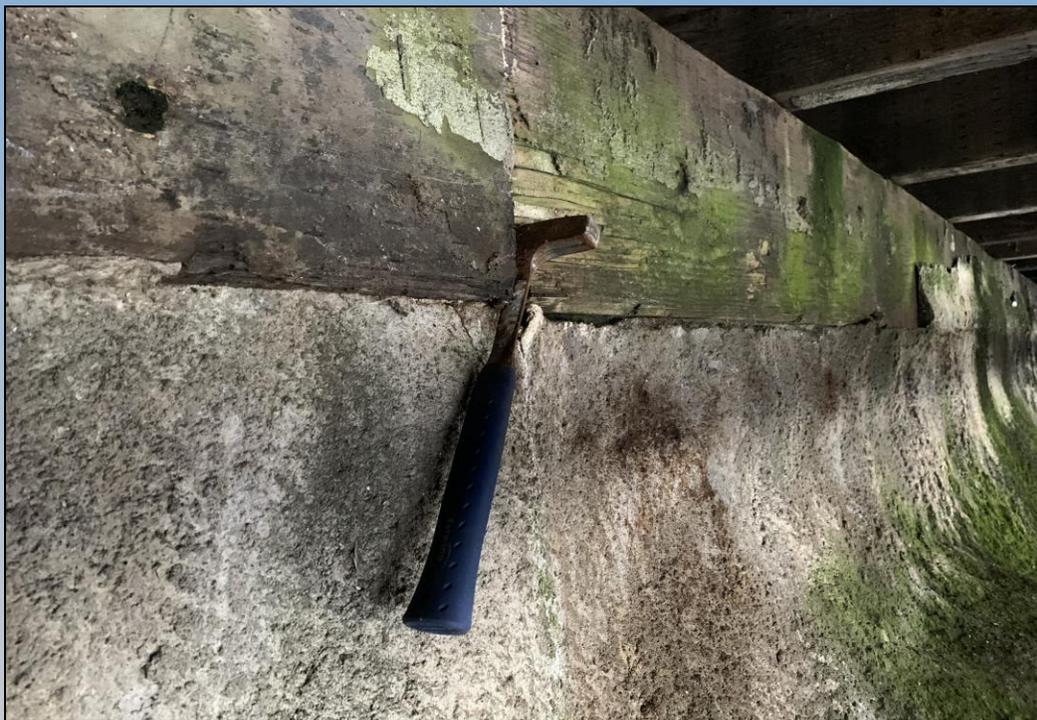
- ◆ 14-inch-high timber cap, extending the length of the wall, exhibits severe decay and section loss due to marine borers (see left).

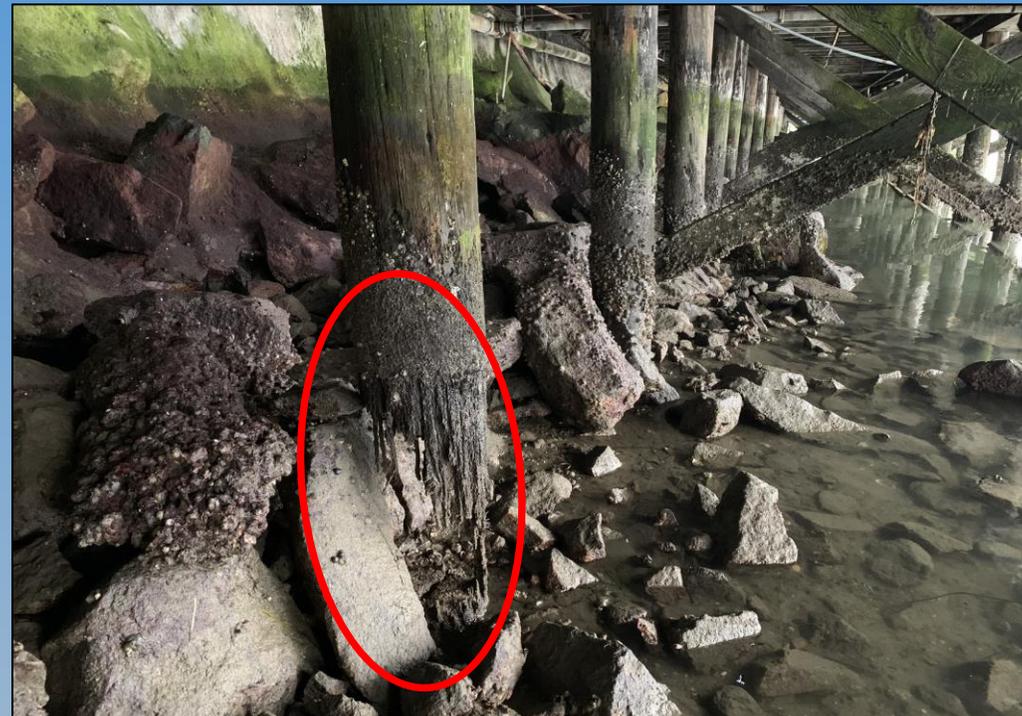
- ◆ Several timber piles show significant damage due to marine borers. Pile shown at right has 100% section loss.

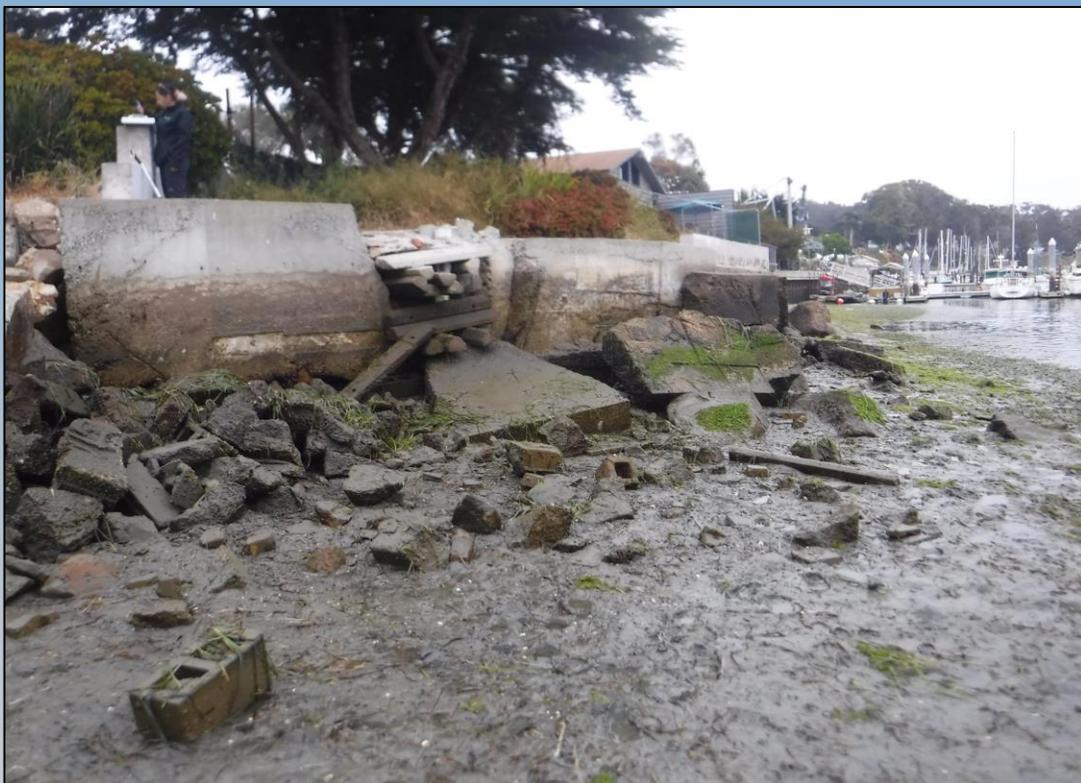
- ◆ Seawall 2 is in **critical** condition, with various stages of construction/repairs. The original wall has failed and the repairs have also failed (see left).

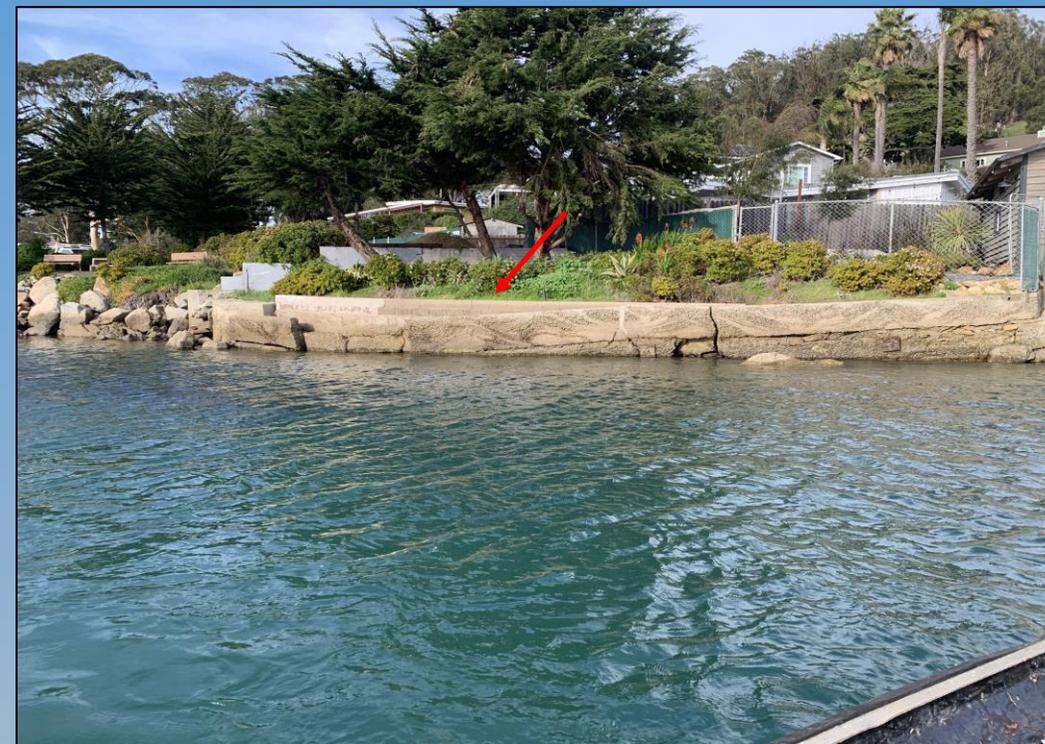
- ◆ Concrete structure south of Revetment 12 and public boat launch, extending 84 feet (see right).

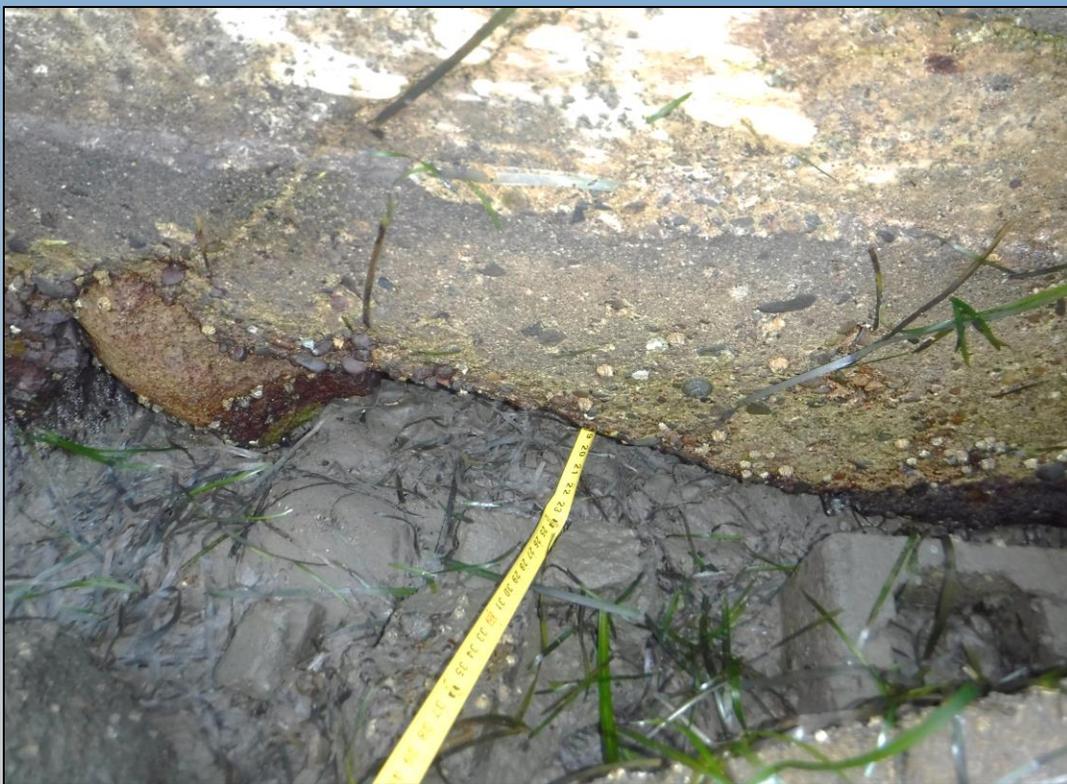
- ◆ Undermining of the wall up to 2 feet deep can be seen (see left).

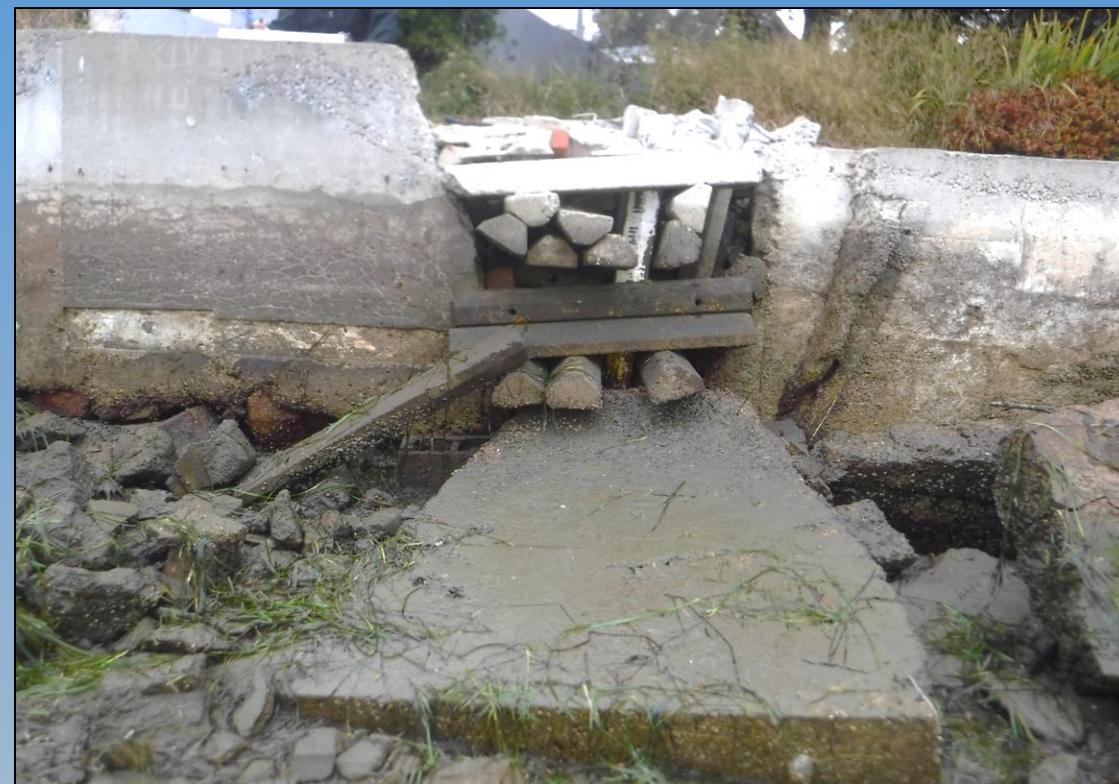
- ◆ **Failed** section of the wall, various sections of concrete have been placed in the void to retain the soil (see right).

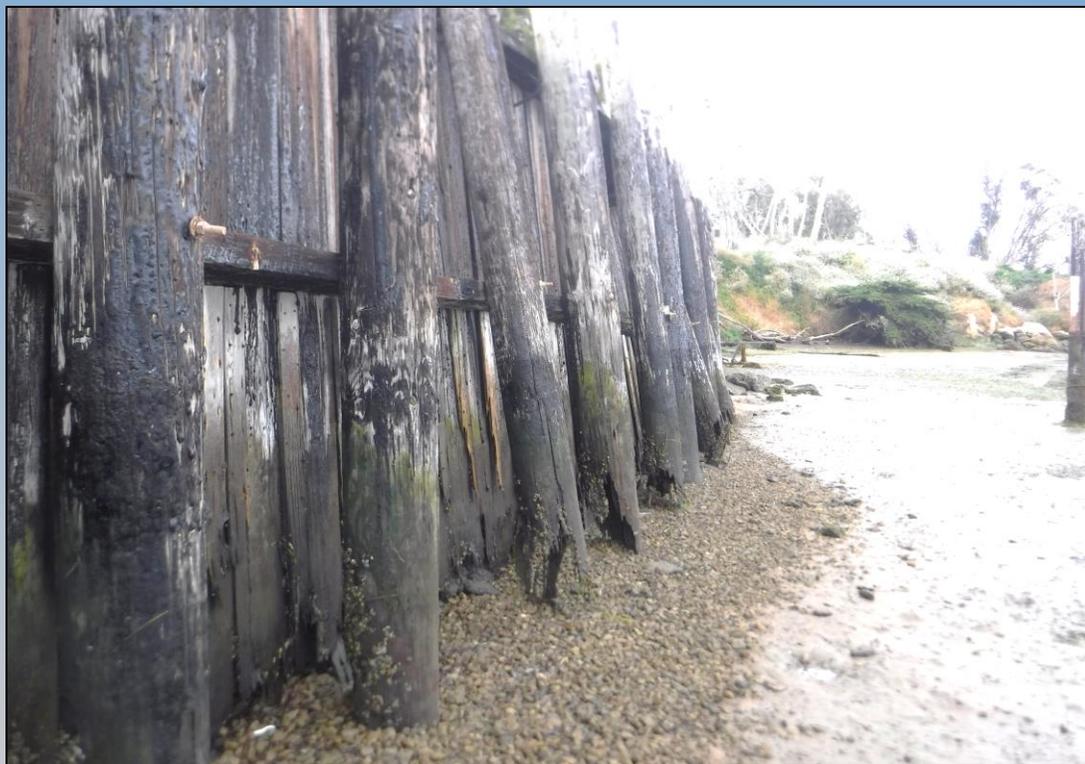
- ◆ In ***critical*** condition as decay and marine borer damage has degraded the lower portion of the sheet piles (see left).

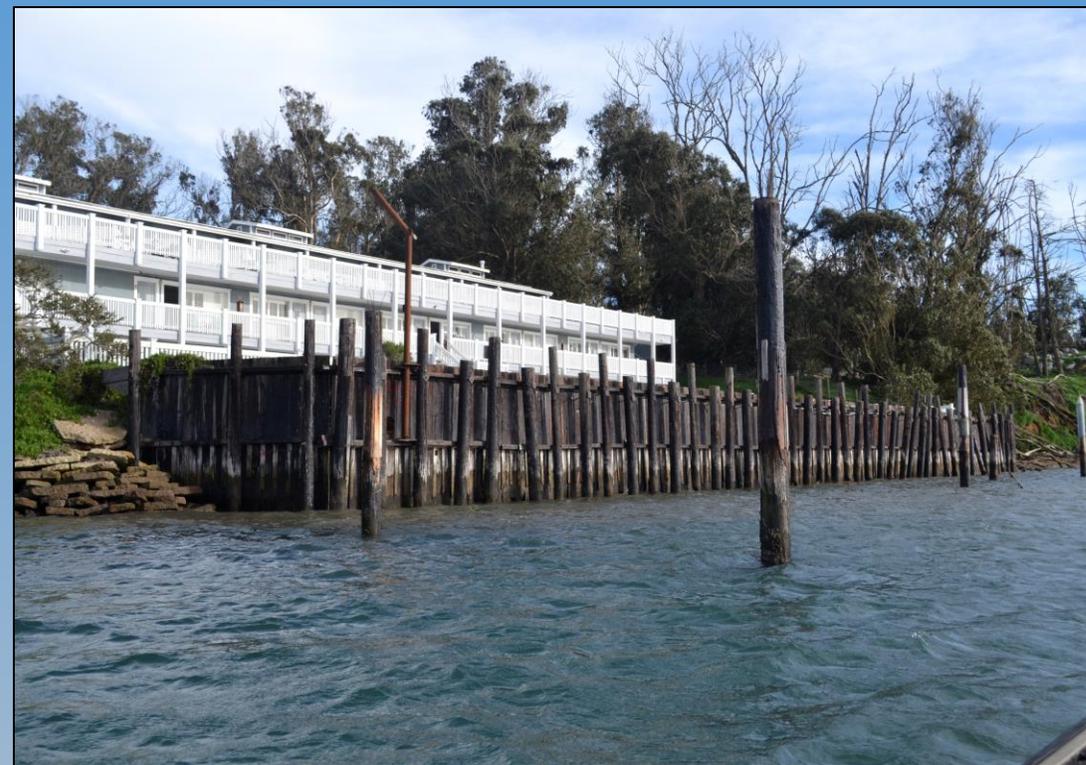
- ◆ Located behind the Inn at Morro Bay extending the length of the parking lot and is 213 feet long (see right).

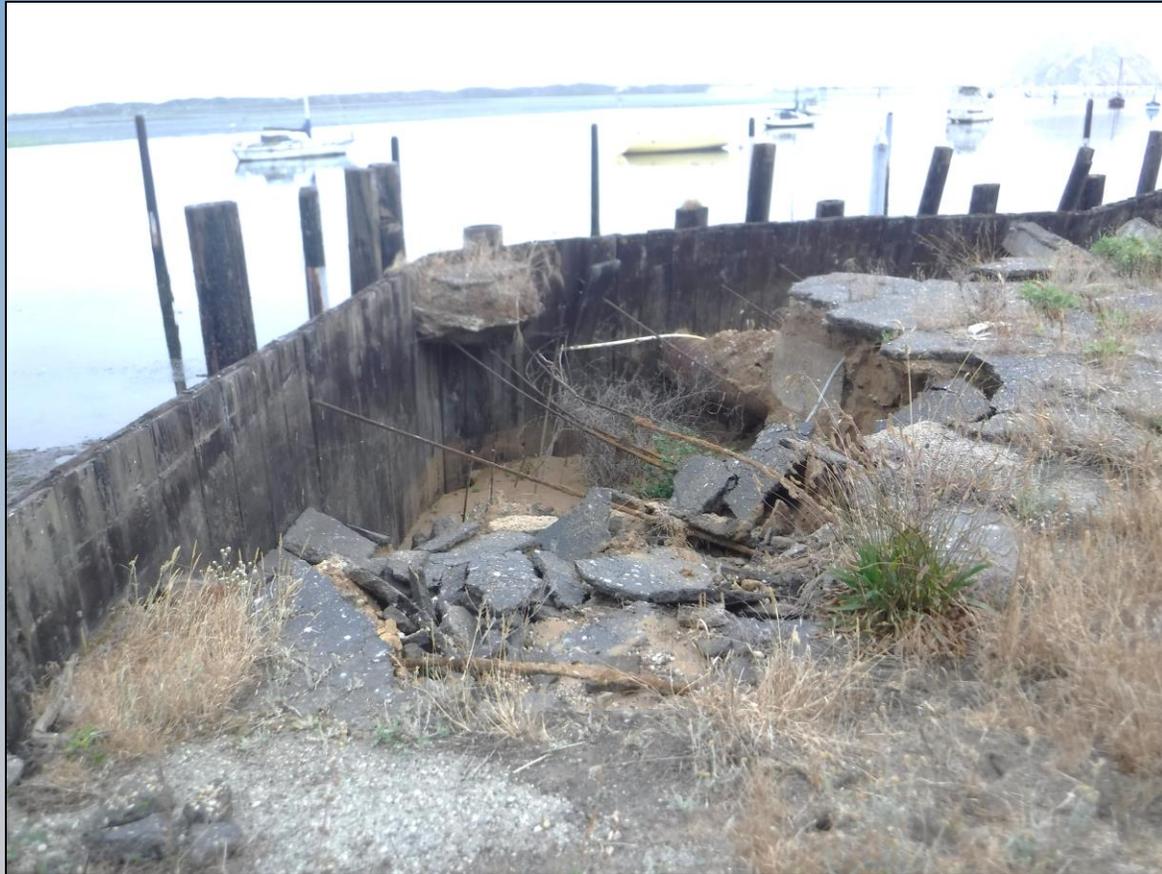
- ◆ Significant voids behind the wall and failure of the AC paving (see left).

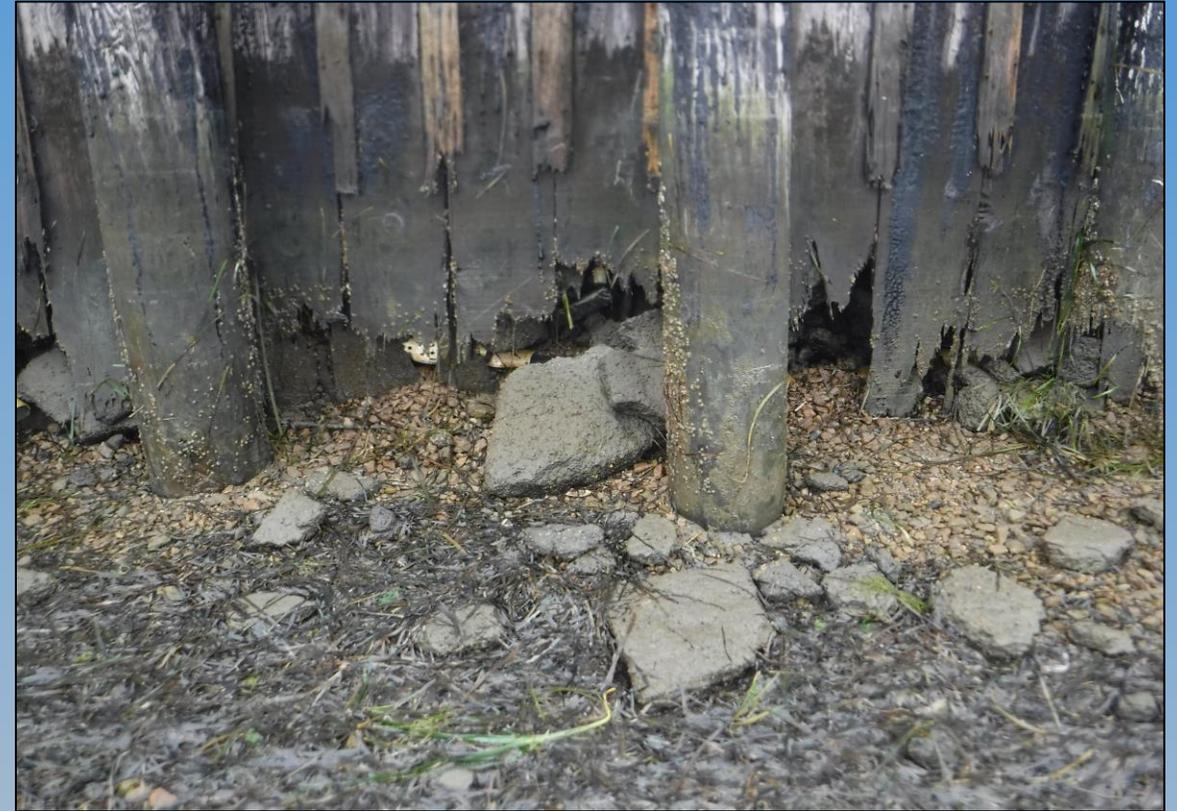
- ◆ Retained soils migrating through the wall (see right).

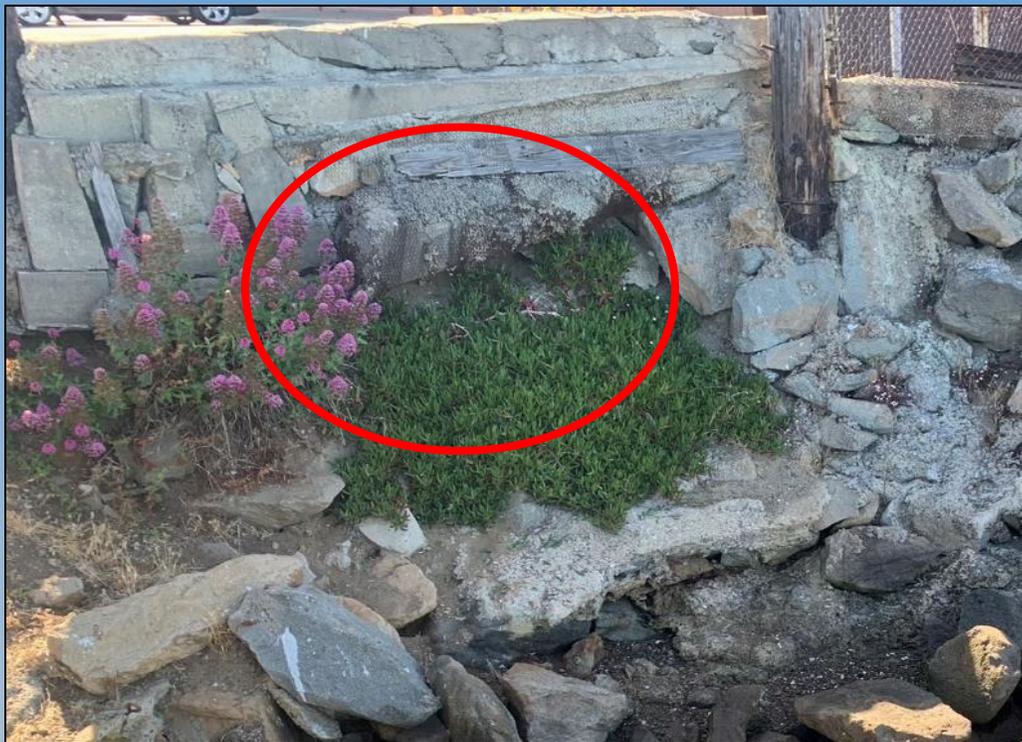
- ◆ **Makeshift portion Revetment 9 made up of miscellaneous pieces of concrete and timber debris.**

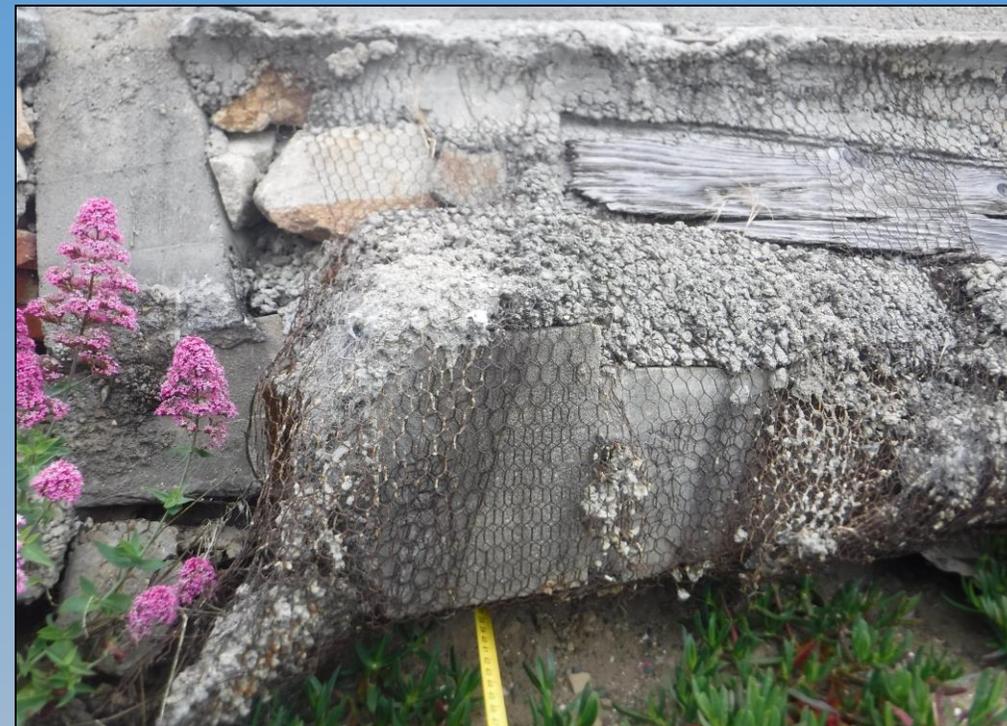
- ◆ **A portion of the wall is undermined by up to 3.5 feet.**

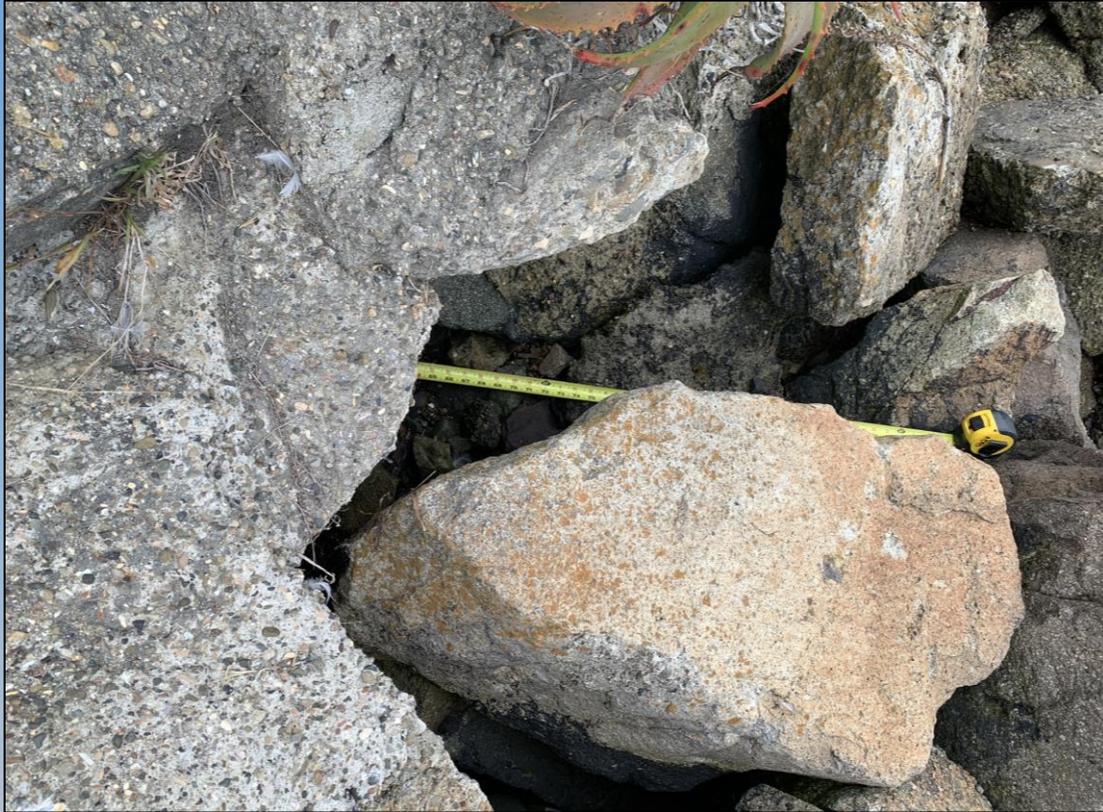
- ◆ Significant void up to 6 feet deep at Revetment 3, which is in serious condition.

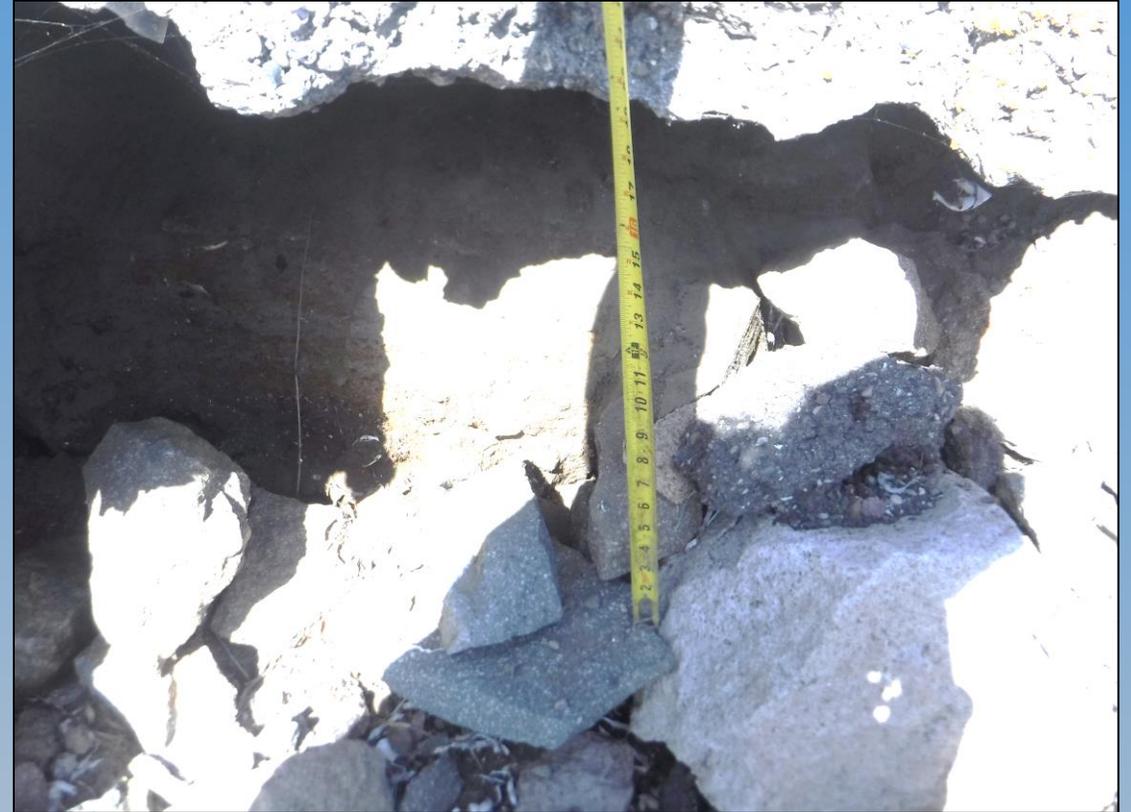
- ◆ Significant 2-foot-high void, extending 15 feet along Revetment 4.

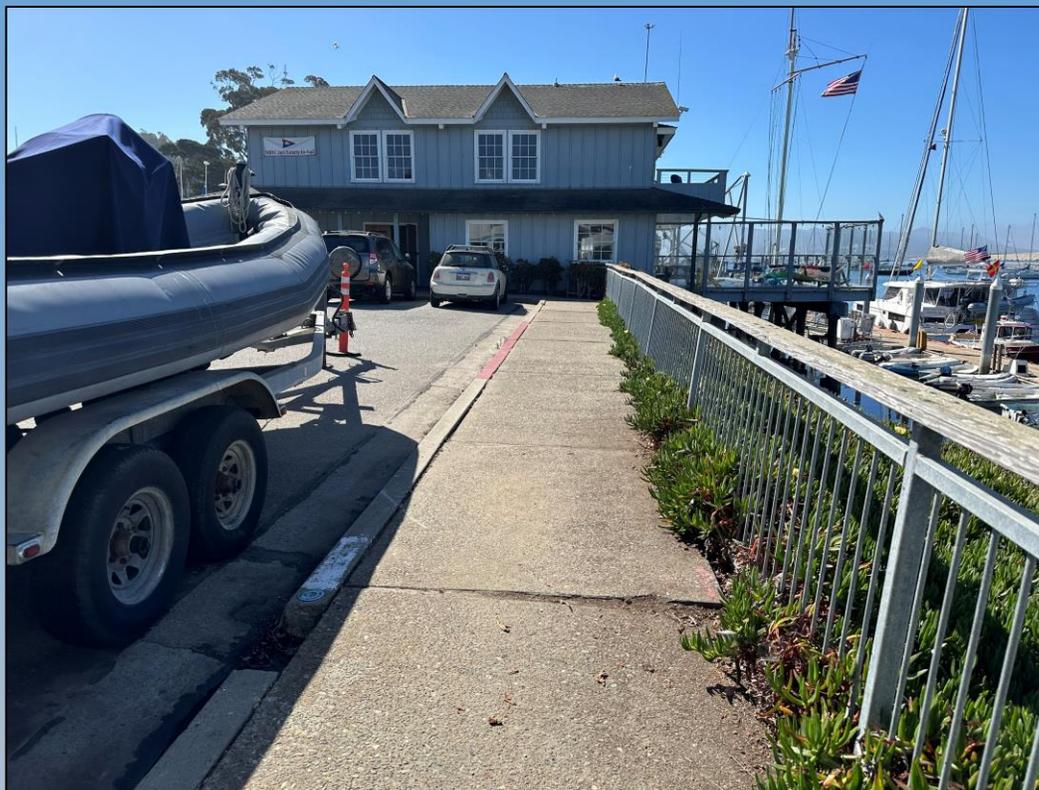
- ◆ Settlement observed at the sidewalk, and the sidewalk and railing are rotated towards the water at Revetment 10.

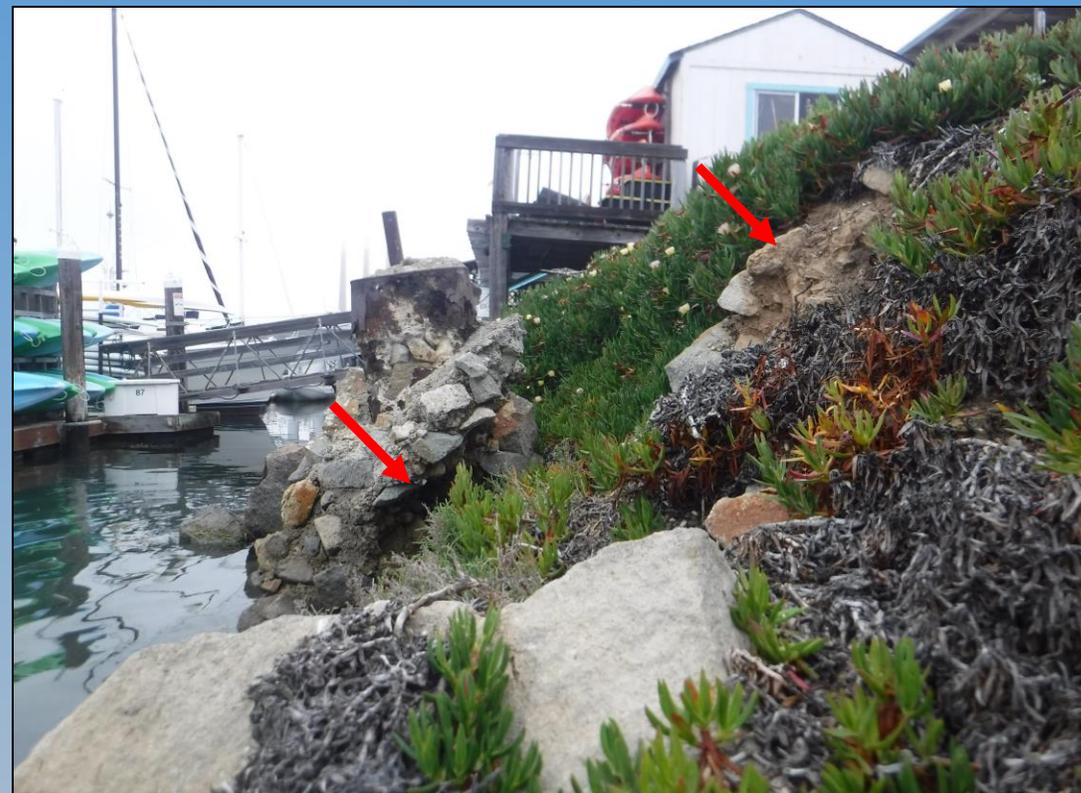
- ◆ Sections of large voids, heavy vegetation, and erosion of fine material at Revetment 10.

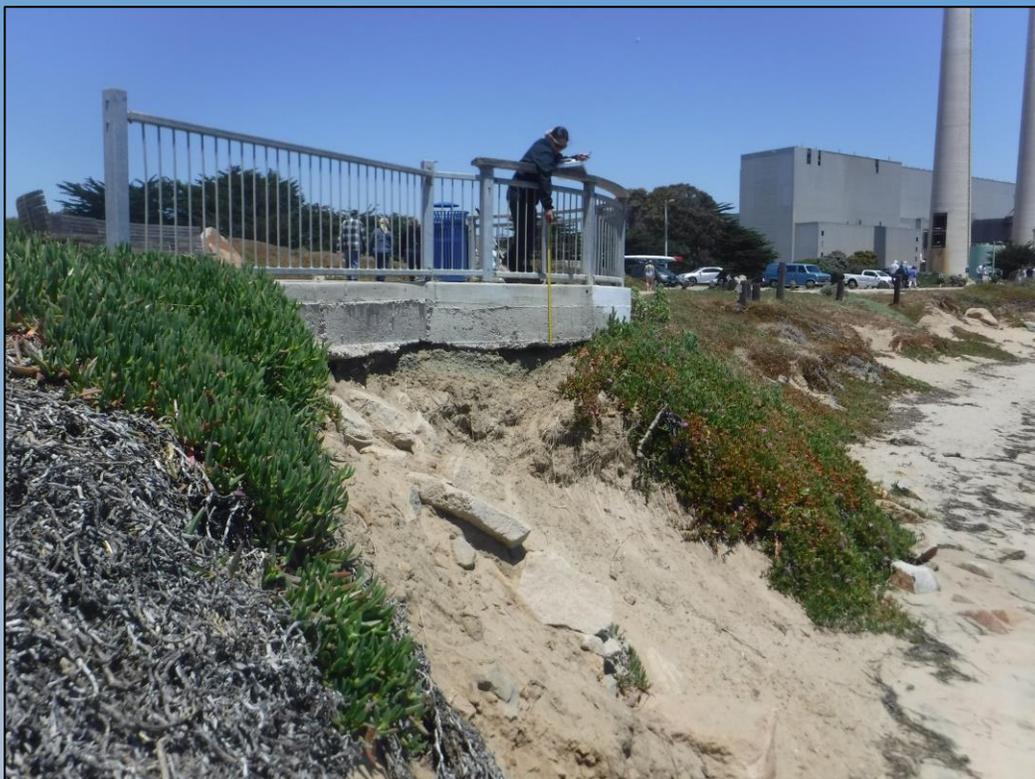
- ◆ Missing rock revetment, erosion, and undermined observation deck footing at Revetment 2.

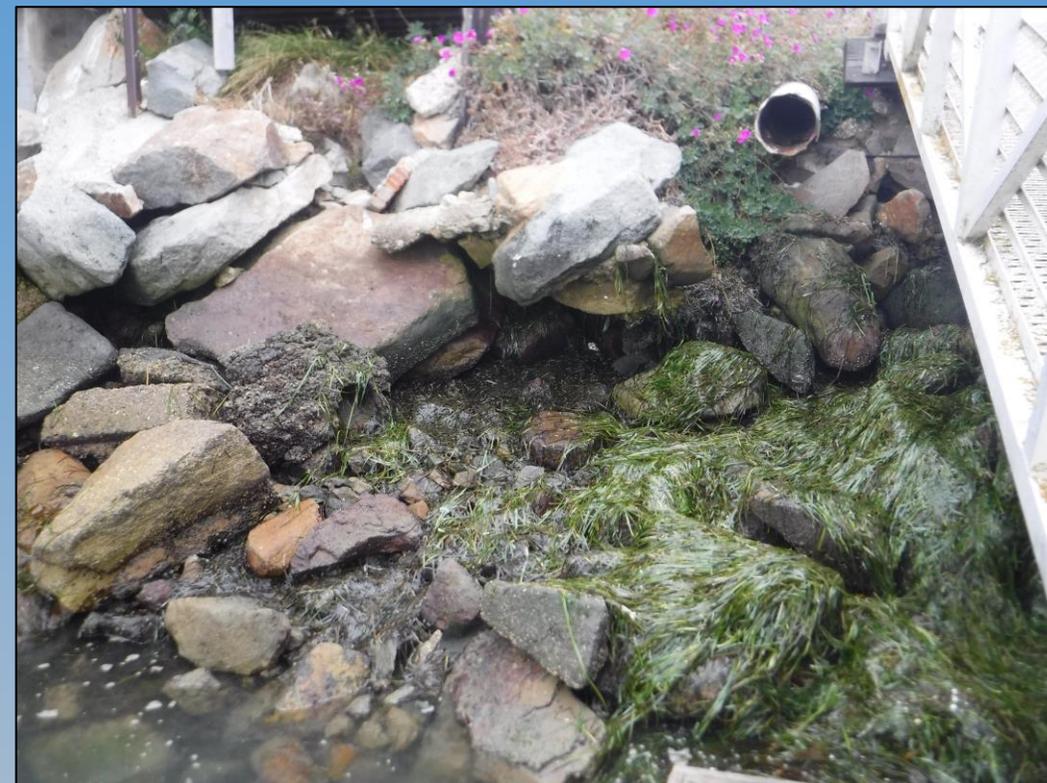
- ◆ Sections of large voids, leaving upper section of rock and drain pipe unsupported at Revetment 7.

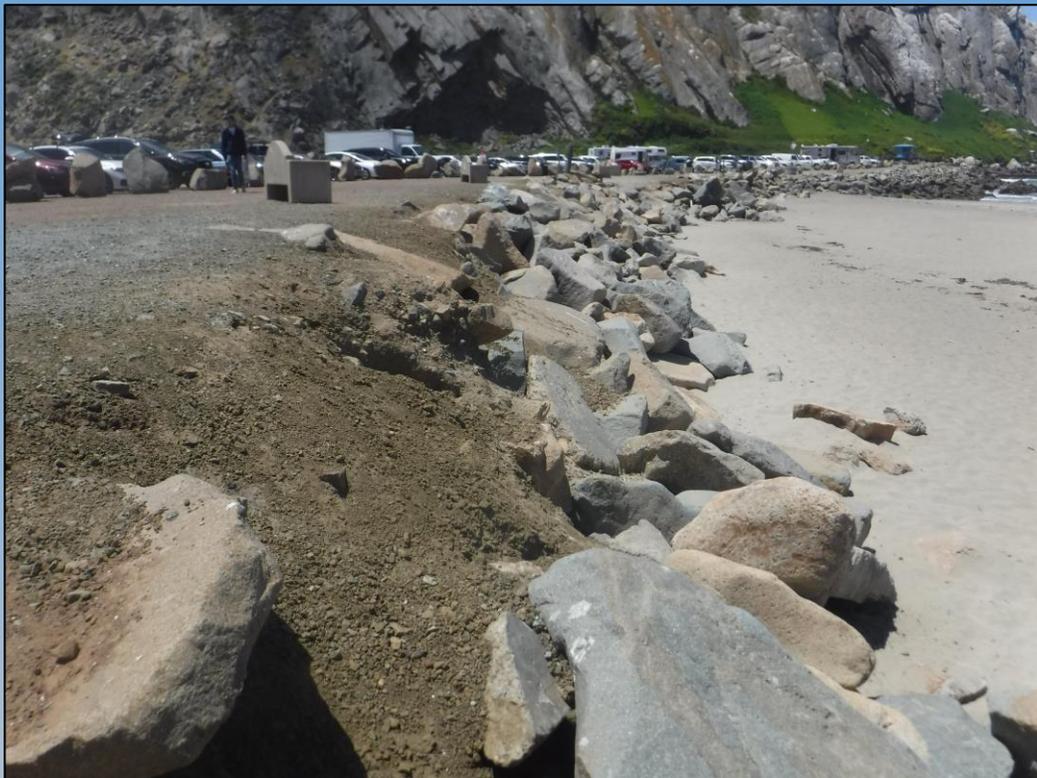
- ◆ Top of slope is not protected. Erosion of fine material and missing rock is noted at Revetment 1.

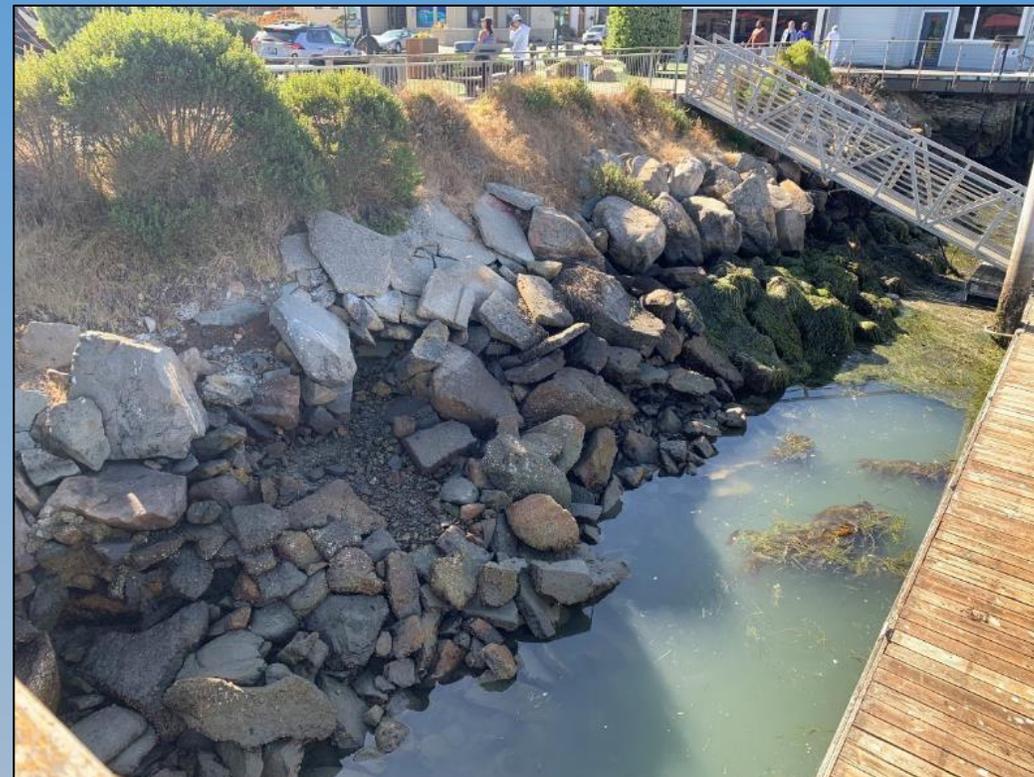
- ◆ Missing armour stone exposes the subgrade at Revetment 7.

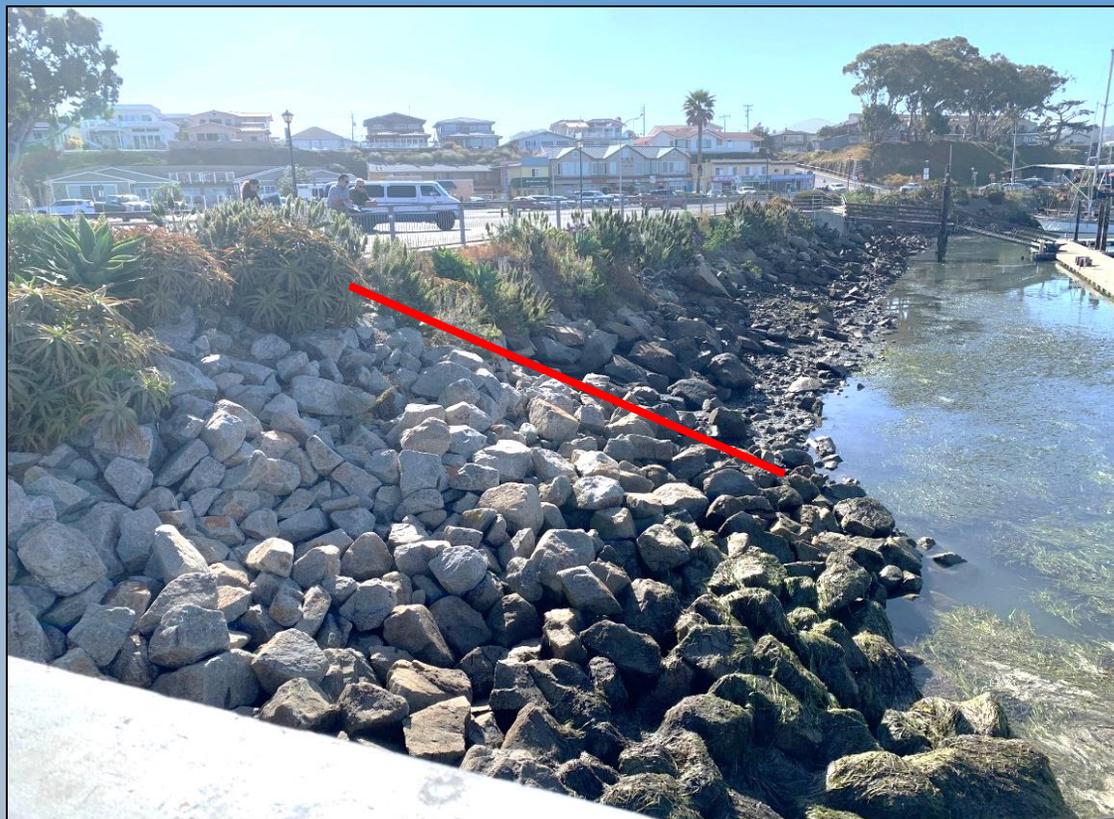
- ◆ Rehabilitated section of revetment transitions to a steeper slope with inconsistent rock sizes and concrete debris at Revetment 4.
