INSPECTION AND ASSESSMENT OF REVTMENTS AND SEAWALLS MORRO BAY, CA

January 23, 2025

Richard Brady & Associates

Subject: Inspection and Assessment of Revetments and Seawalls, Morro Bay, CA

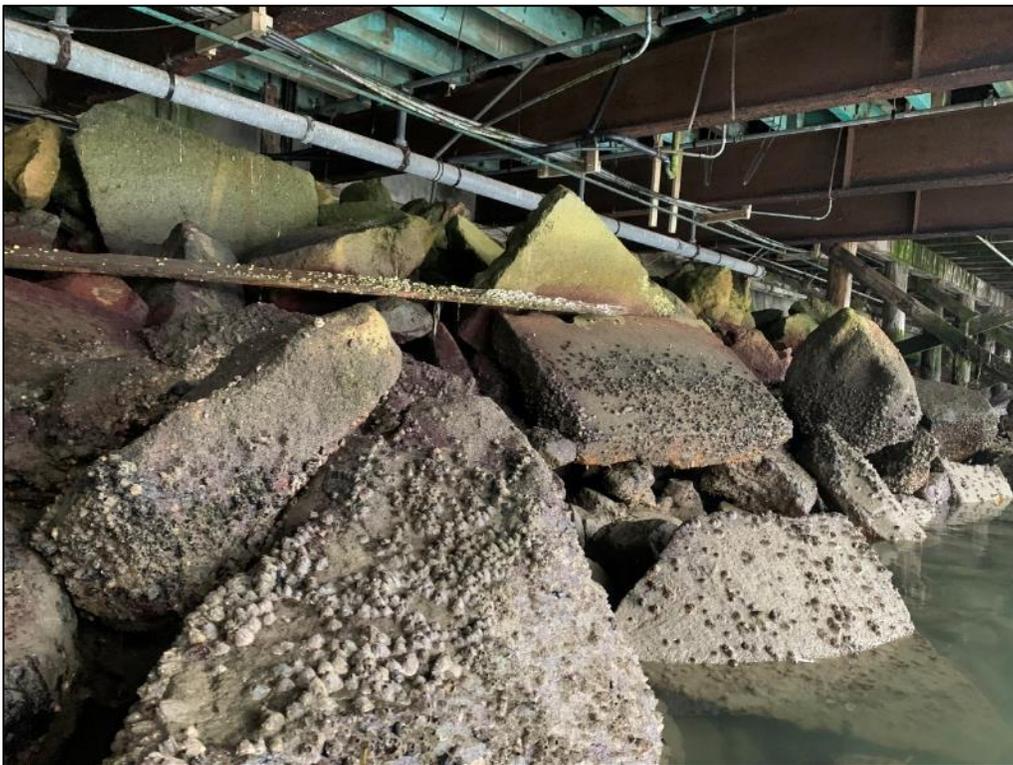
Photo 7. STA 0+00 Looking South at the revetment placed in front of the seawall.

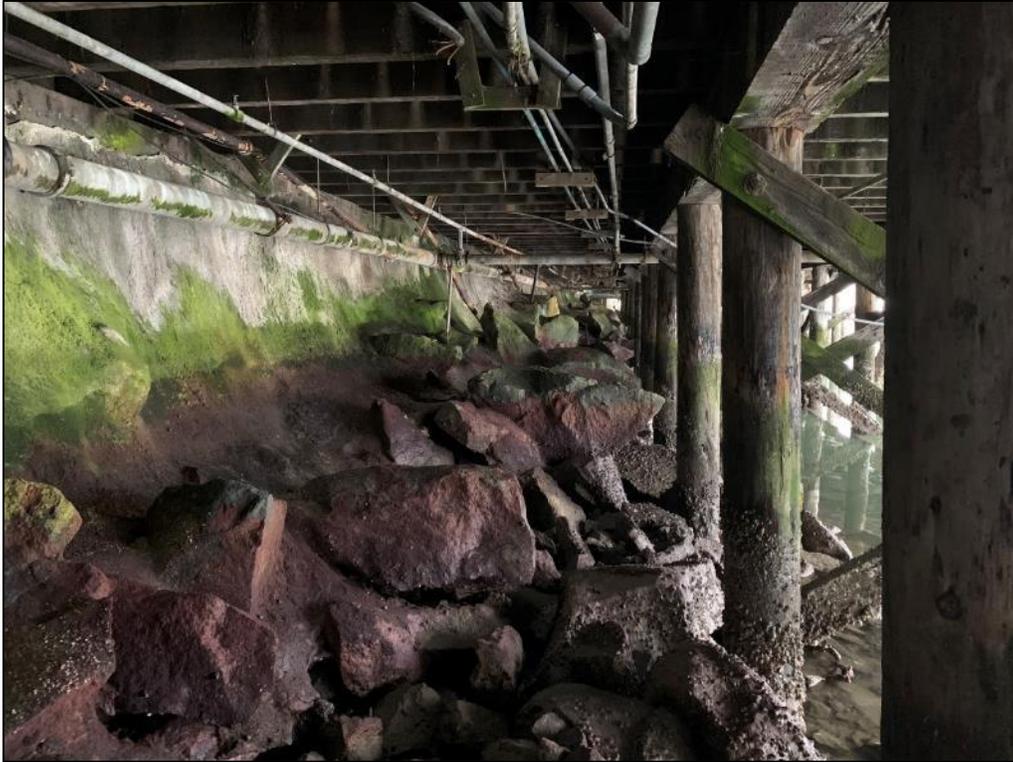
Photo 8. STA 0+45 Looking Southeast at shotcrete placed over the wall and revetment.

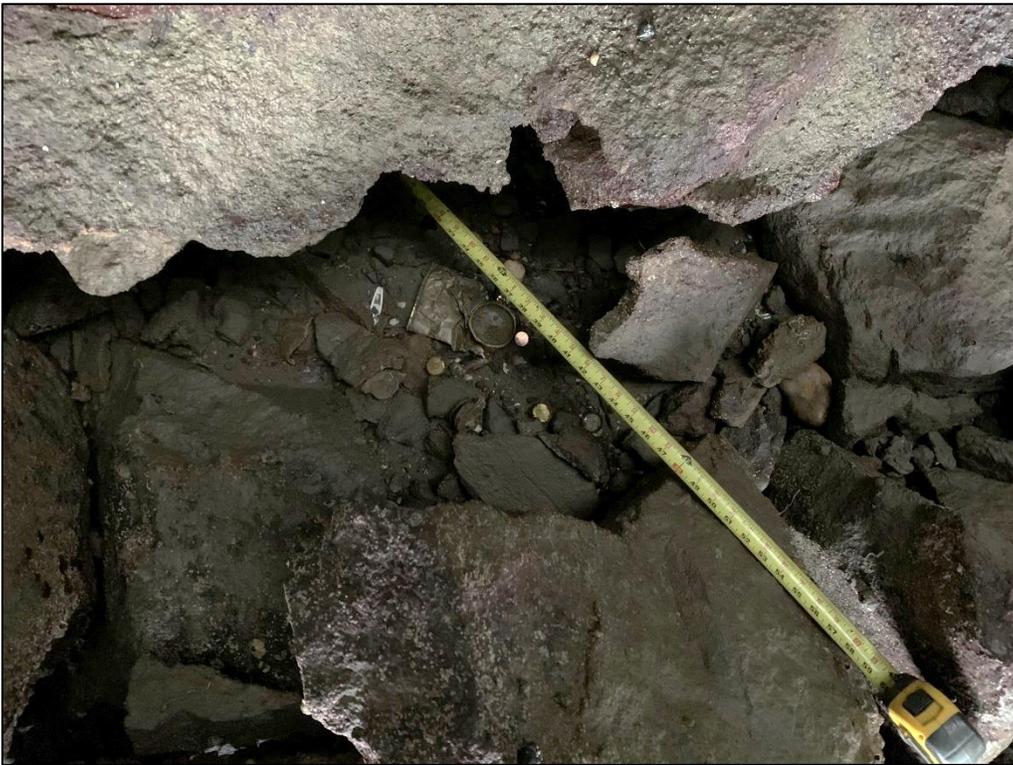
Photo 9. Seawall 1 STA 0+43 Shotcrete undermined up to 3 ft deep.

Although the seawall is in *fair* condition, its condition is not able to be properly assigned without further investigation. It is likely the seawall was constructed in the 1940's and is approximately 80 years old and has exceeded its service life. Due to its age, it is strongly recommended that a long-term solution be considered that would be in line with the life expectancy of the current surrounding developments, which would likely be to replace the seawall entirely. **A comprehensive repair or replacement approach should be developed once the wharf is thoroughly assessed so wharf and seawall improvements can be coordinated. Geotechnical and coastal engineering considerations should be included in the investigation.**

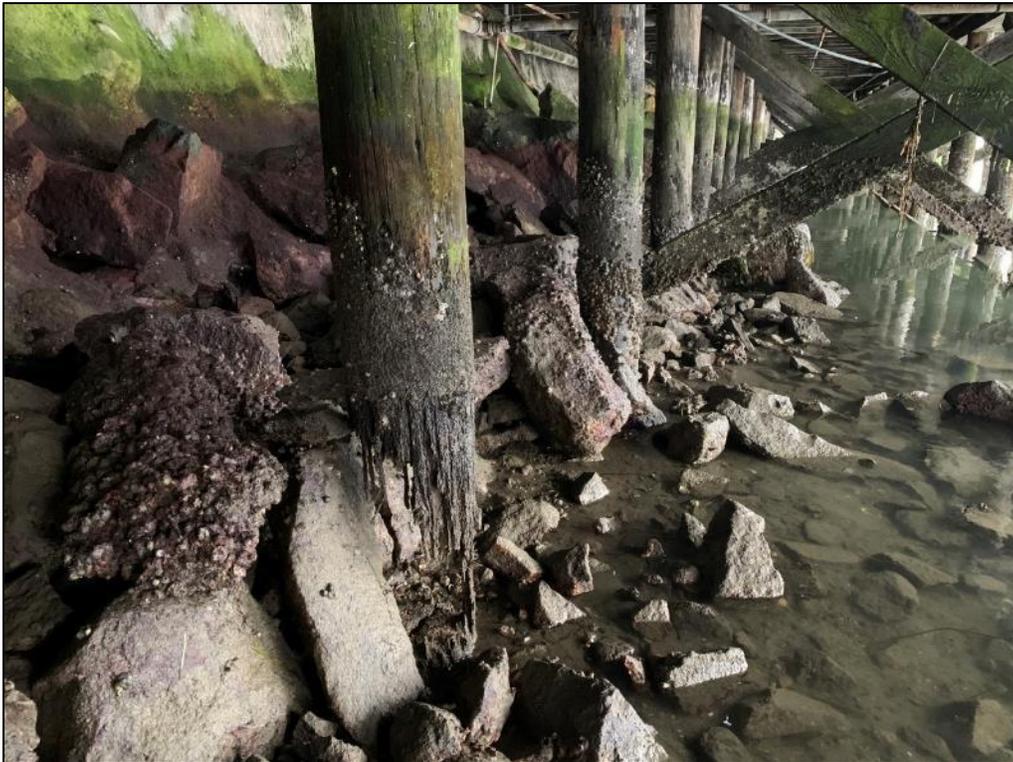
Photo 11. STA 00+43 Pile with 100% section loss (out of scope).

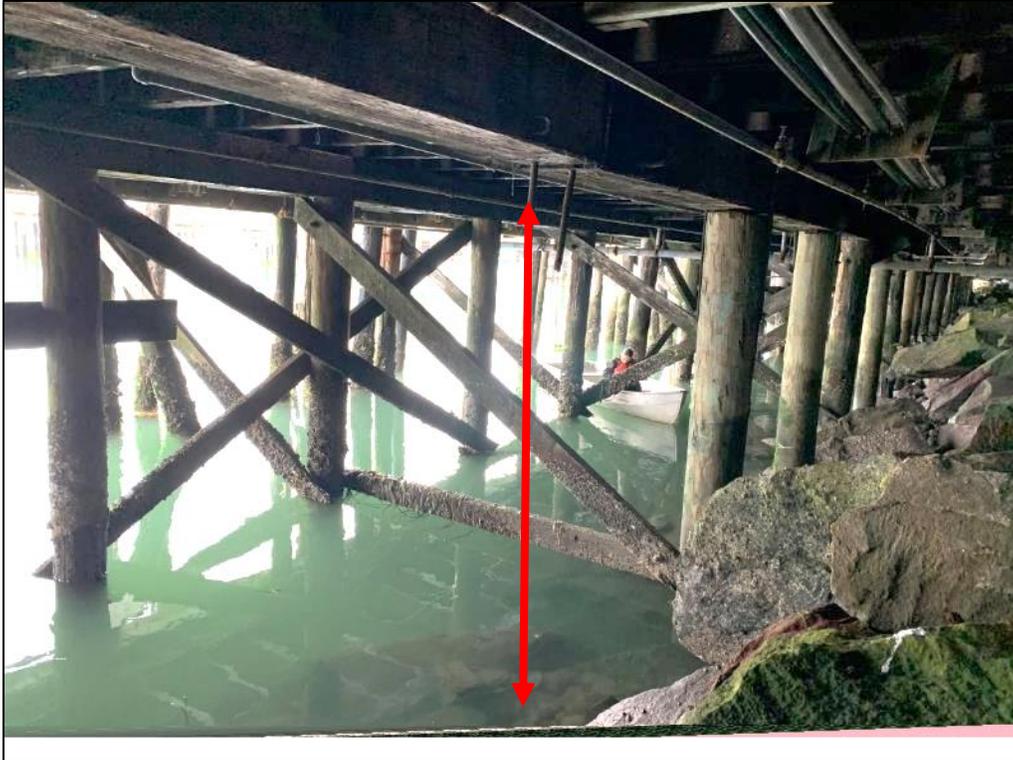
Photo 12. Seawall 1 STA 1+44 Missing pile (out of scope).

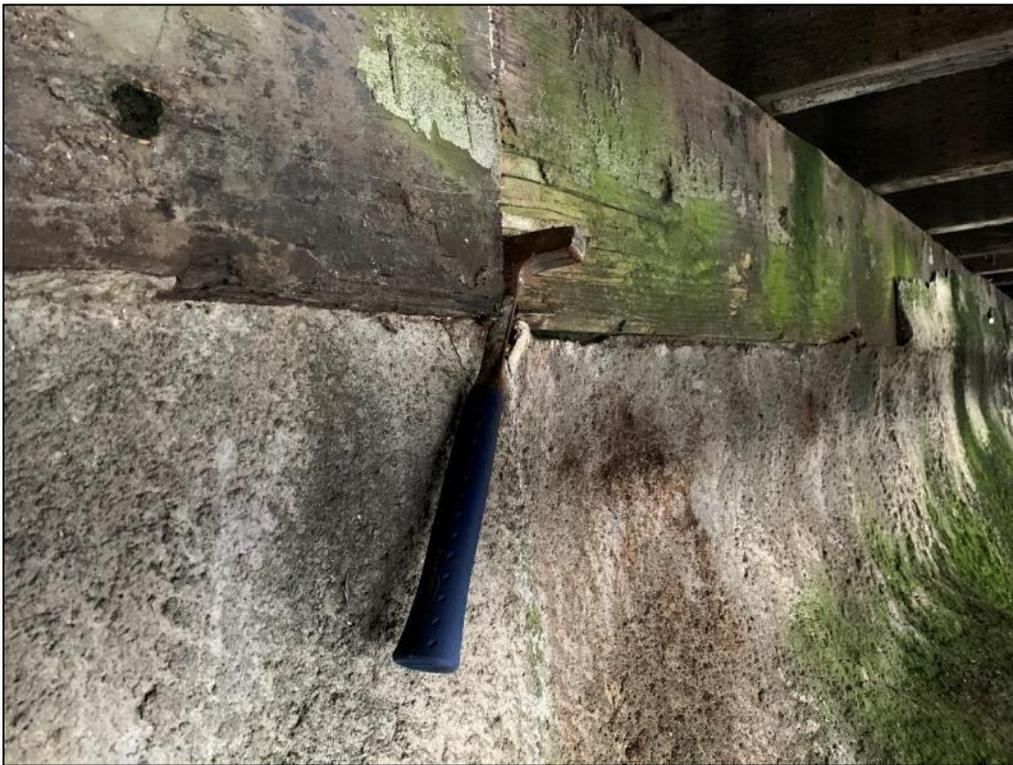
Photo 13. STA 1+00 Deteriorated timber cap (out of scope).

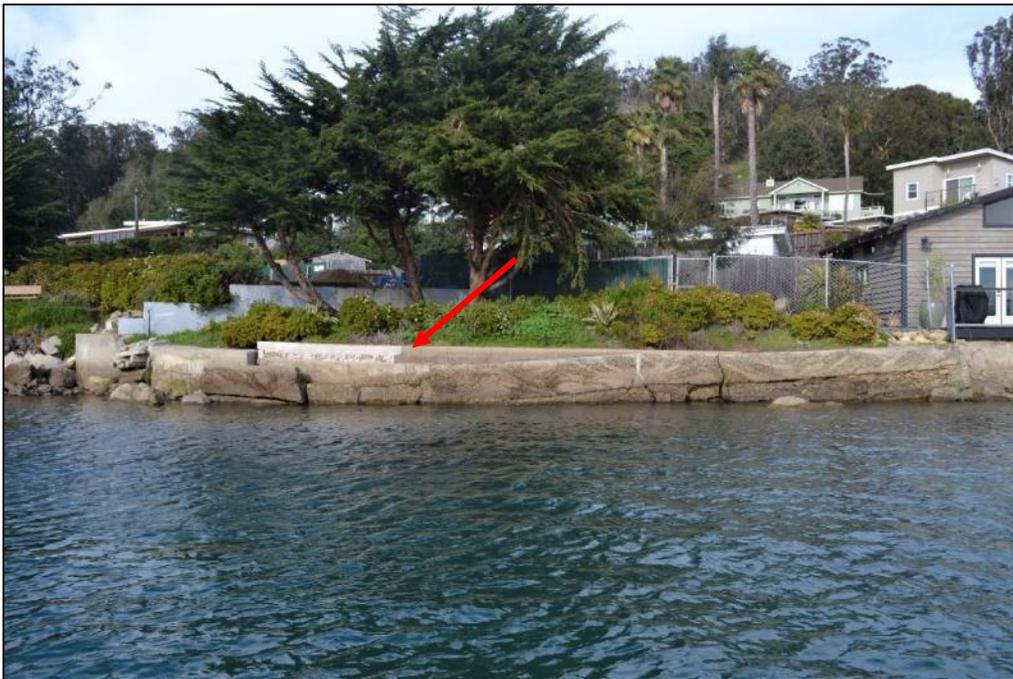
Photo 14. Overall view of the wall where settlement is obvious, and the CMU wall added behind (red arrow) is seen.

The wall is beyond repair and the entire extent (84 ft) should be removed and replaced. The wall could be replaced in kind with a cast-in-place concrete retaining wall designed to comply with new code conditions. Alternatively, replacing the wall with a rock revetment could be explored and could be more economical. Both options would require input from CCC.

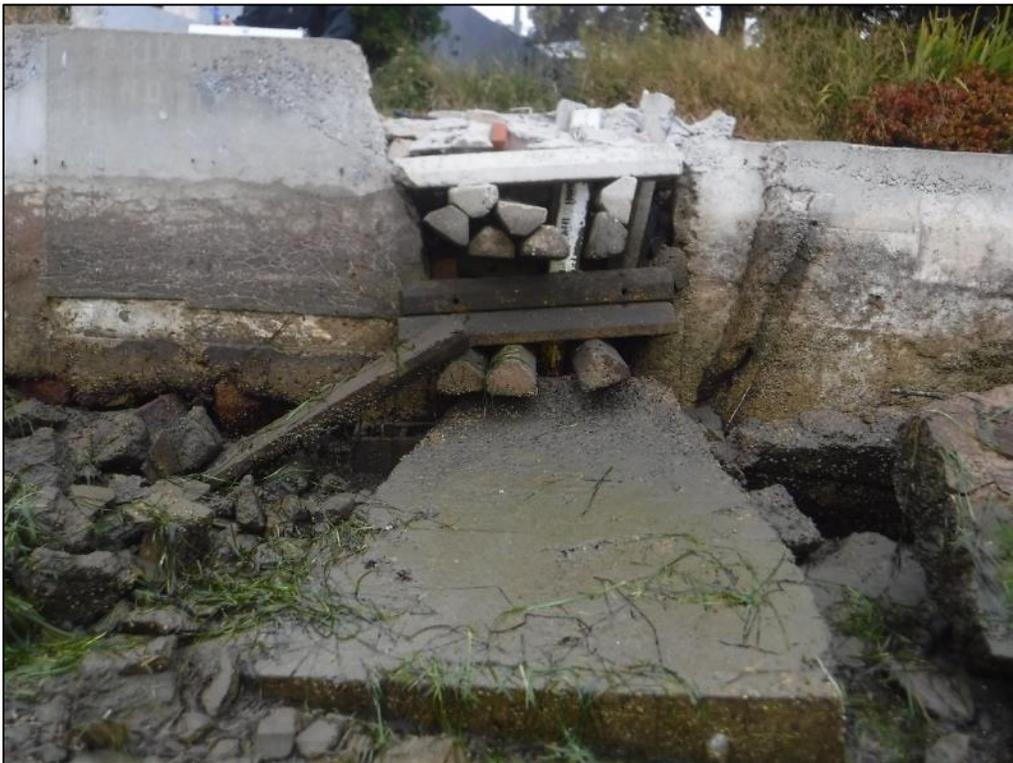
Photo 16. STA 0+10 where the wall section has failed, and various sections of concrete have been placed in the void to attempt to retain the soil.

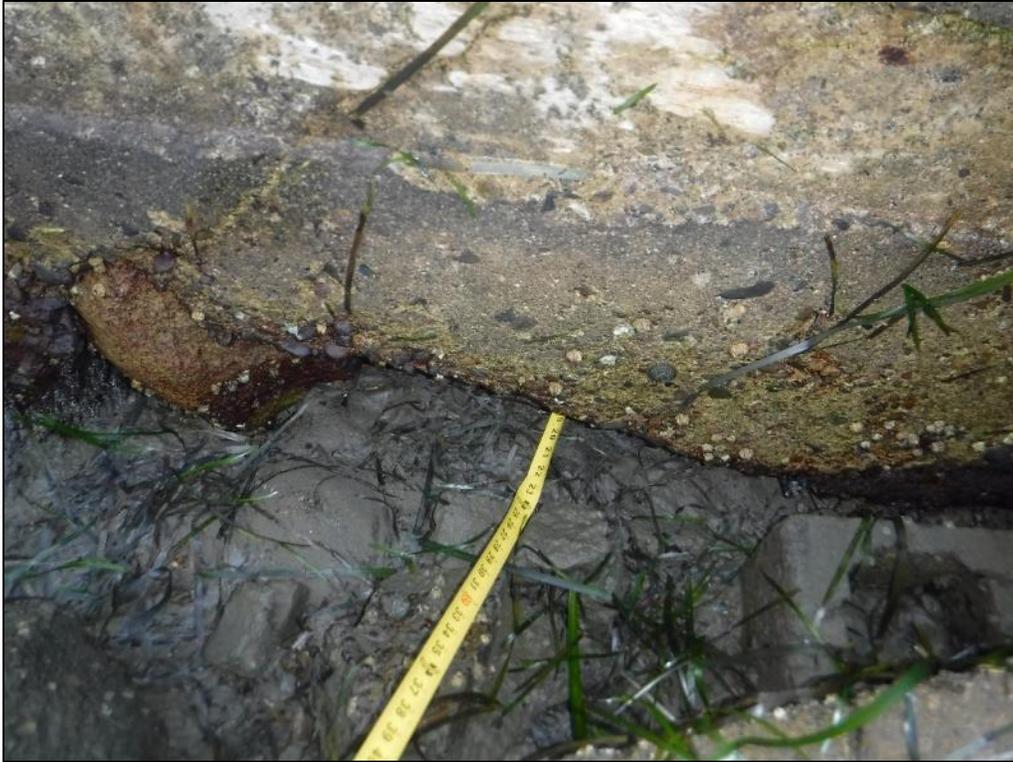
Photo 17. STA 0+06 where undermining up to 2-foot-deep is recorded.

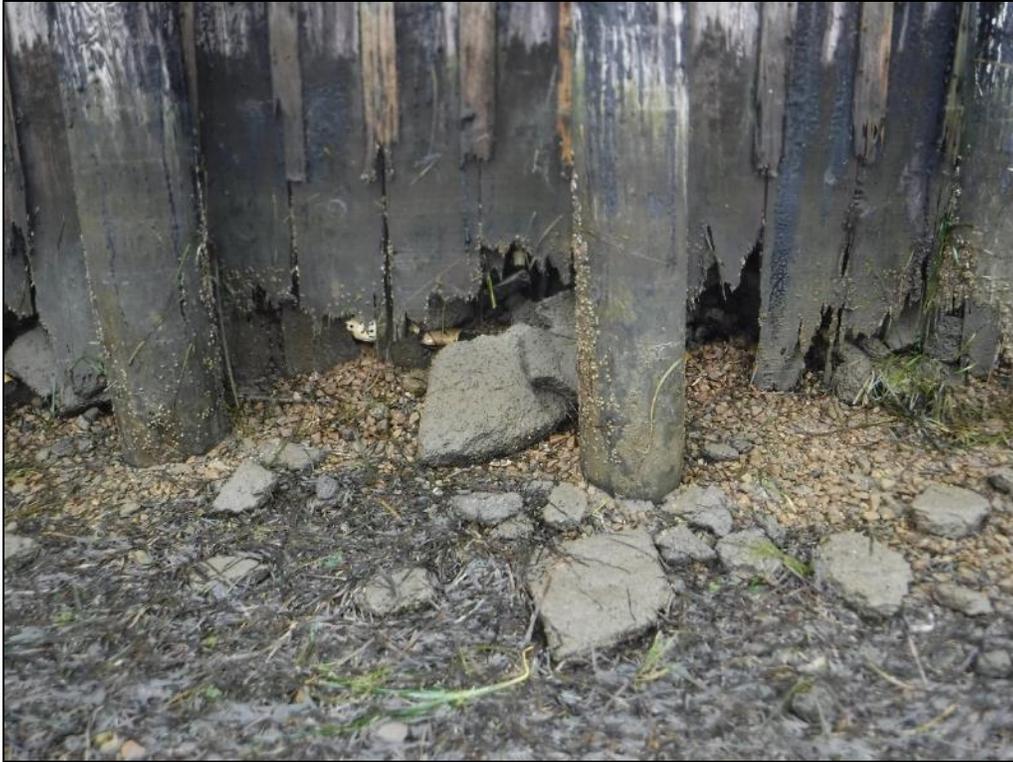
Photo 21. STA 0+20 Close up of degraded timber sheet piles.

required to eliminate damage to the new wall from stormwater runoff. Dredging would be required to reclaim the material lost through the failed wall and allow vessels to berth. Both options would require input from CCC.

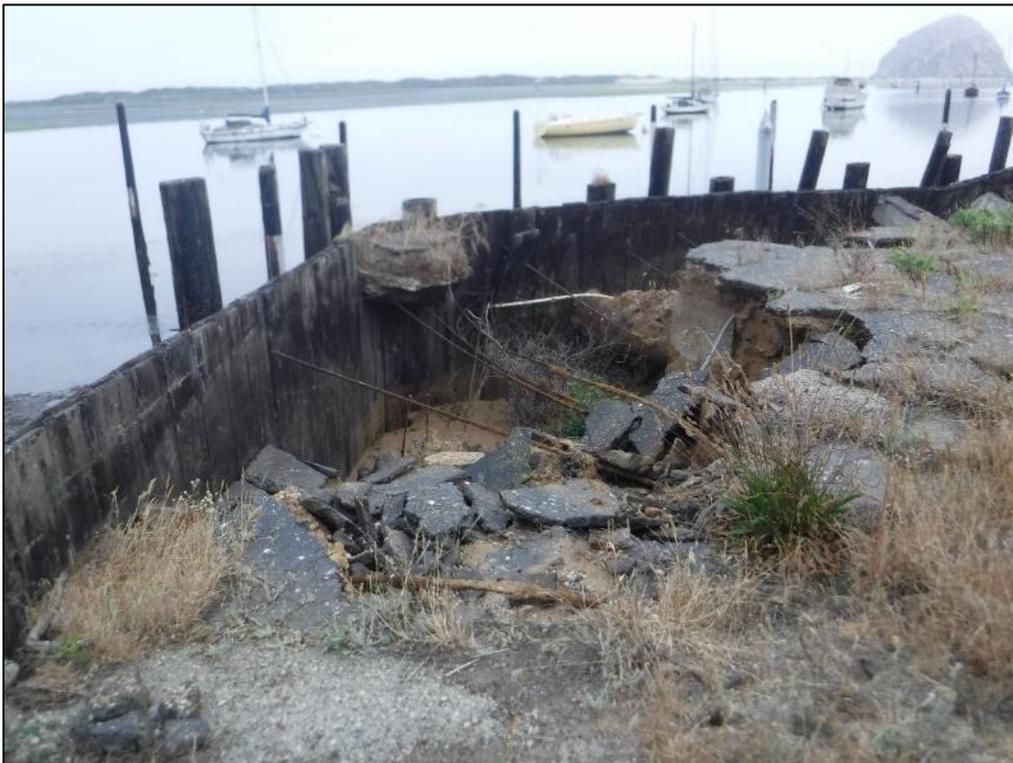
Photo 22. STA 1+73 Loss of material behind the wall and exposed tie backs.

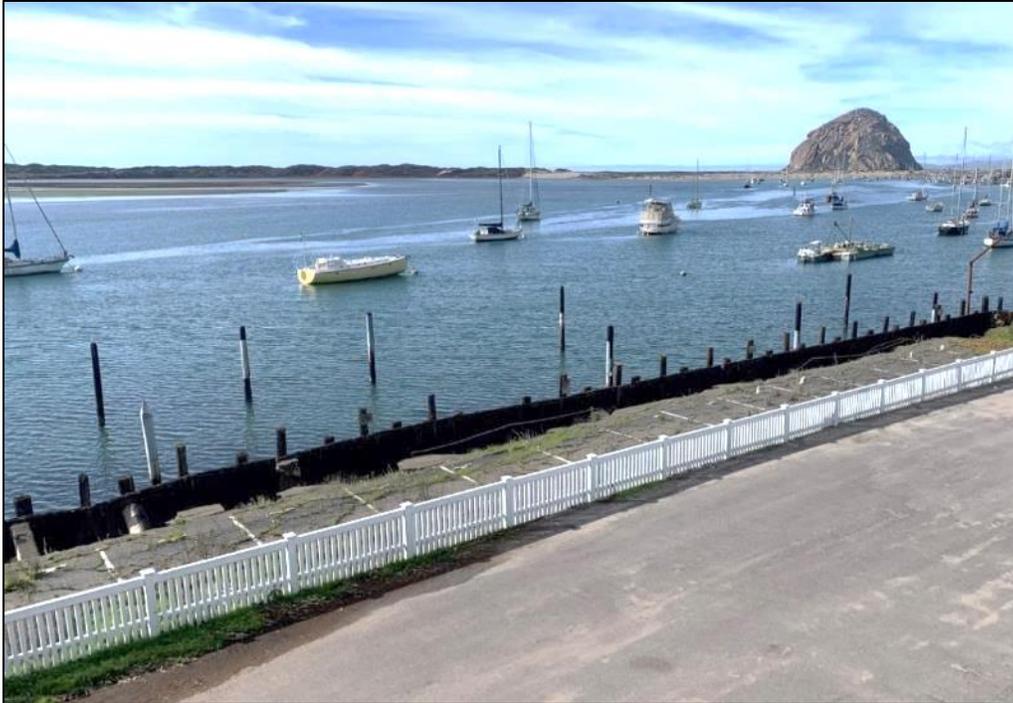
Photo 23. Looking west where a fence has been installed to restrict access to the failed wall.

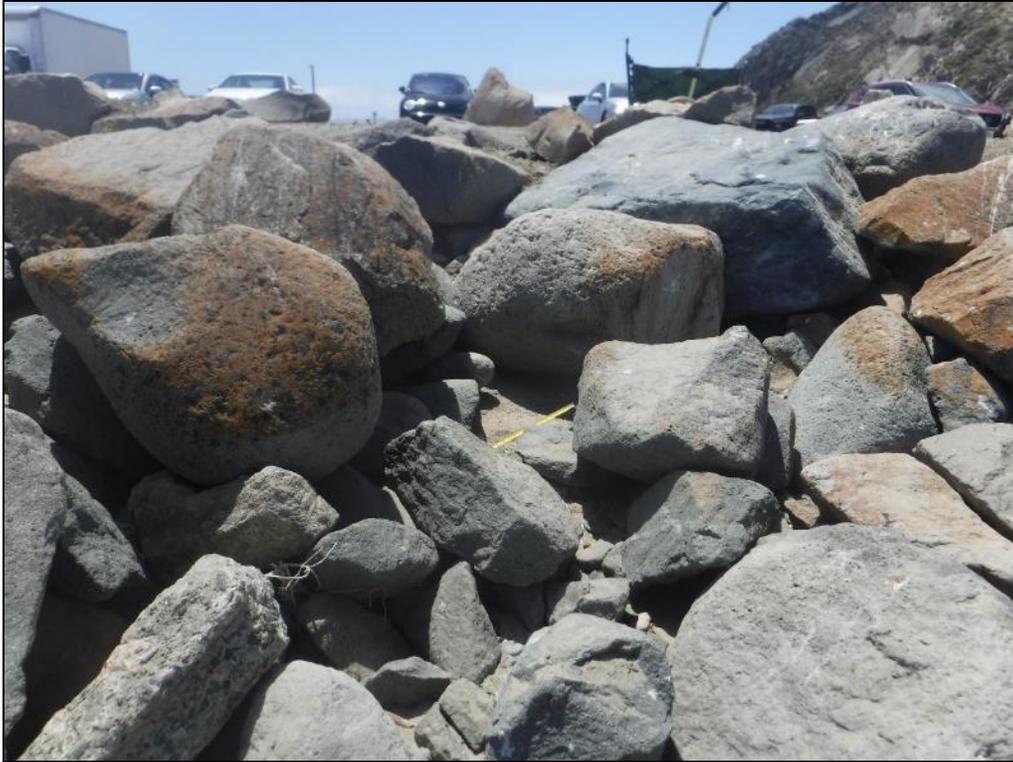
Photo 24. Revetment 1 STA 5+00 Loss of rock throughout, erosion and voids at top. The tape measure identifies a large void.

See Appendix B for recommendations by station. Because of exposure to ocean waves, 4-ton armor stone should be added in areas where rocks were missing and up to the top of the slope. Improvements to surface drainage are necessary to mitigate long-term effects of runoff. Sections of the revetment where *moderate* damage was recorded should be refurbished, see Section 5 for more detail.

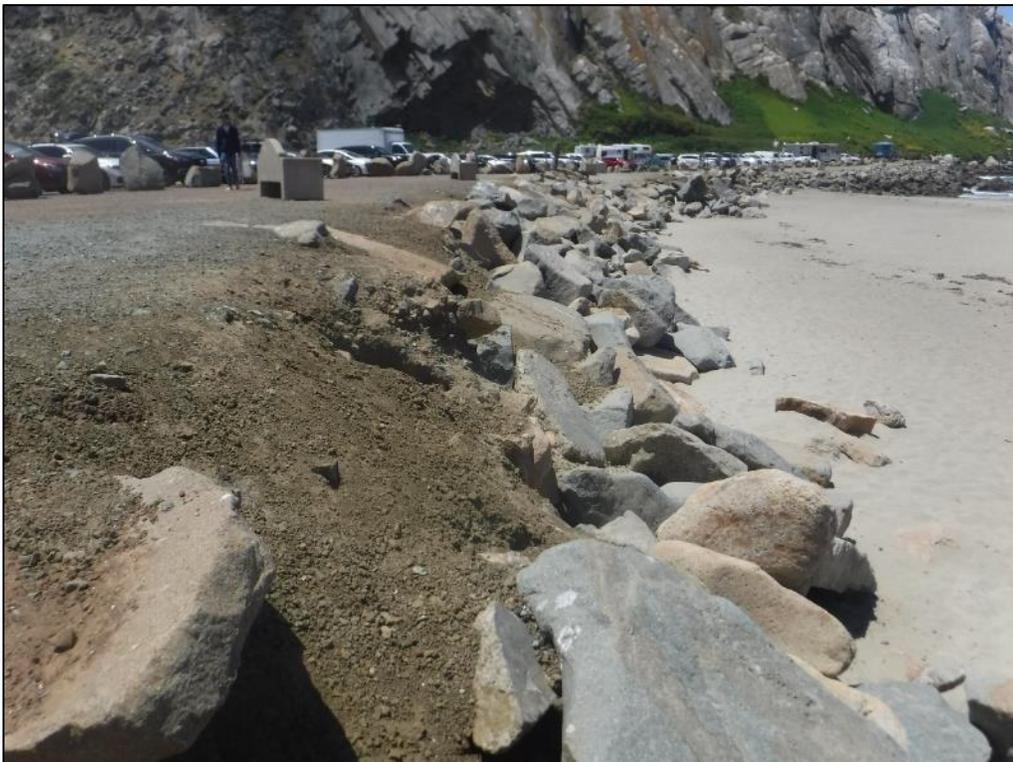
Photo 25. STA 7+00 The top of the slope is not protected. Erosion of fine material is seen at the top, large voids, and missing rock is noted.

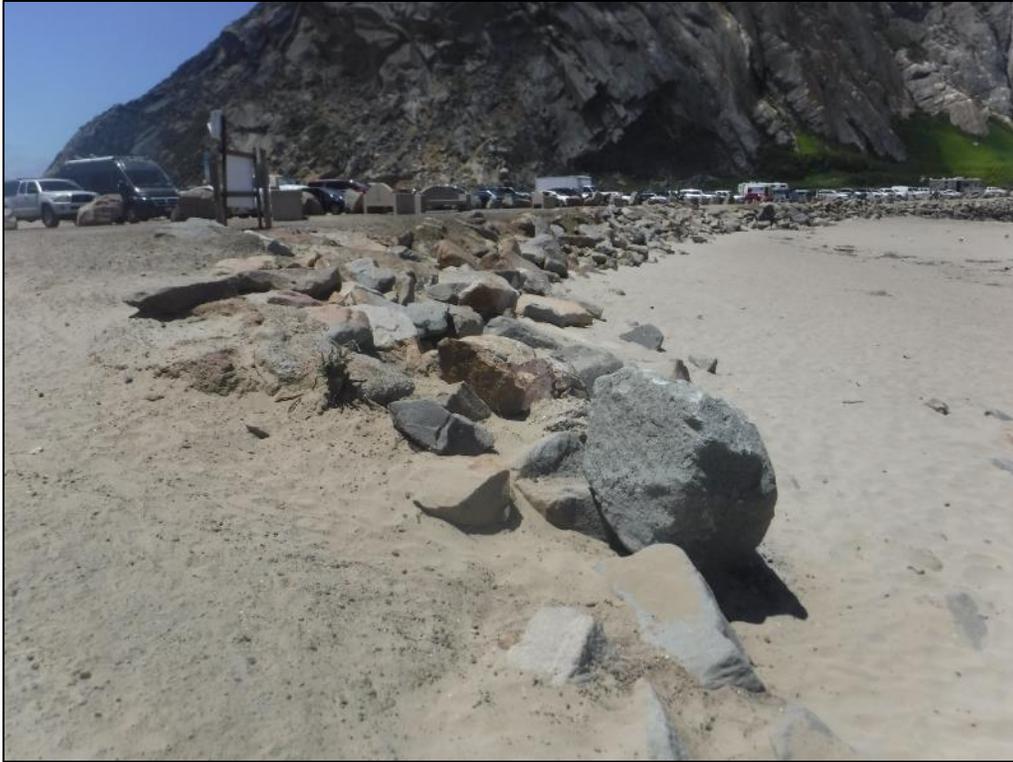
Photo 26. Revetment 1 STA 7+40 Looking west where large voids and missing armor stone is recorded.

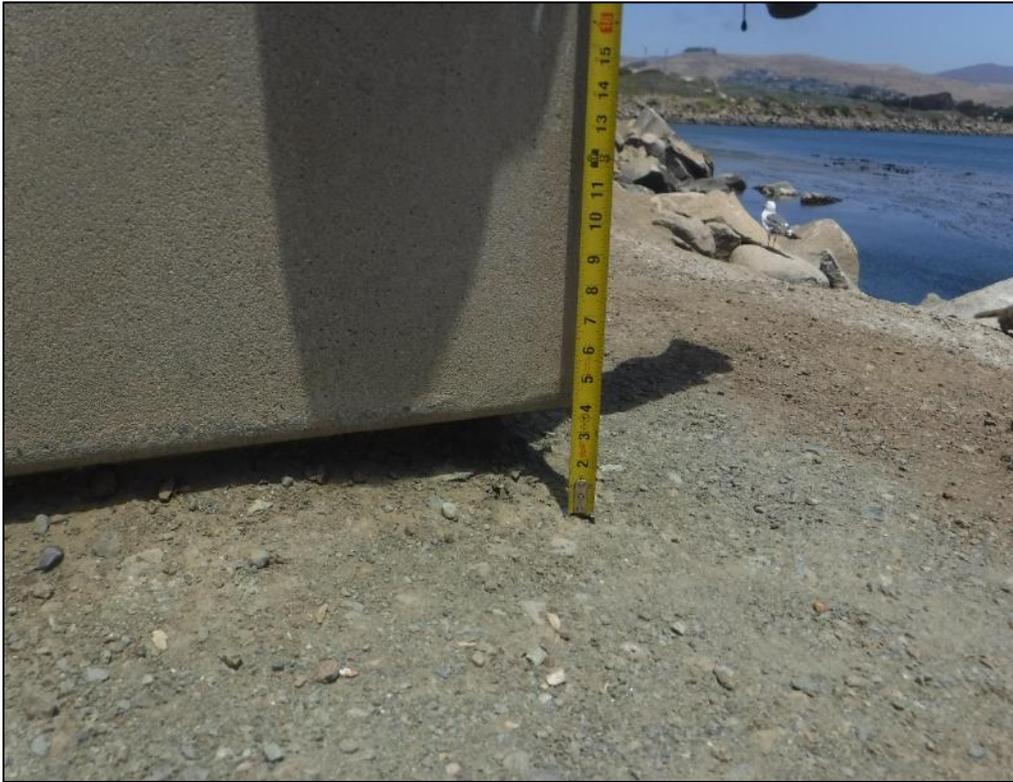
Photo 27. Revetment 2 STA 2+00 Concrete bench is undermined by 4-in.

Reference the table in Appendix B for the recommendations pertaining to this section. In general, there are areas with *major* damage that need to be rebuilt, as described in Section 5. The steep sections should have additional rock added. Improvements to surface drainage are necessary to mitigate long-term effects of runoff. This area needs to be addressed to protect the shoreline and the public walkway.

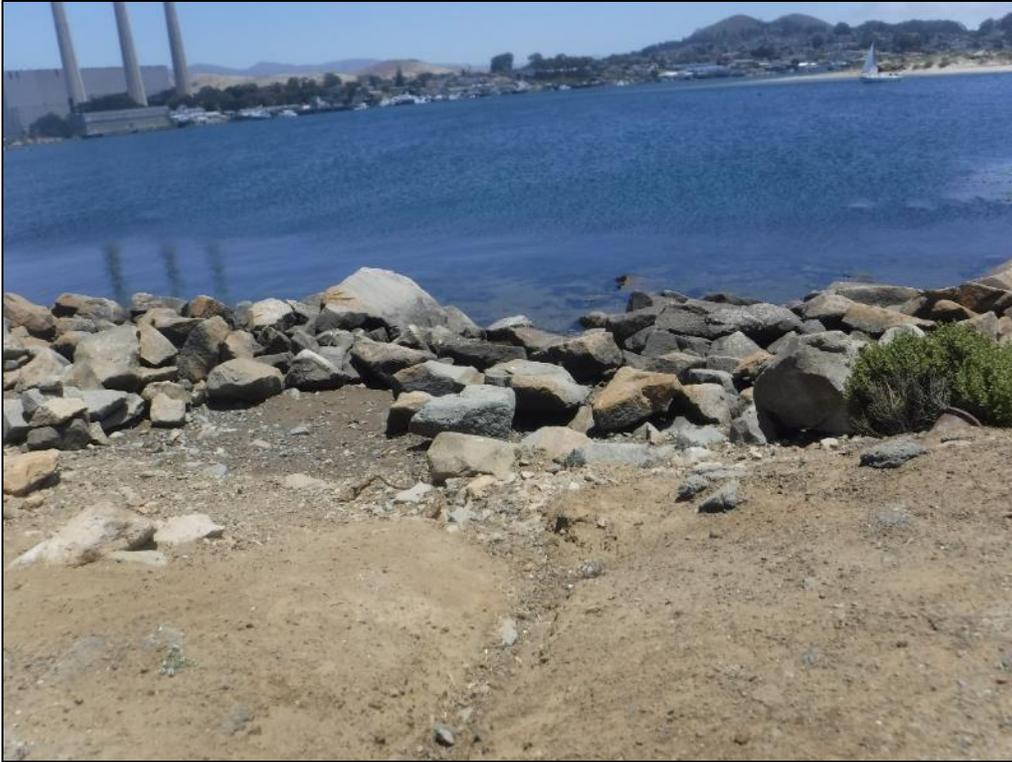
Photo 28. Revetment 2 STA 5+60 Loss of fine material due to runoff has resulted in the crown failing, slope spreading, loss of rock, voids, and exposed subgrade.

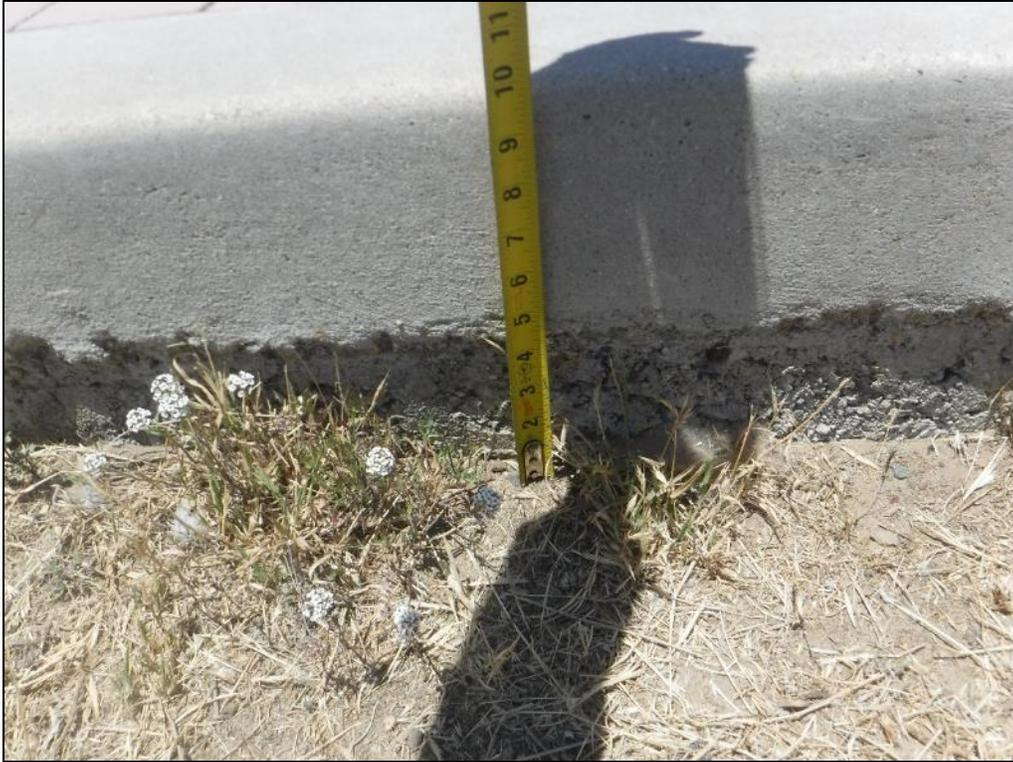
Photo 30. Revetment 2 STA 8+00 Approximately 5-in of lost material due to erosion.

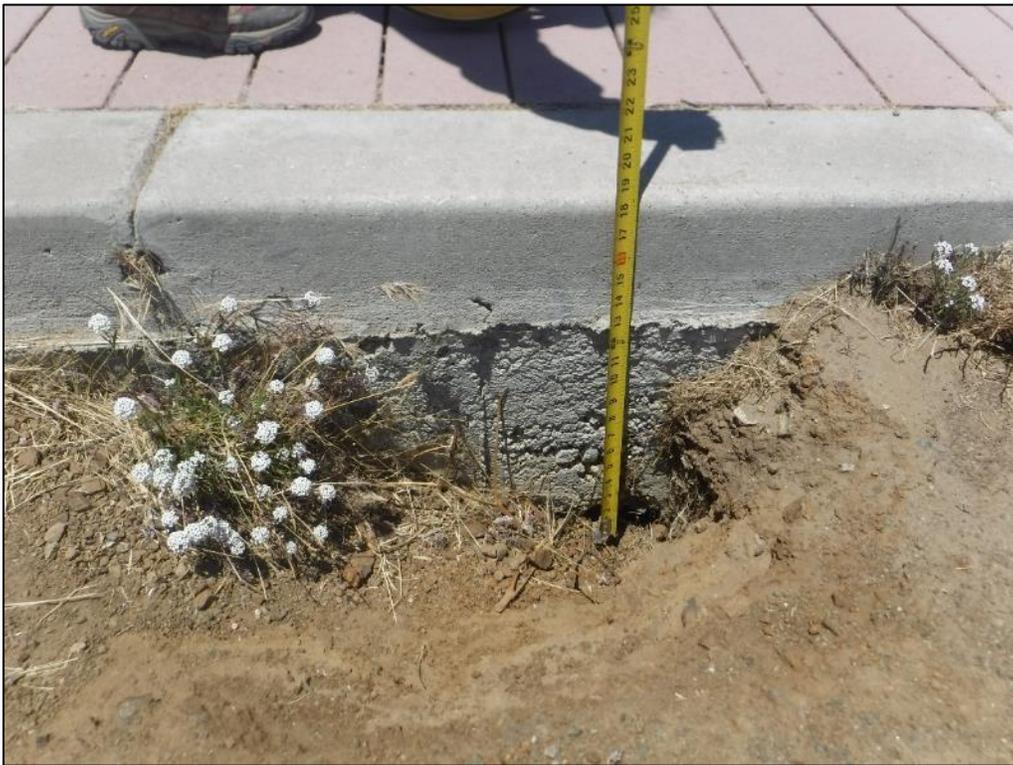
Photo 31. Revetment 2 STA 14+66 Up to 13-in of material is lost resulting in undermining of the sidewalk.

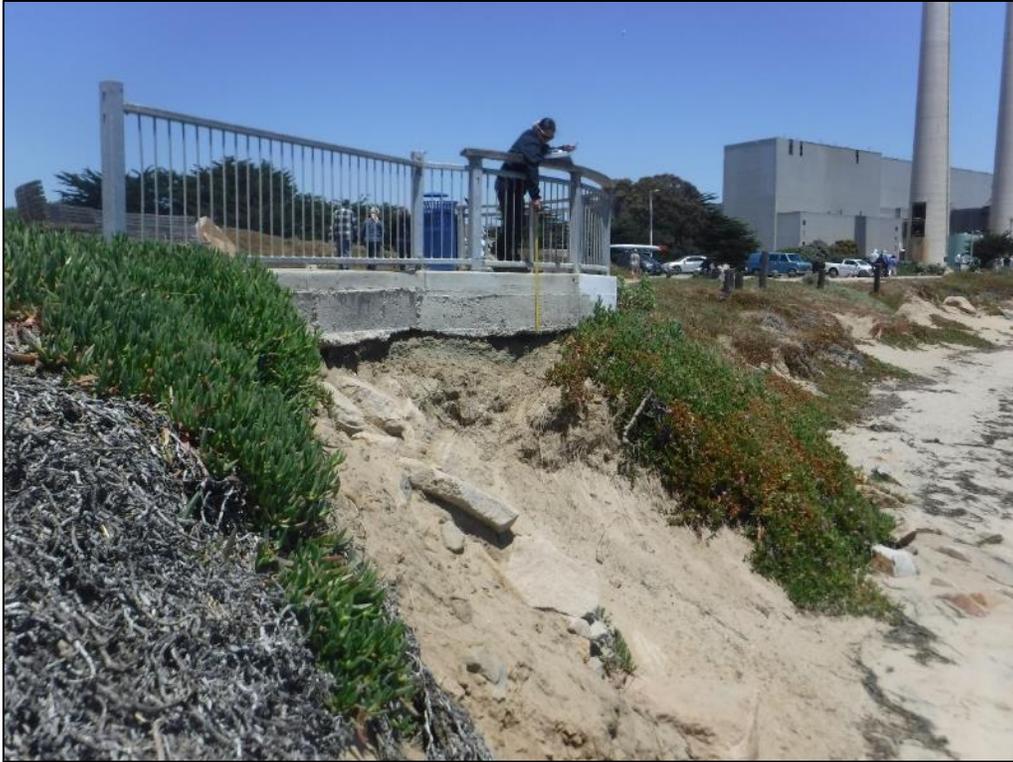
Photo 32. Revetment 2 STA 20+00 Missing rock revetment, erosion, and undermined observation deck footing.

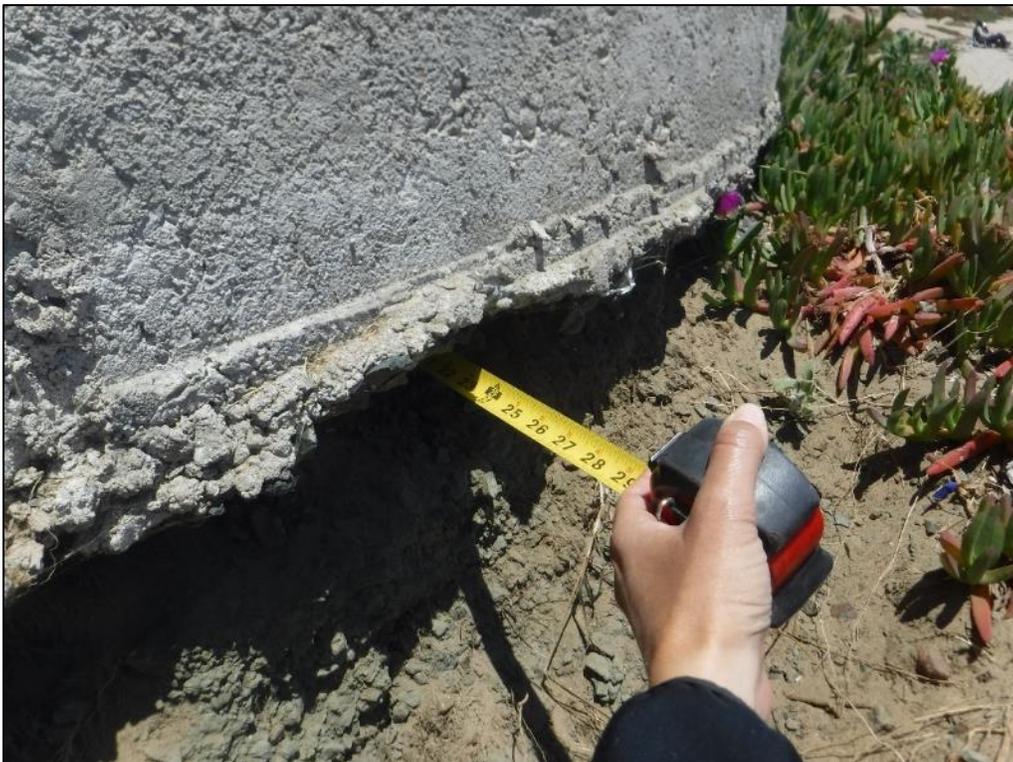
Photo 33. Revetment 2 STA 20+00 Undermined observation deck footing up to 2 ft deep.

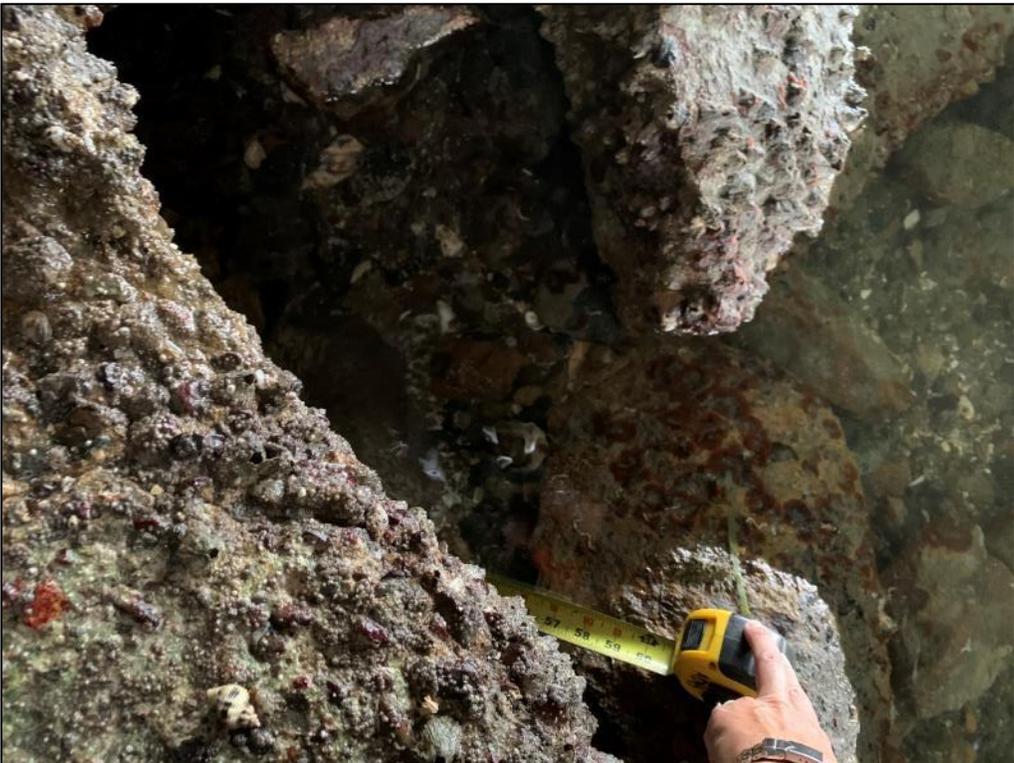
Photo 38. Revetment 3 STA 1+36 A close up showing the void extends 6 ft deep.

Recommendations for this revetment are included in Appendix B. Due to the observed slope, significant voids, migration of rock, and exposed underlayer, the revetment should be rebuilt. Alternatively, a sheet pile wall or tie back wall could be explored as a potential solution for protecting the shoreline in this area. Improvements to surface drainage are necessary to mitigate long-term effects of runoff.

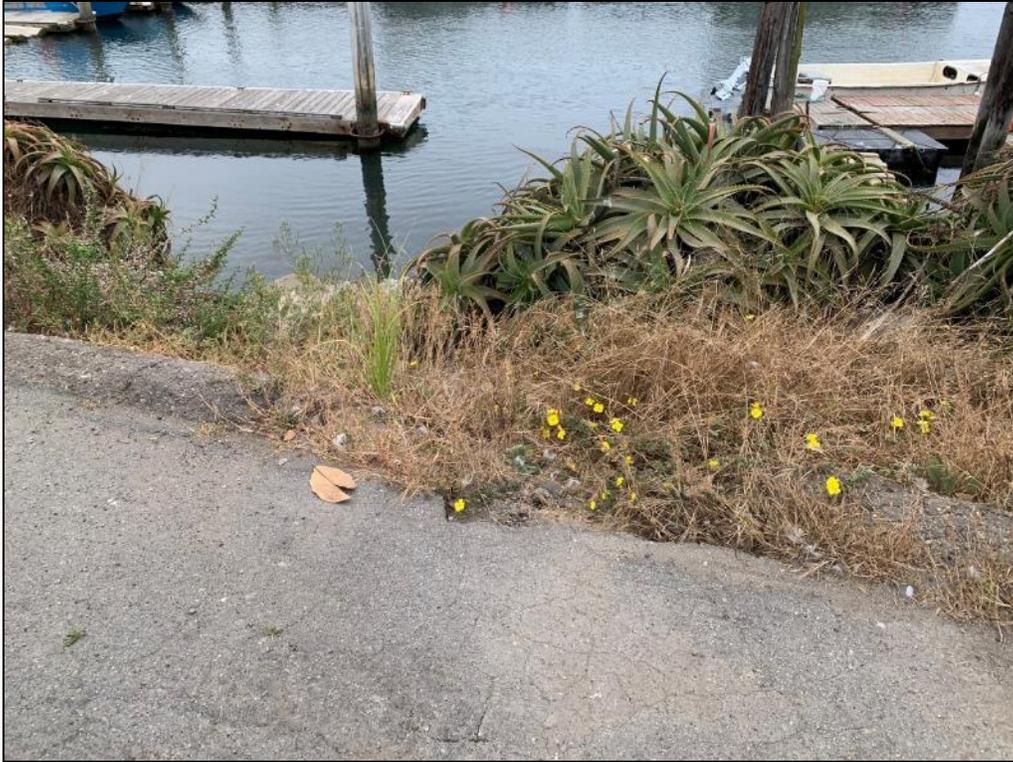
Photo 39. Revetment 3 STA 0+00 Missing curb and erosion.

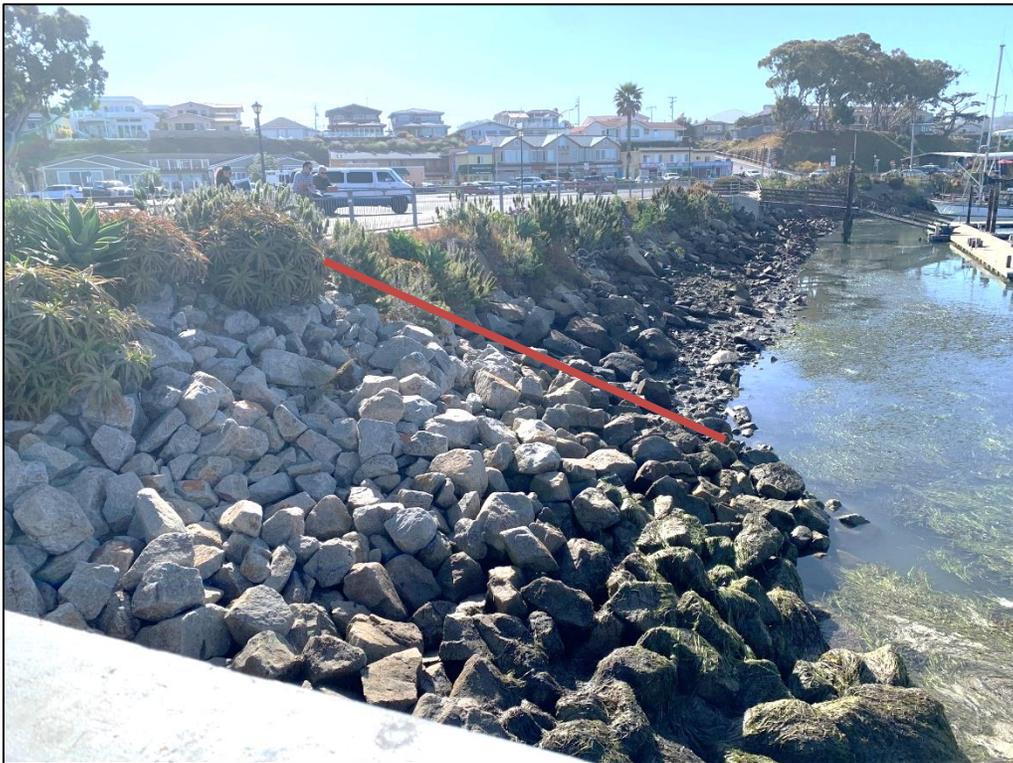
Photo 40. Revetment 4 Looking south from the South T-Pier where the rehabilitated section of revetment transitions to a steeper slope with inconsistent rock sizes and concrete debris.

Reference Appendix B for recommendations at this revetment. In general, the revetment to the north and in front of the concrete ramp access should be refurbished and to the south should be rebuilt to protect the public walkway and ramp access.

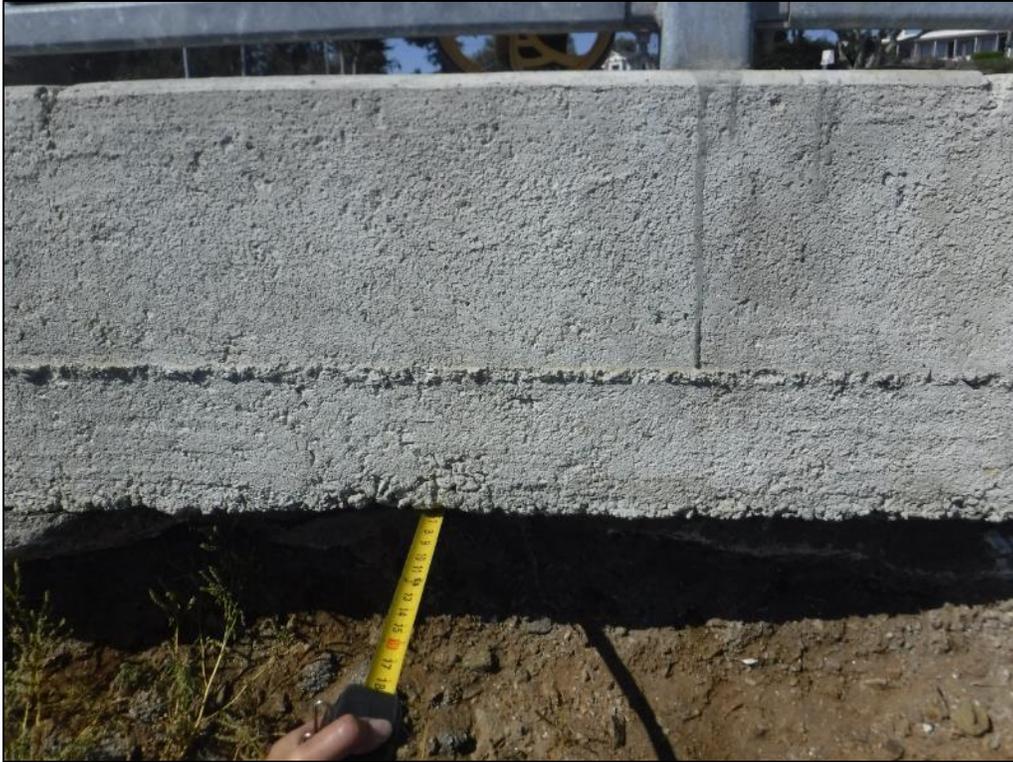
Photo 41. Revetment 4 STA 1+55 Sidewalk footing undermined up to 8-in deep.

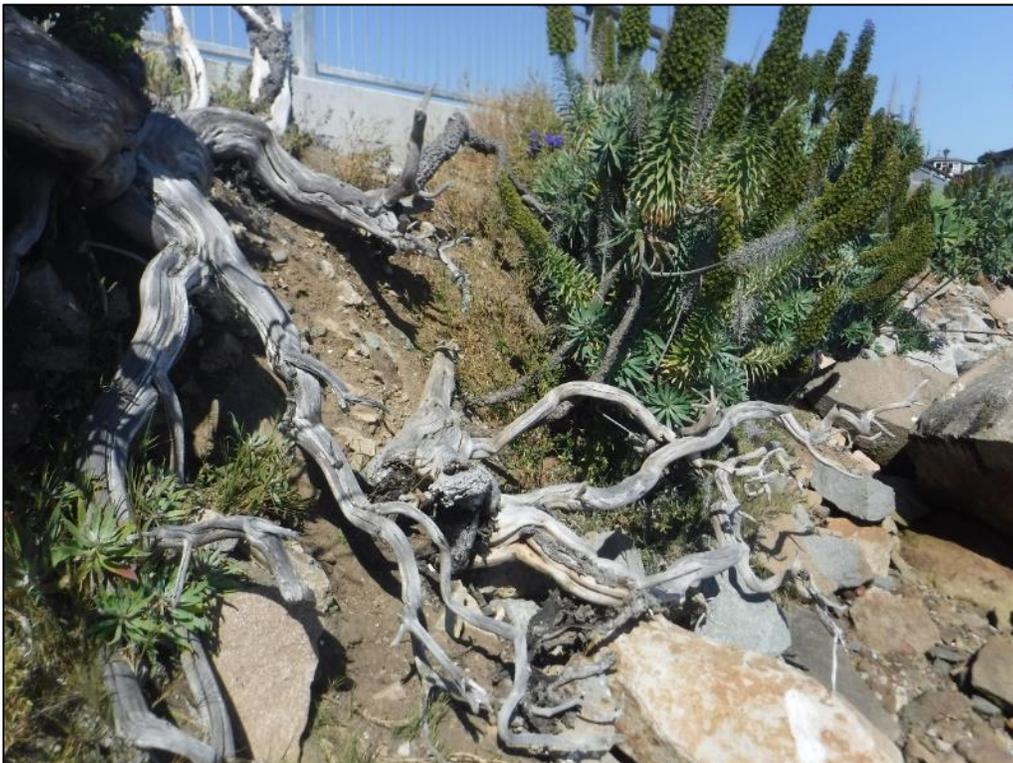
Photo 42. Revetment 4 STA 1+22 Sections of concrete debris mixed with 20-in and smaller rock. Missing rocks exposing subgrade, heavy vegetation, and potential undermined of walkway at top.

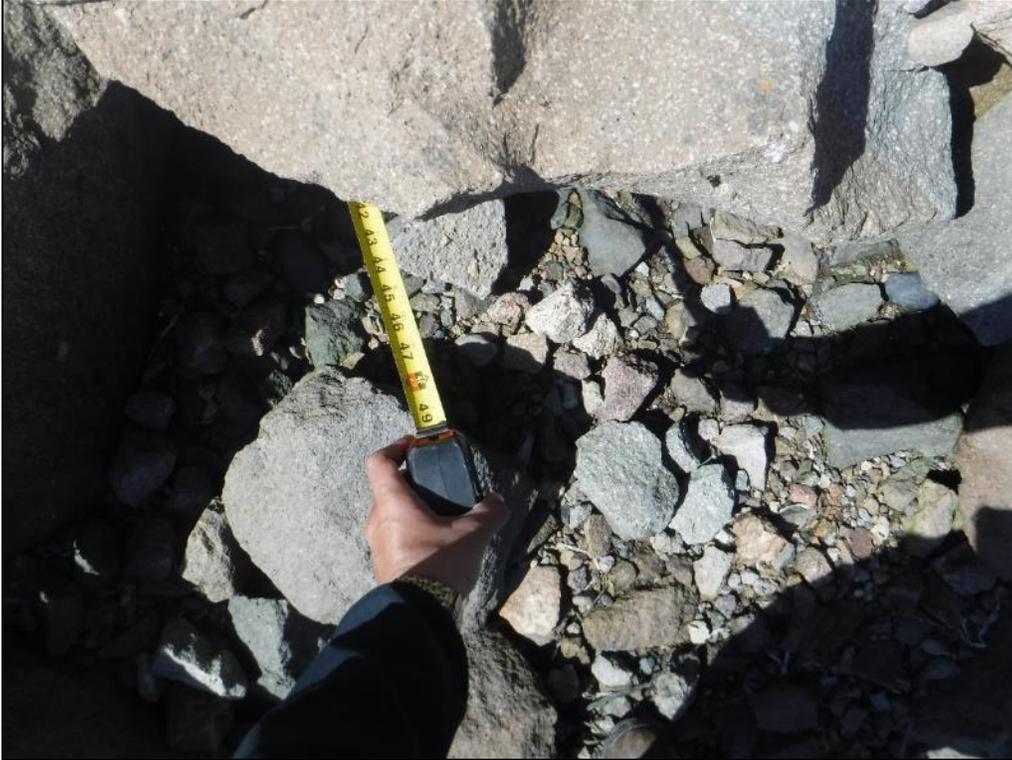
Photo 43. Revetment 4 STA 2+06 Large rock on the top 3rd of the revetment is undermined by 4 ft.

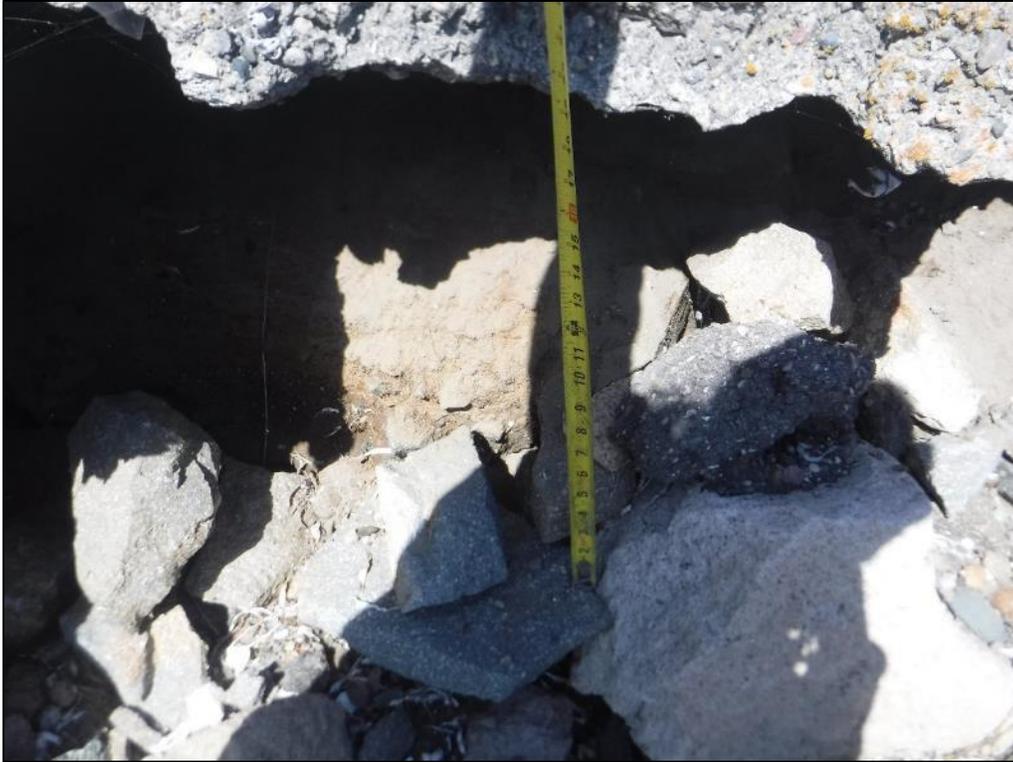
Photo 45. Revetment 4 STA 5+00 A Void at elevation +8 ft MLLW was up to 2 ft high and extended 15 ft along the revetment.
