INSPECTION AND ASSESSMENT OF REVTMENTS AND SEAWALLS MORRO BAY, CA

January 23, 2025

Richard Brady & Associates

Subject: Inspection and Assessment of Revetments and Seawalls, Morro Bay, CA

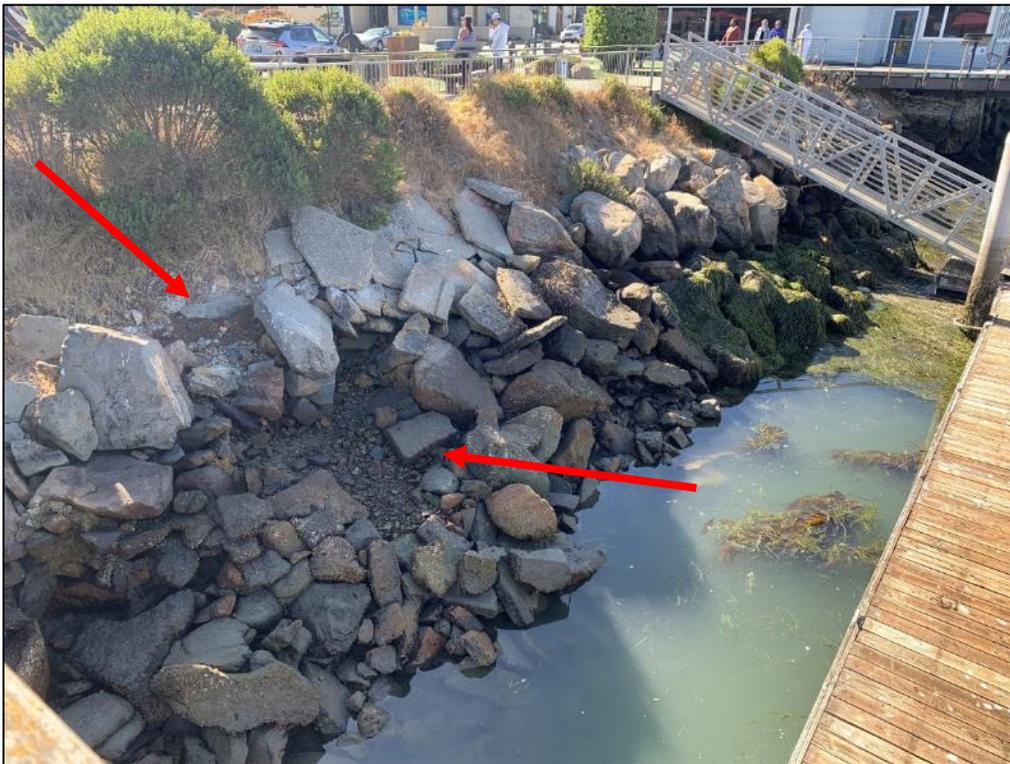
Photo 47. Revetment 5 STA 1+86 Looking west. Missing armour stone exposes the subgrade.

The table in Appendix B recommends that areas with *minor* damage have rock added and areas with *moderate* damage be refurbished. The revetment around the public access pier should be refurbished and at this time the abutment and bent foundation should be repaired.

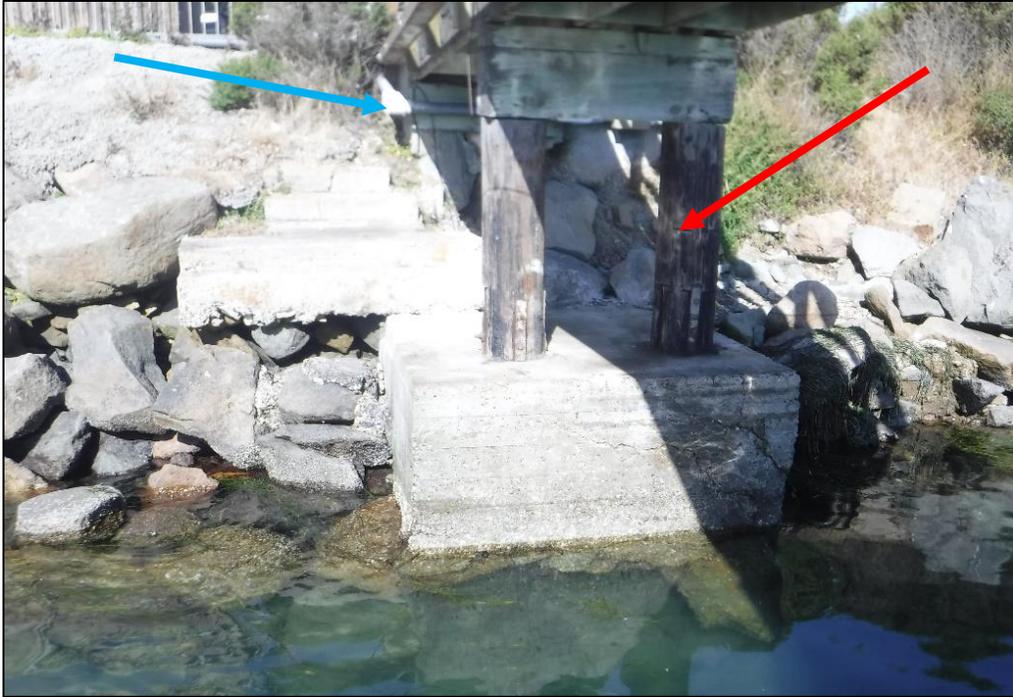
Photo 48. Revetment 5 STA 1+00 The abutment (blue arrow) and first bent (red arrow) of the public access pier. The bent foundation was undermined however the size of void was not recorded. A previous foundation is seen to the left of the pier where minor undermining was observed.

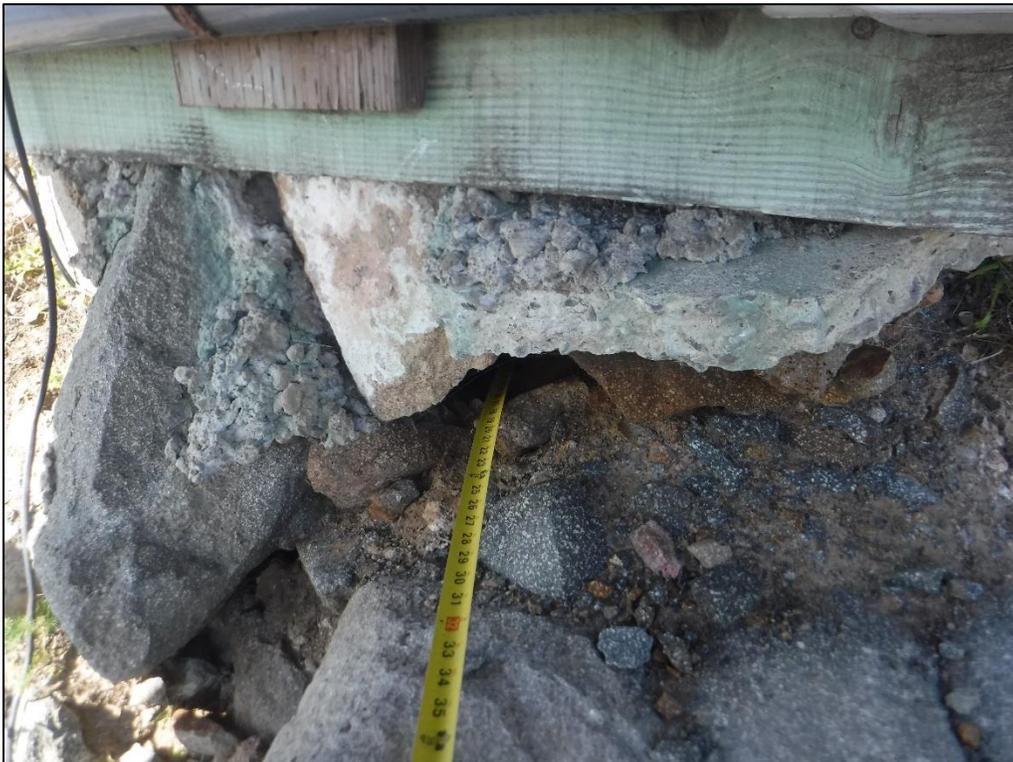
Photo 49. The pier abutment, shown in Photo 48, is undermined up to 2 ft deep and 1 ft high.

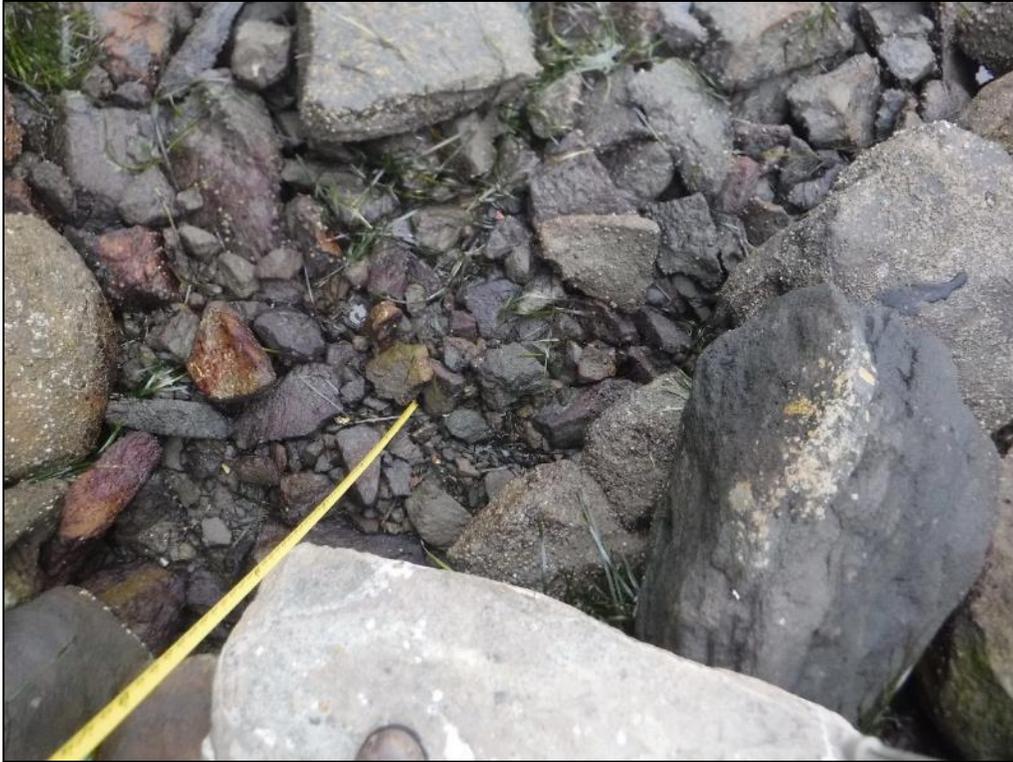
Photo 51. Revetment 6 STA 0+40 Rock and section of slope is missing resulting in a vertical drop and unsupported rock.

The table in Appendix B recommends that the revetment be refurbished. This effort will need to be coordinated with repairs to the public access pier. Ideally the revetment should be deconstructed, new piles at Bent 1 driven, the filter layer placed, and the rocks restacked. Improvements to surface drainage are necessary to mitigate long-term effects of runoff.

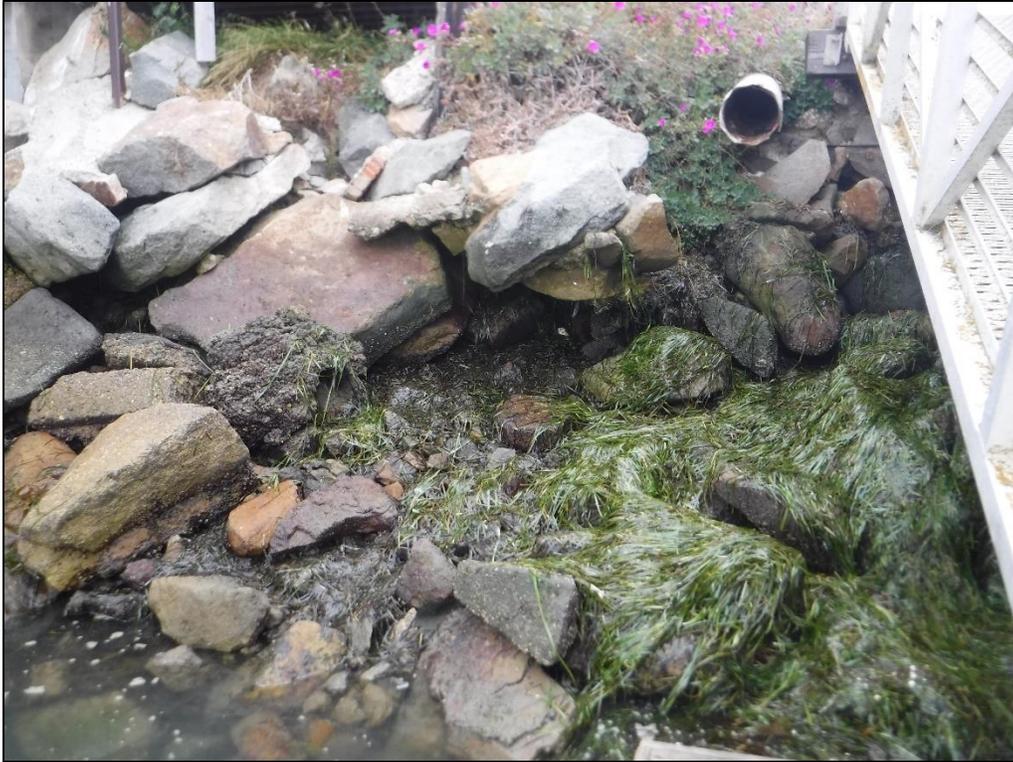
Photo 53. Revetment 7 STA 0+14 Large voids in the middle of the slope leaving upper section of rock and the drain pipe unsupported.

Reference Appendix B for recommendations. The revetment should be refurbished. This effort will need to be coordinated with repairs to the public access pier and the public access walkway to the south. Ideally the revetment should be deconstructed, new piles at bent 1 driven, the filter layer placed, and the rocks restacked. Improvements to surface drainage are necessary to mitigate long-term effects of runoff.

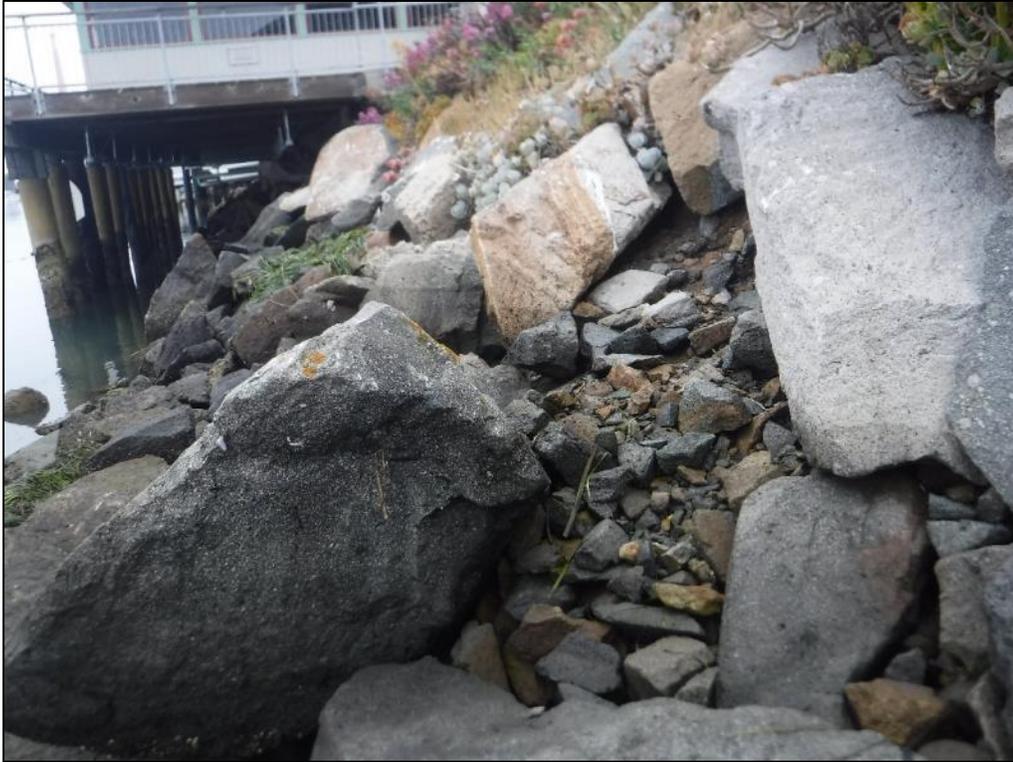
Photo 56. Revetment 8 STA 0+53 Subgrade soil and gravel exposed.

Reference Appendix B for recommendations at this revetment. The revetment should be refurbished to protect the sidewalk and gangway abutment. Improvements to surface drainage are necessary to mitigate long-term effects of runoff.

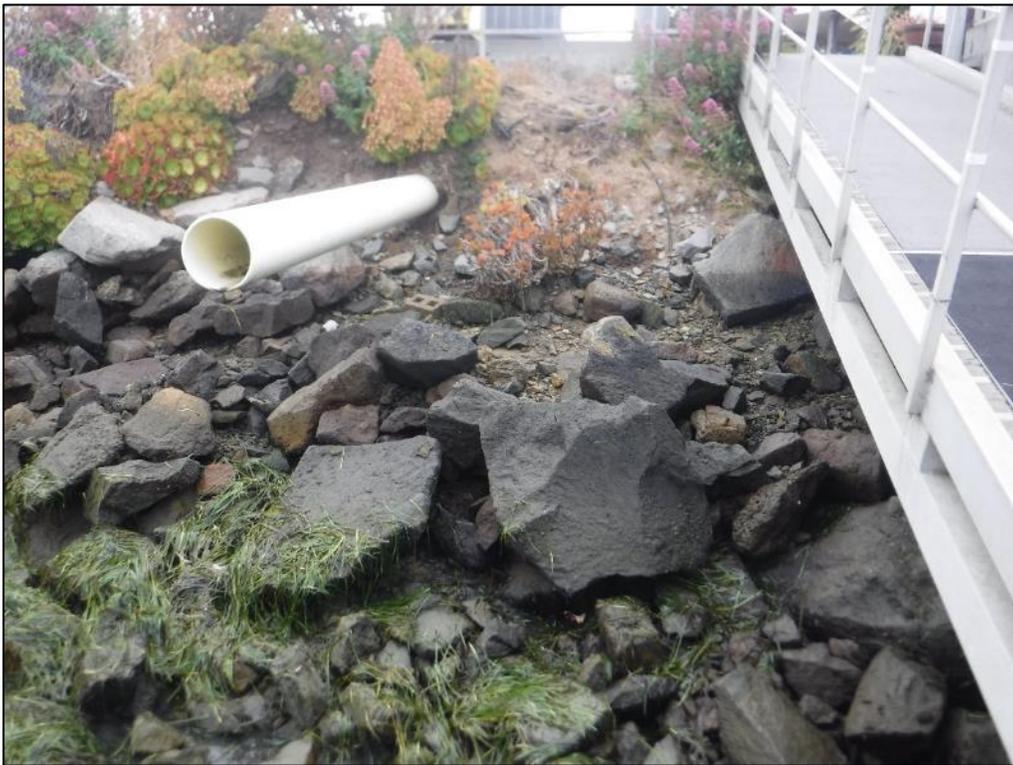
Photo 57. Revetment 8 STA 0+63 Rock missing and migrating down the slope. A 12-in unsupported drain pipe, erosion, and loss of material is shown.

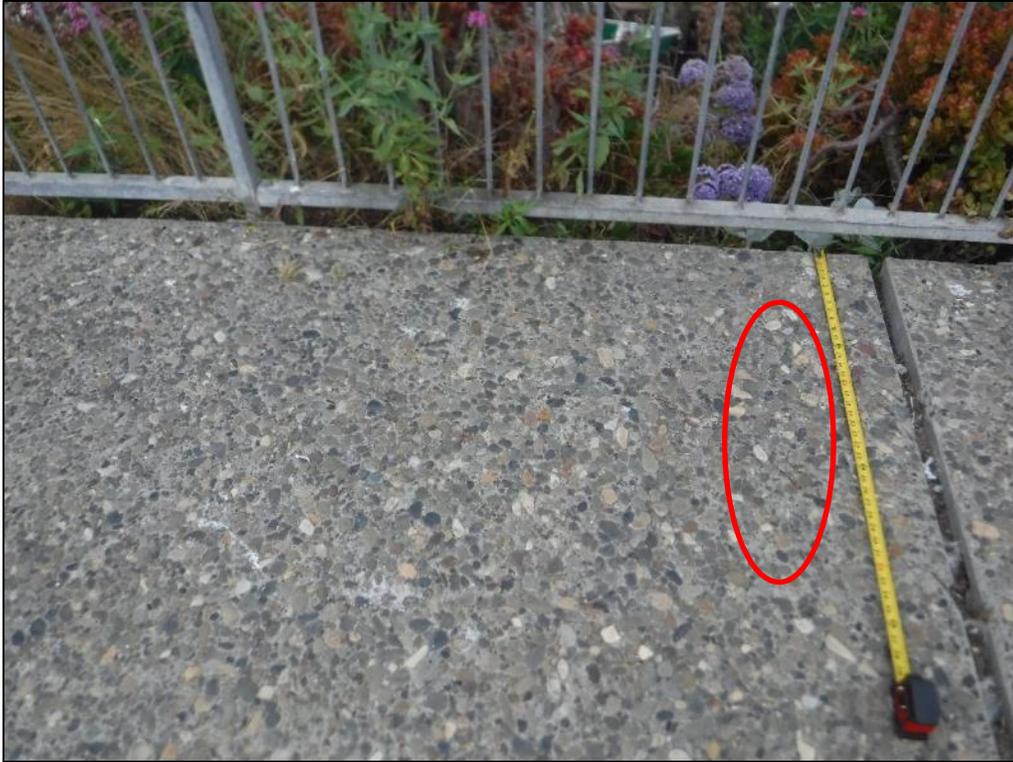
Photo 58. Revetment 8 STA 0+54 Crack (red circle) and settlement of the concrete sidewalk indicates potential settlement.

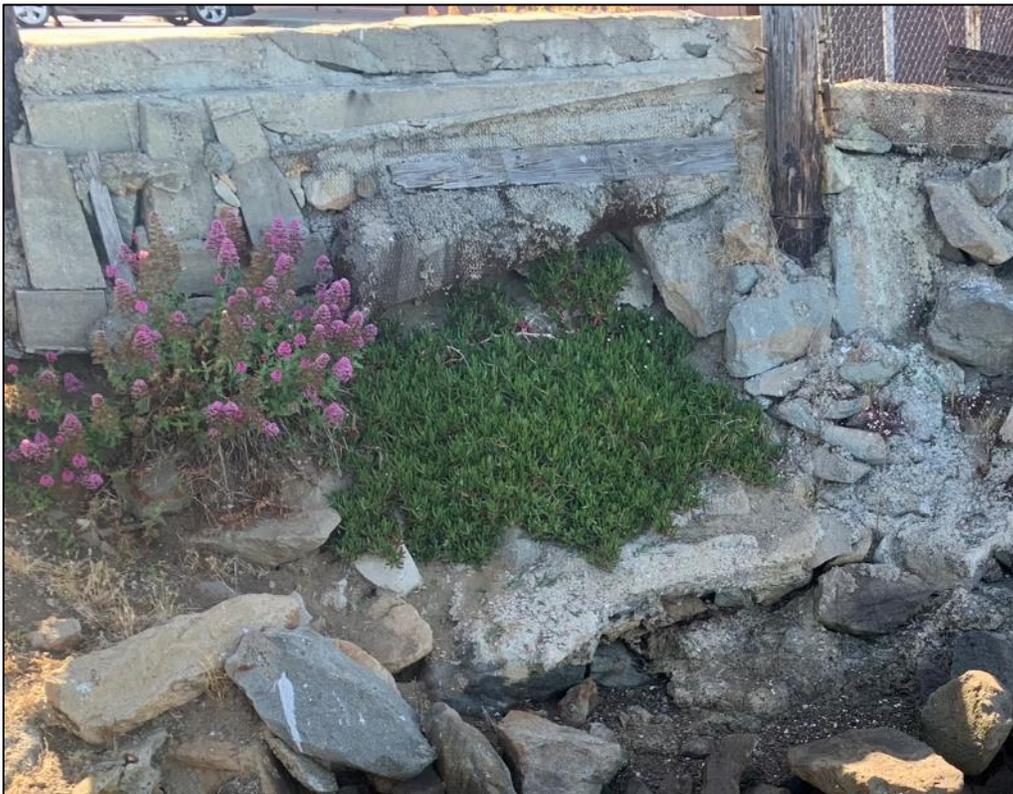
Photo 61. Revetment 9 STA 0+60 Looking east at makeshift concrete wall.

Reference Appendix B for recommendations at this revetment. The portion of the revetment to the north of the pier can be refurbished while the portion to the south of the pier should be rebuilt. Repairs will have to be coordinated with the leasehold to the south. Improvements to surface drainage are necessary to mitigate long-term effects of runoff.

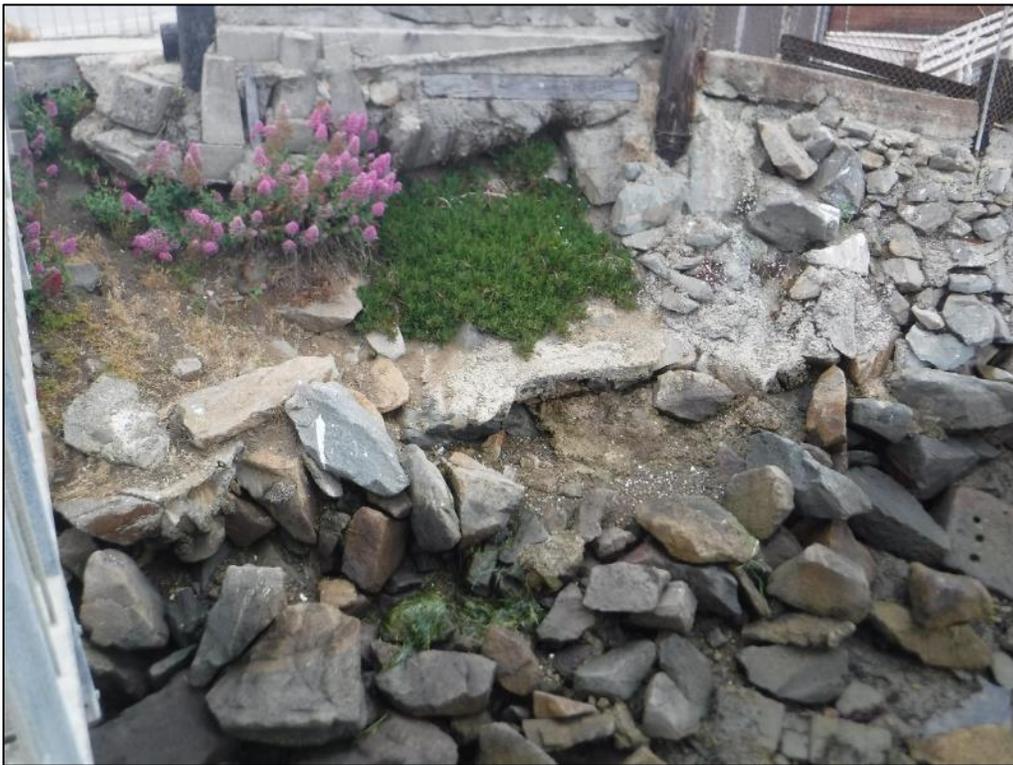
Photo 63. Revetment 9 STA 0+60 Erosion and loss of material below the wall. To the south, the leasehold wall consists of rocks stacked with concrete on a very steep slope.

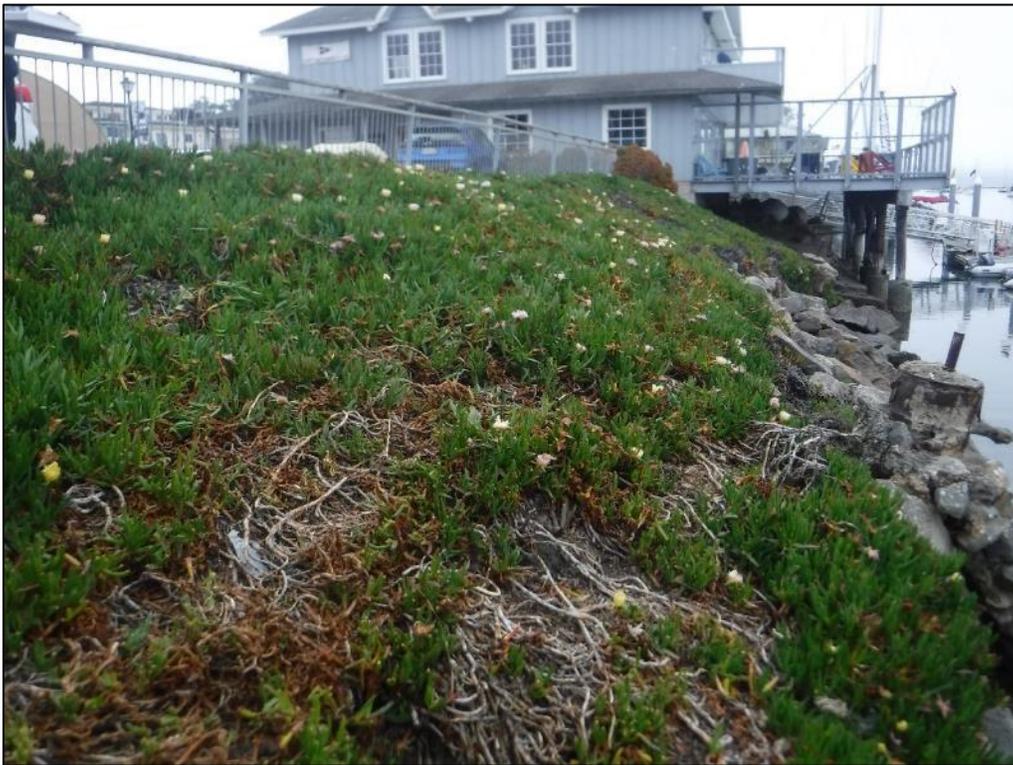
Photo 65. Revetment 10 STA 0+00 Covered by vegetation.

In the meantime, the ice plant should be removed since it has shallow roots, which are not effective in stabilizing steep or deep slopes. Since it appears the top of the slope is missing its rock protection, the ice plant could contribute to erosion by sliding down the slope and taking large portions of soil with it. Improvements to surface drainage are necessary to mitigate long-term effects of runoff.

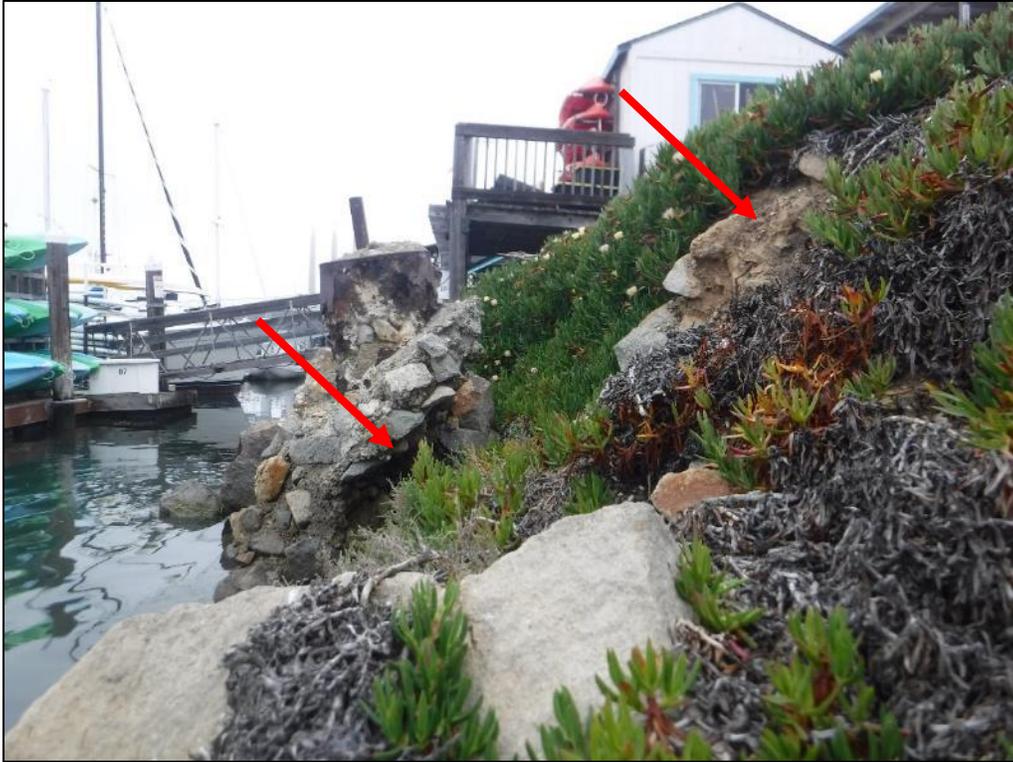
Photo 66. Revetment 10 STA 0+50 Missing revetment and large voids.

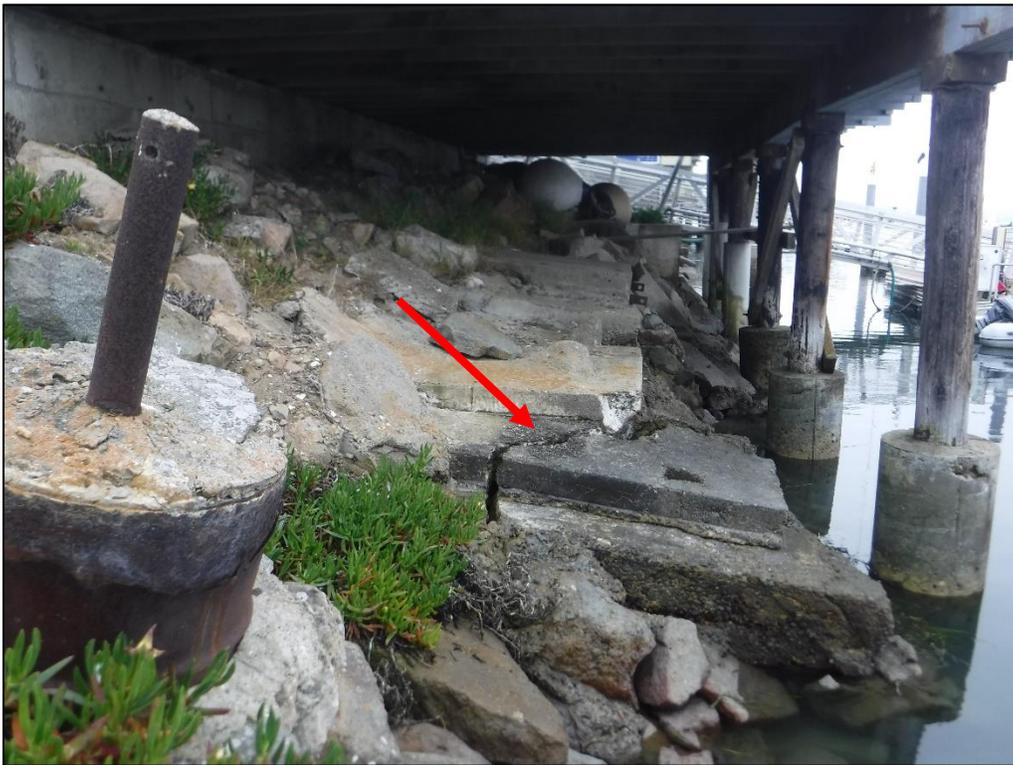
Photo 67. Revetment 10 STA 0+81 Looking at the leasehold to the south where the concrete placed over the revetment has cracked due to loss of rock support.

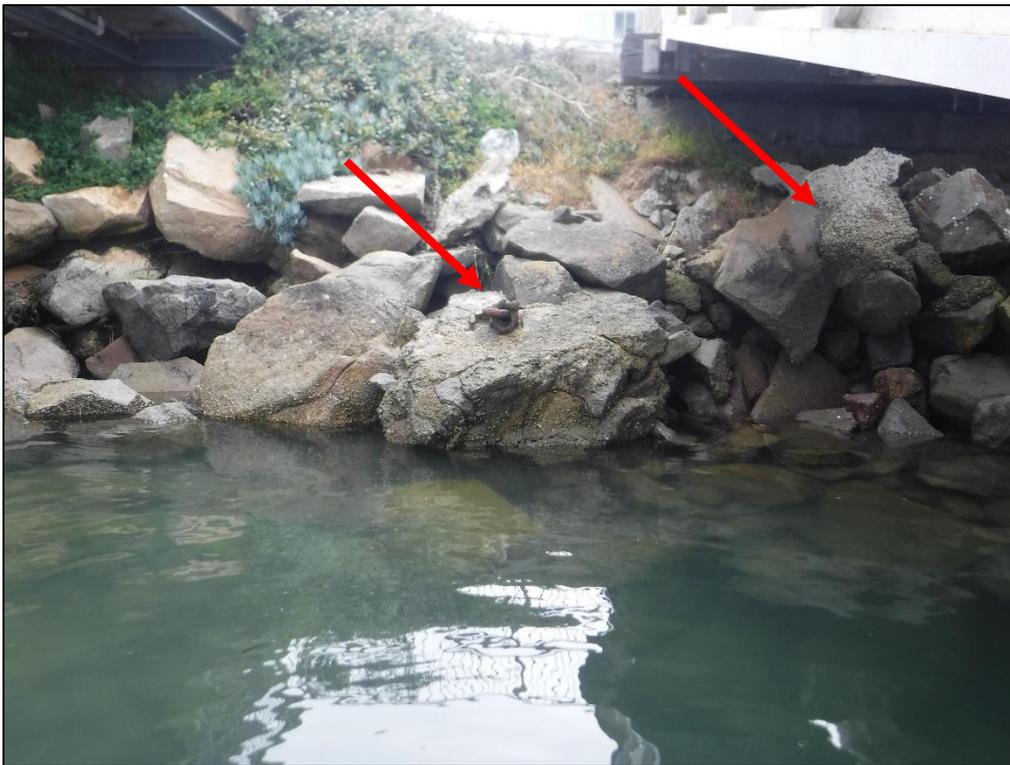
Photo 68. Revetment 11 STA 0+00 Looking east between the northern leasehold and the public access gangway. Miscellaneous sections of concrete are seen.

Reference Appendix B for recommendations at this revetment. Revetment 11 should be refurbished. Construction will need to be coordinated with the surrounding leaseholds. Improvements to surface drainage are necessary to mitigate long-term effects of runoff.

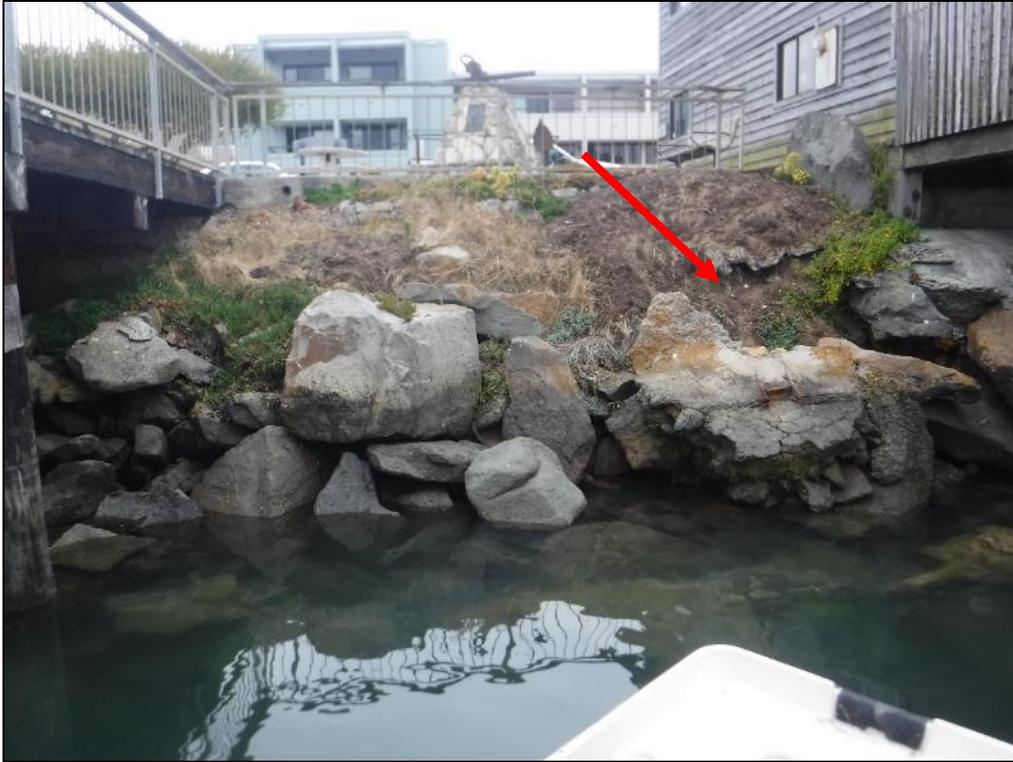
Photo 69. Revetment 11 STA 0+35 Looking west between the public access pier and the south leasehold. The top of slope is not protected, large rocks and concrete are sliding down the slope and voids are noted.

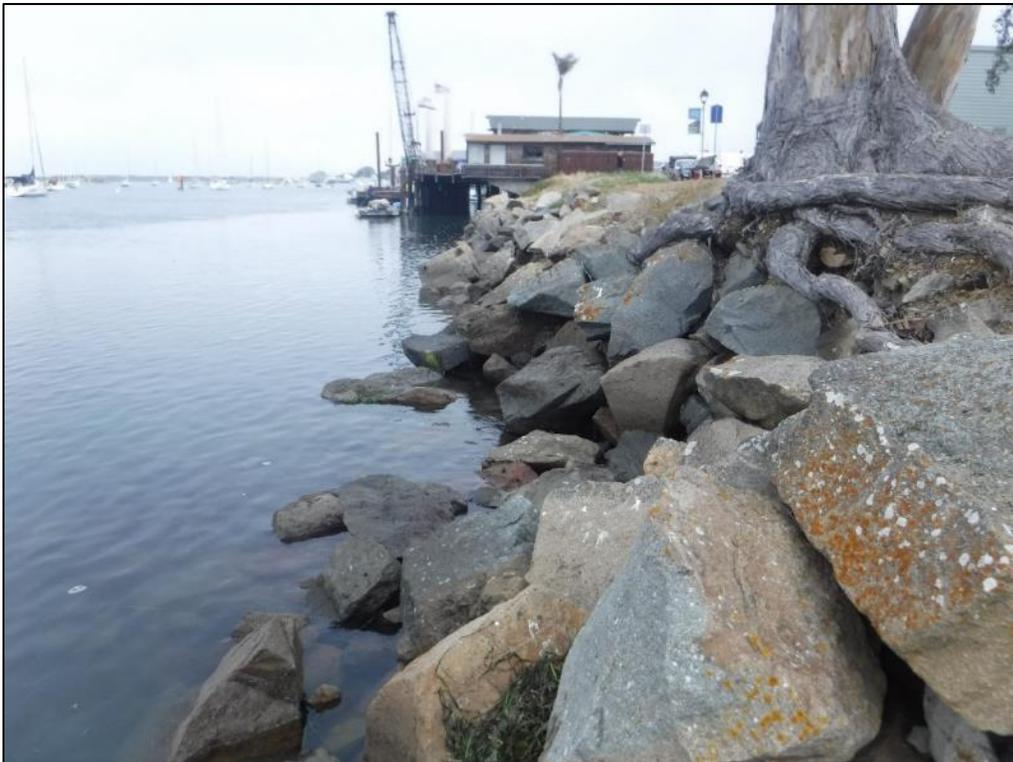
Photo 70. Revetment 12 STA 2+00 Erosion and Undermining below the tree.

There are several areas where undermining and erosion is observed, suggesting the rock slope is not adequately retaining the soil behind the revetment. Erosion from runoff and tidal activity will continue to erode these areas. Where the top third of the slope is steeper than 1.5:1, the slope is unstable, and failure could occur. Improvements to surface drainage are necessary to mitigate long-term effects of runoff.

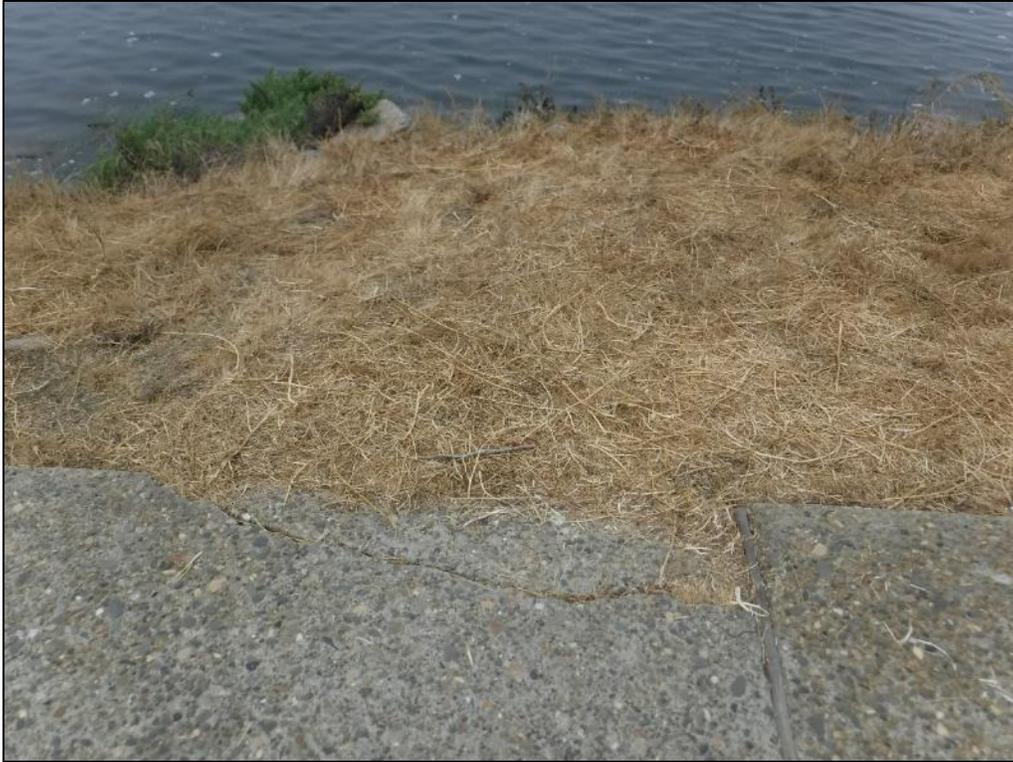
Photo 71. Revetment 12 STA 4+25 Undermined concrete sidewalk, cracked concrete, and evidence of erosion.

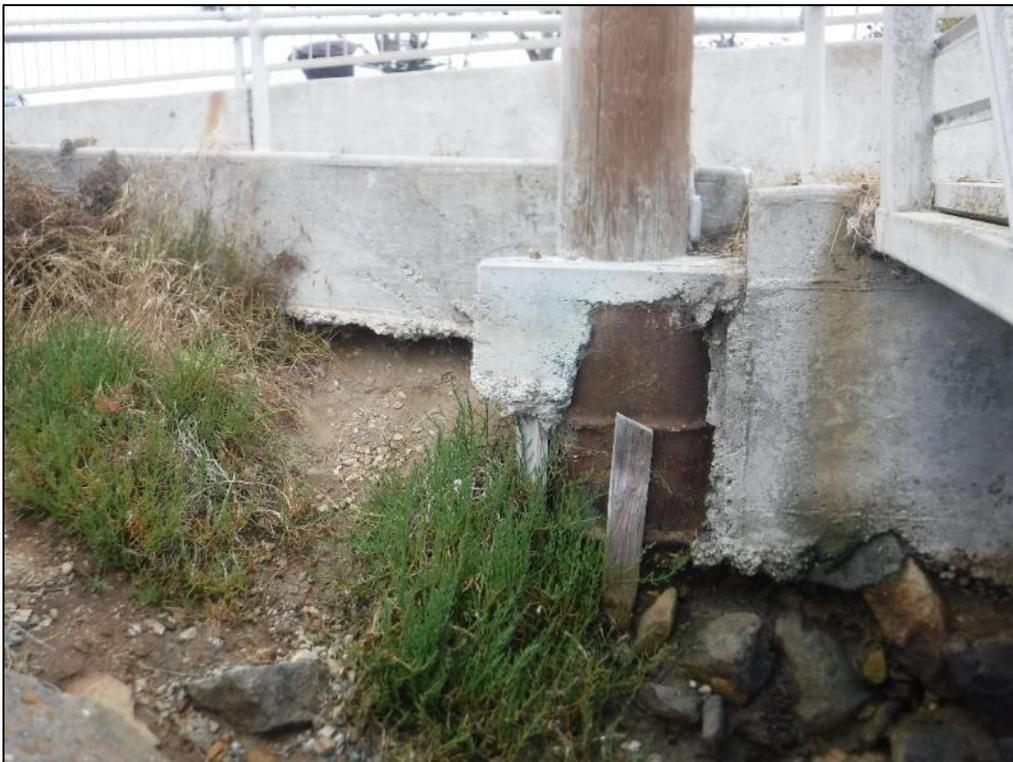
Photo 72. Revetment 12 STA 6+38 Erosion of fine material.

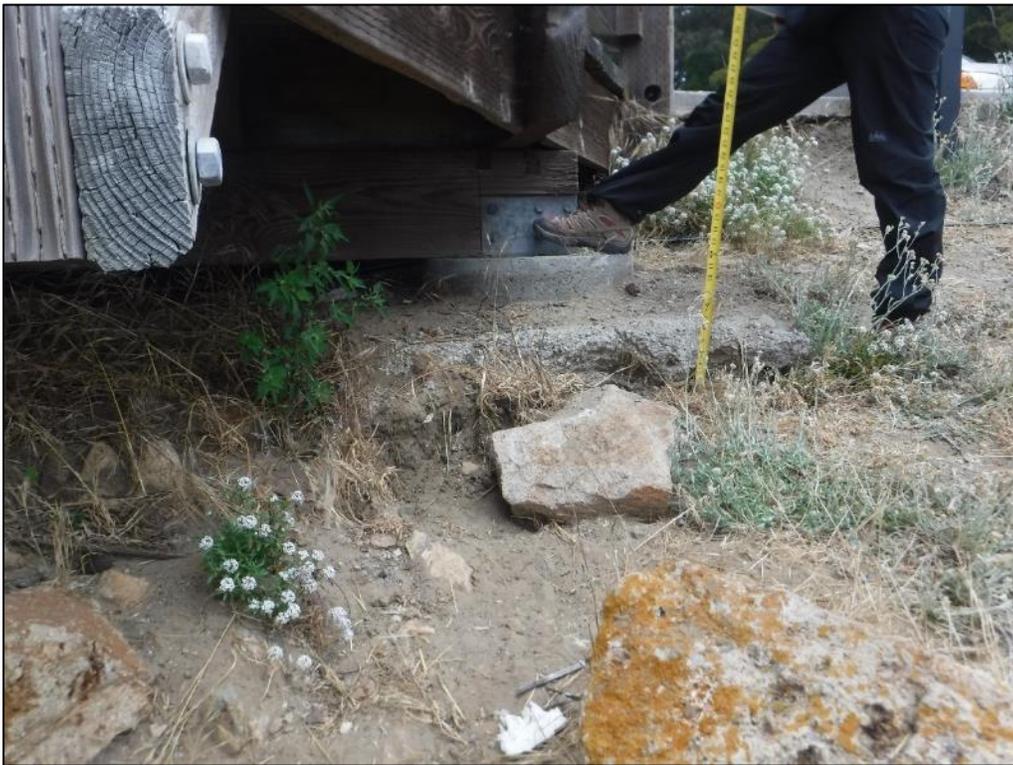
Photo 78. Revetment 12 STA 14+00 The footing for public access platform is exposed.

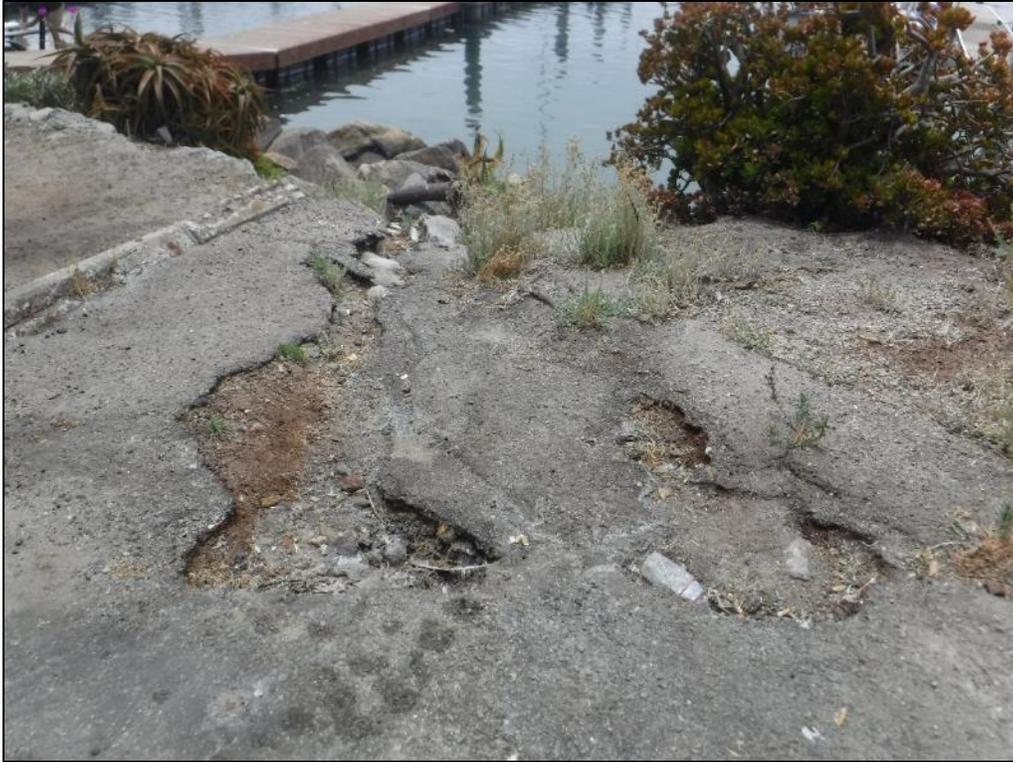
Photo 79. Revetment 12 STA 16+00 Erosion and failed AC paving.

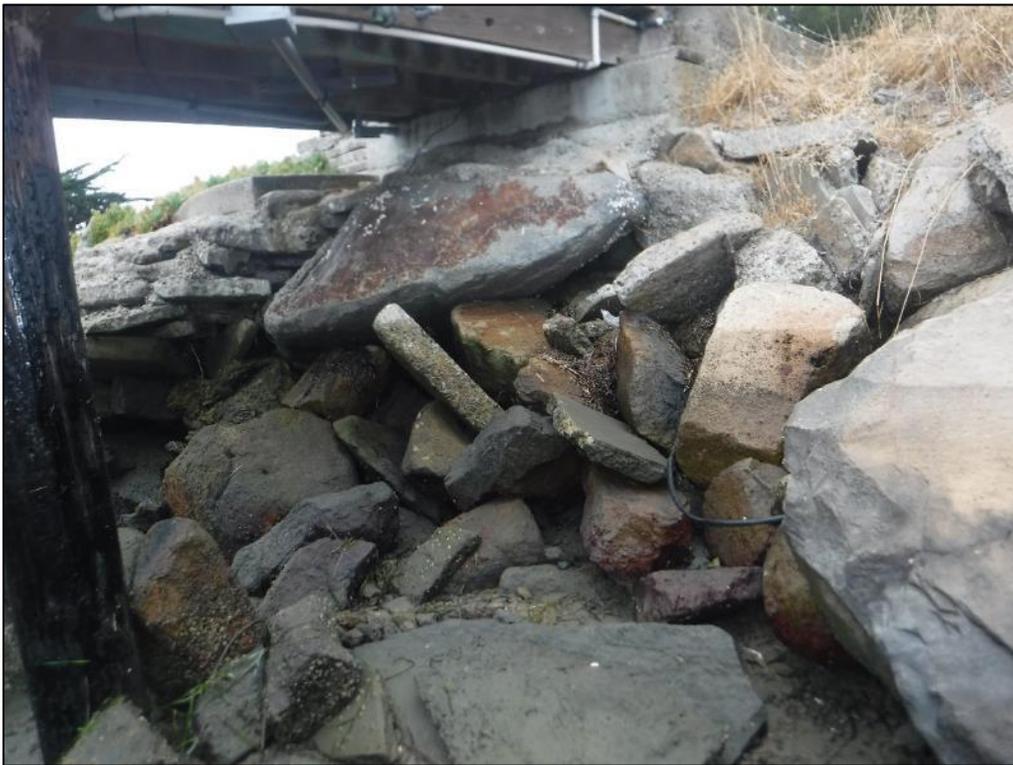
Photo 80. Revetment 12 STA 17+40 Brow abutment inadequately supported, migration of rock material down slope.
