Appendix D: GEOTECHNICAL DATA REPORT

Project No.
25170.000.001

October 10, 2024

Subject: Inspection and Assessment of Revetments and Seawalls
Morro Bay, California

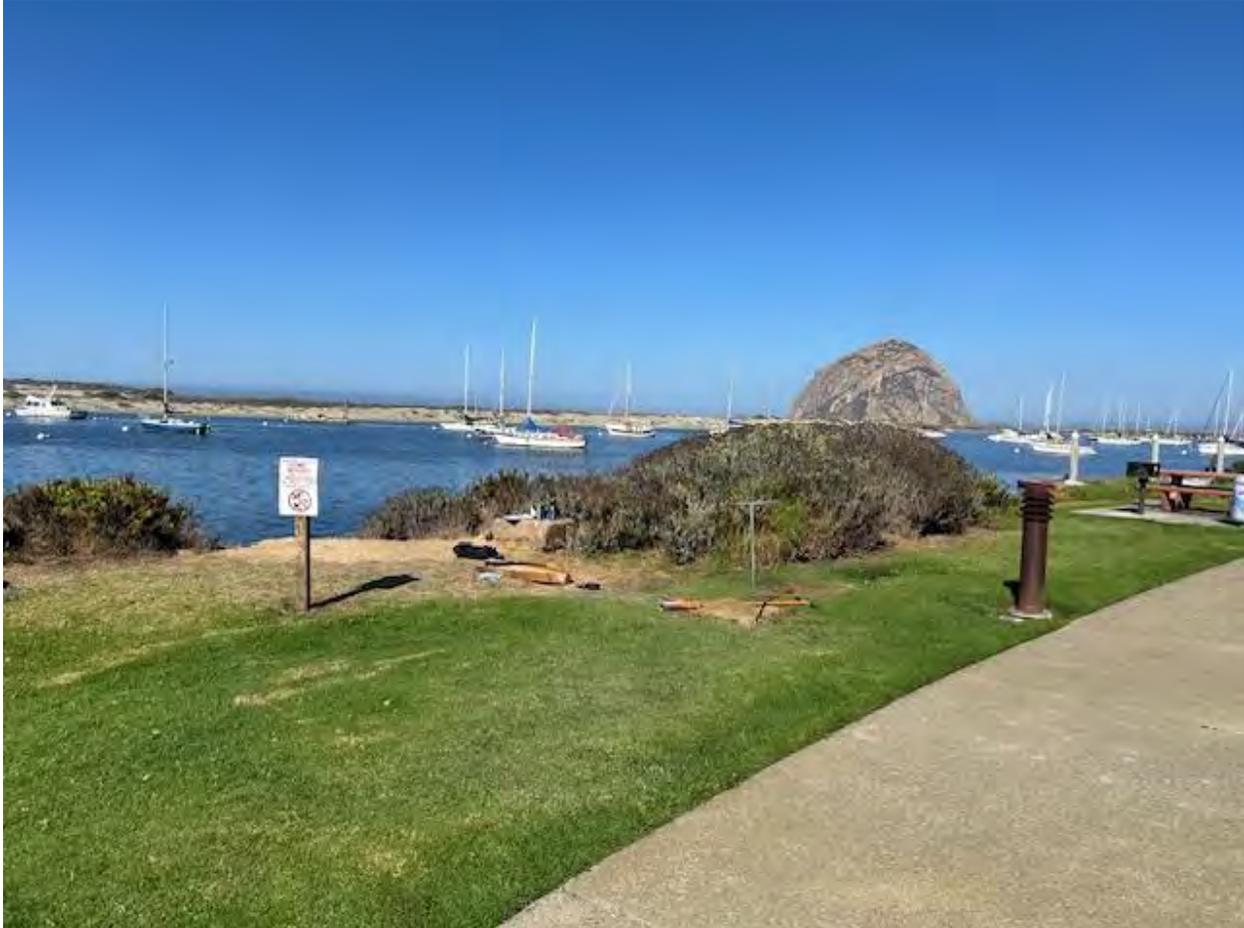
PHOTO 1: Hand Auger HA-1

As shown in Figure 2B, we performed hand augers HA-1 and HA-2 at Revetment 12 within Tidelands Park. At both HA-1 and HA-2, we encountered poorly graded sand to silty sand with variable amounts of shells. We encountered an approximately 3-inch-thick layer of clay a depth of about 4 feet in HA-1. We encountered practical refusal in HA-1 at a depth of about 5 feet and HA-2 at about 7 feet, due to what felt like gravel or shells. No voids were observed during hand auguring.

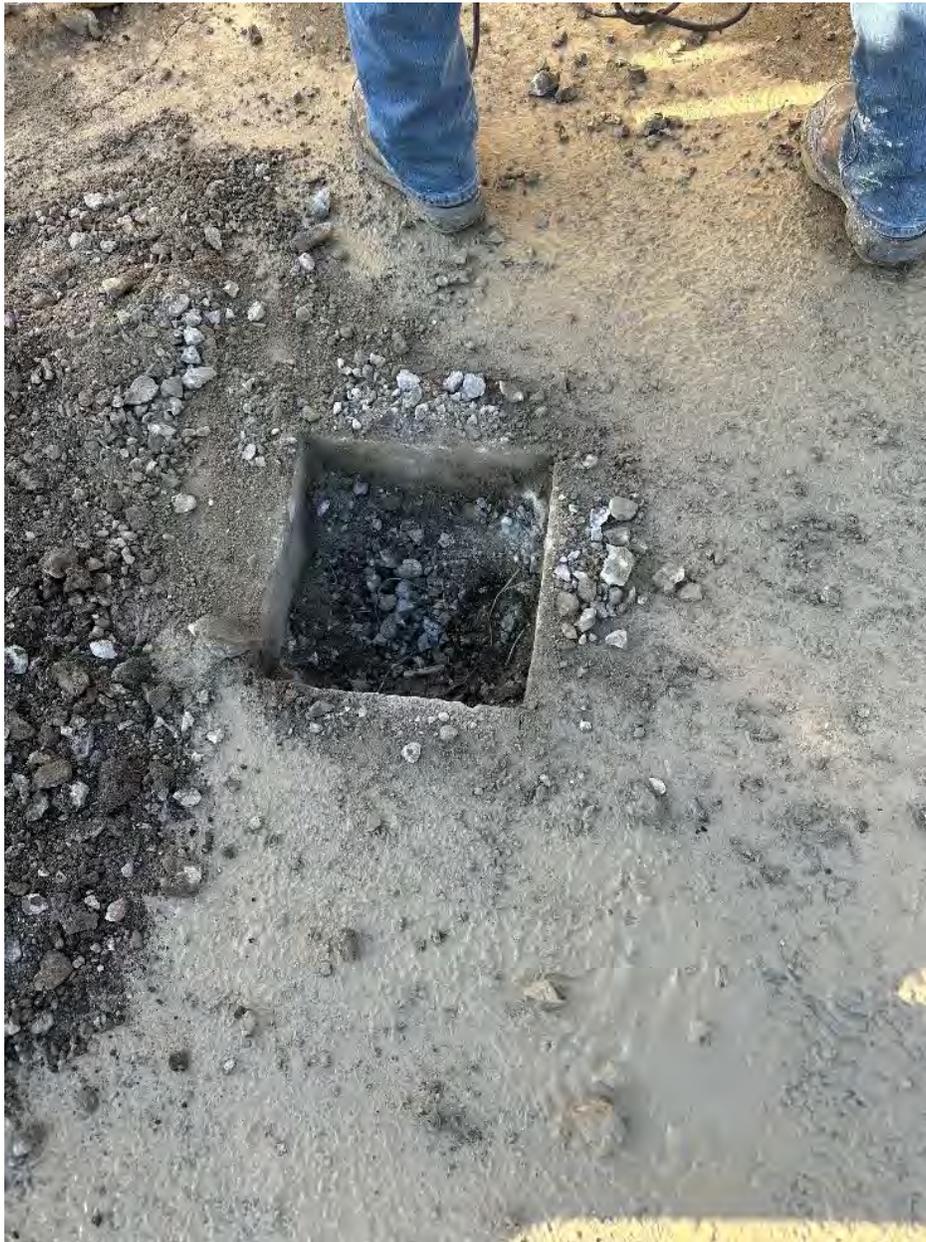
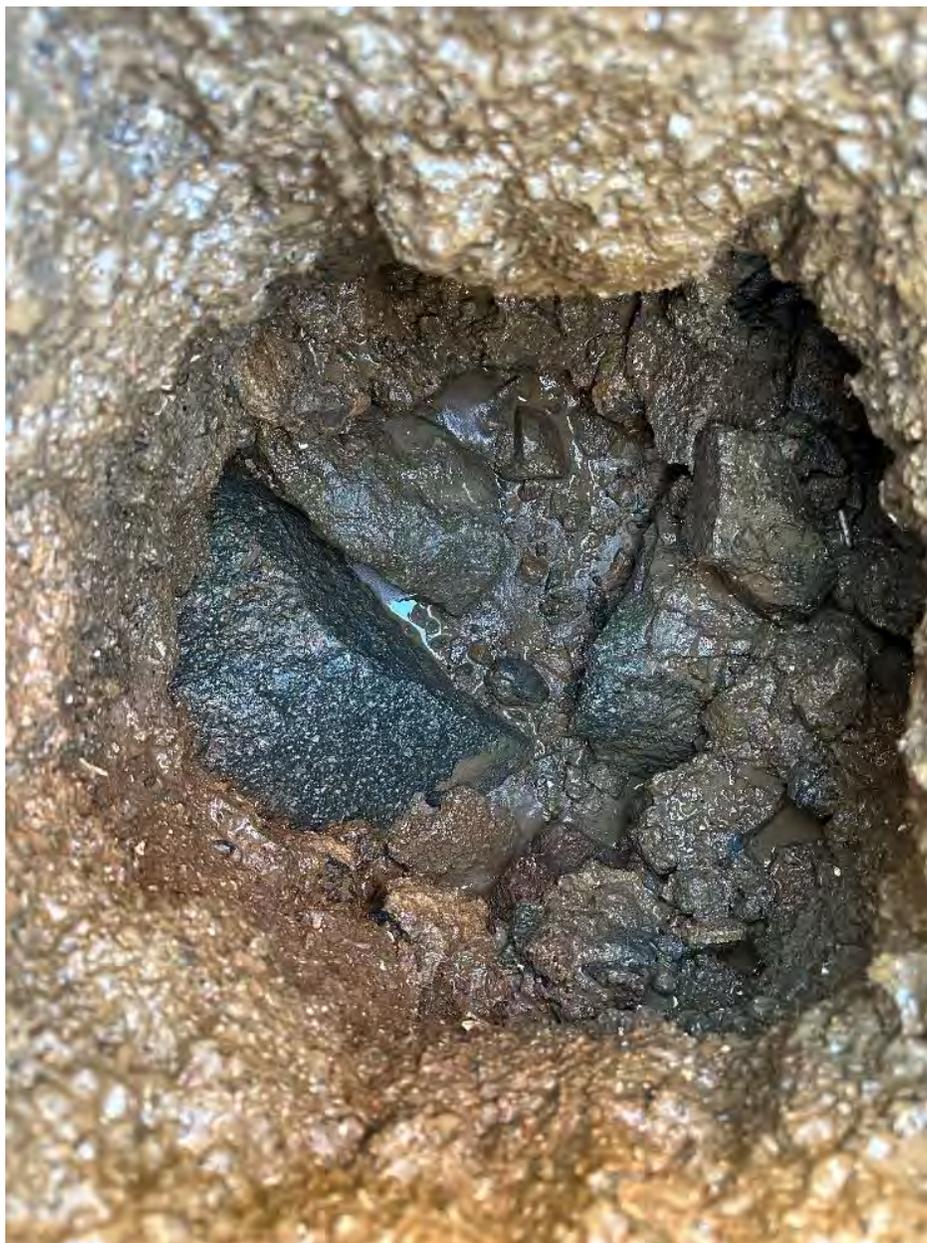
PHOTO 2: Pothole PH-1

We performed pothole PH-1 at Seawall 1, as shown in Figure 2A. We observed 5-inch-thick concrete slab and large rock pieces at a depth of 1 foot below the ground surface. We did not observe any void between the concrete slab and the subgrade. We terminated the pothole at a depth of approximately 2¼ feet due to the rock. The anomalies identified by GeoVision may be small voids within the observed rock.

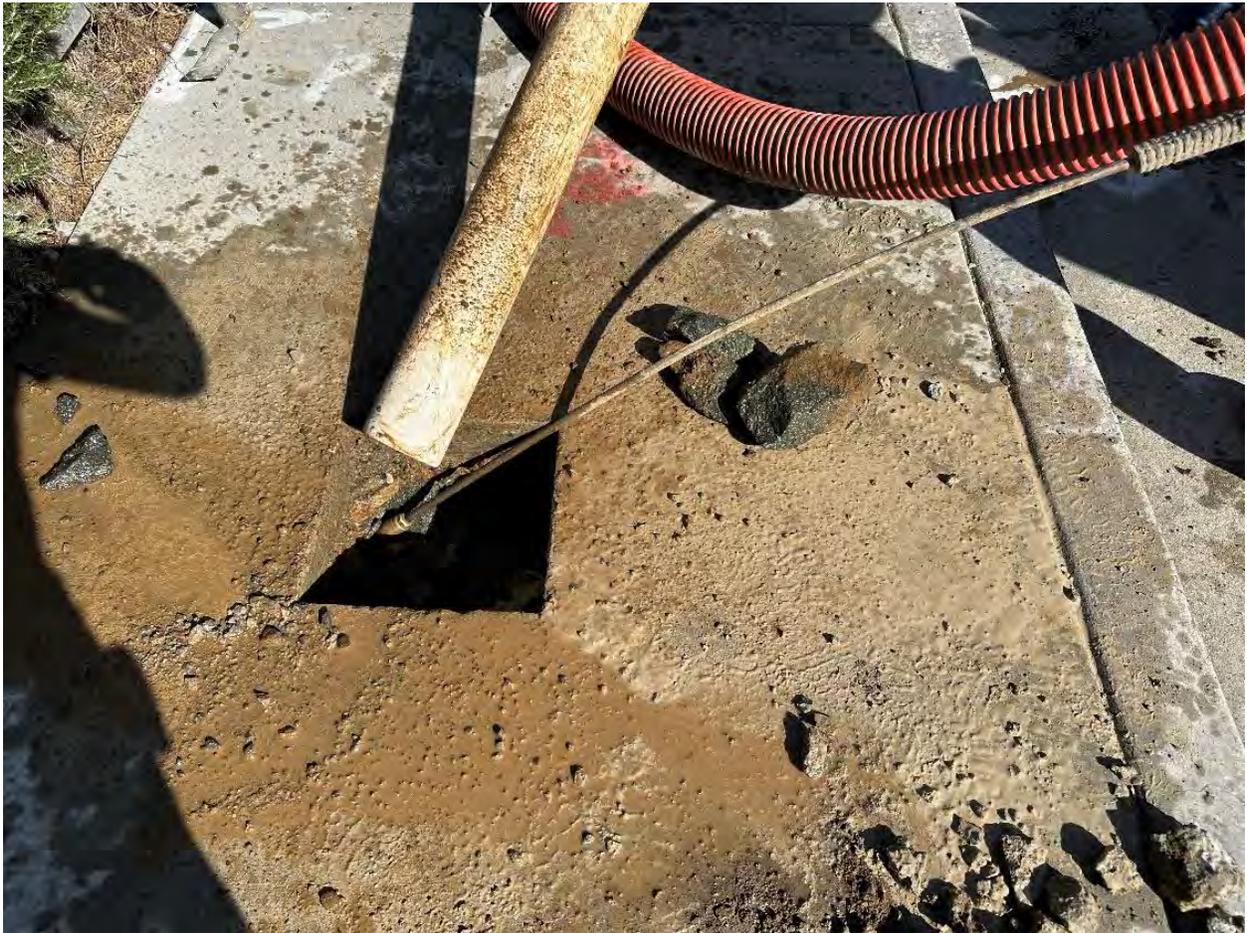
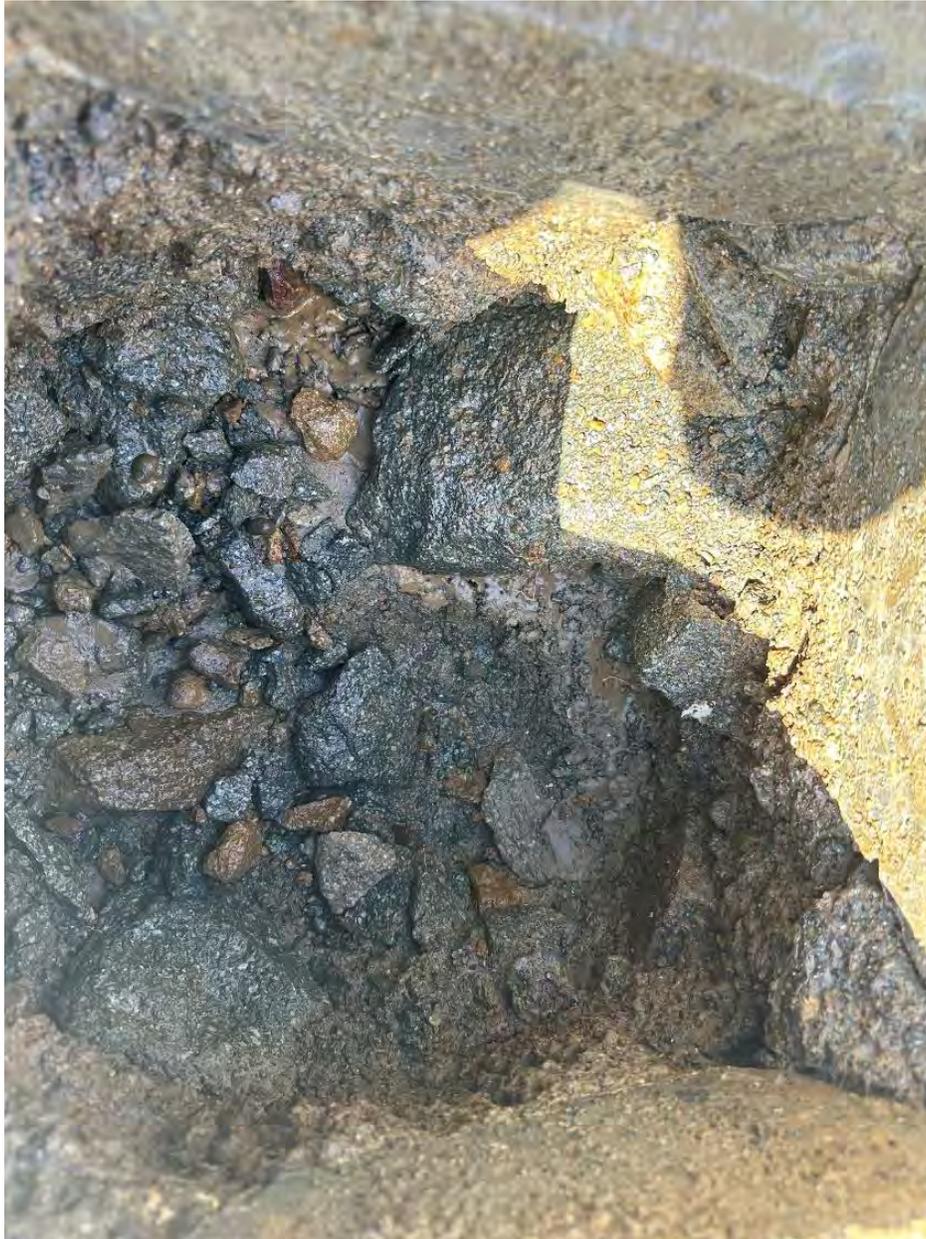
PHOTO 4: Pothole PH-2

We performed pothole PH-2 at Revetment 6, as shown in Figure 2A. We observed a 4-inch-thick concrete slab and large rock pieces directly under the concrete slab. We did not observe a void between the concrete and the subgrade. We terminated the pothole at a depth of approximately 1¼ feet due to the rock. The anomalies identified by GeoVision may be small voids within the observed rock.

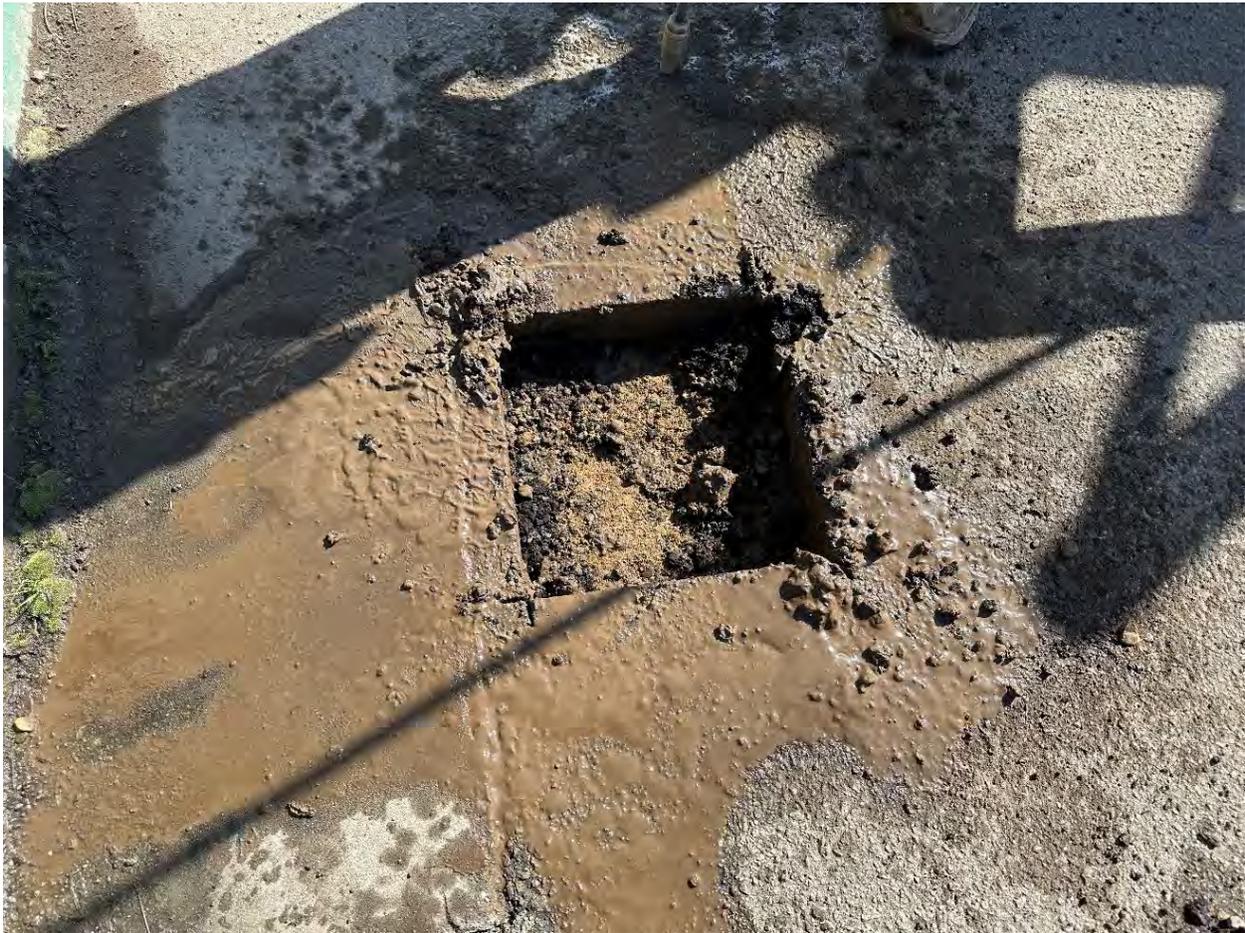
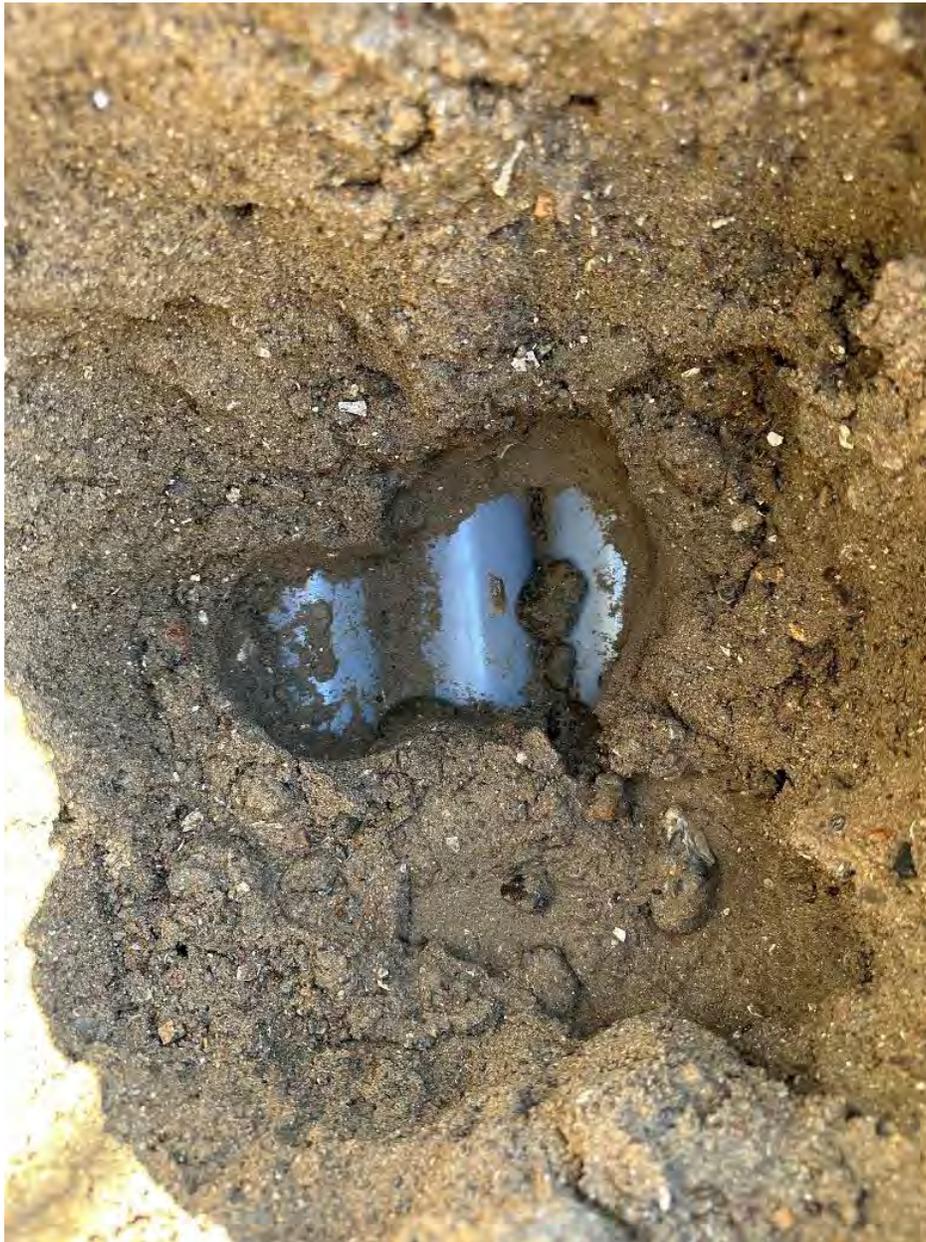
PHOTO 6: Pothole PH-3

We performed pothole PH-3 at Revetment 9, as shown in Figure 2A. We observed 3½ inches of asphalt pavement, poorly graded sand, and multiple communications conduits at a depth of approximately 2 feet. We did not observe a void between the pavement and the subgrade. We terminated the pothole when the conduit was observed.

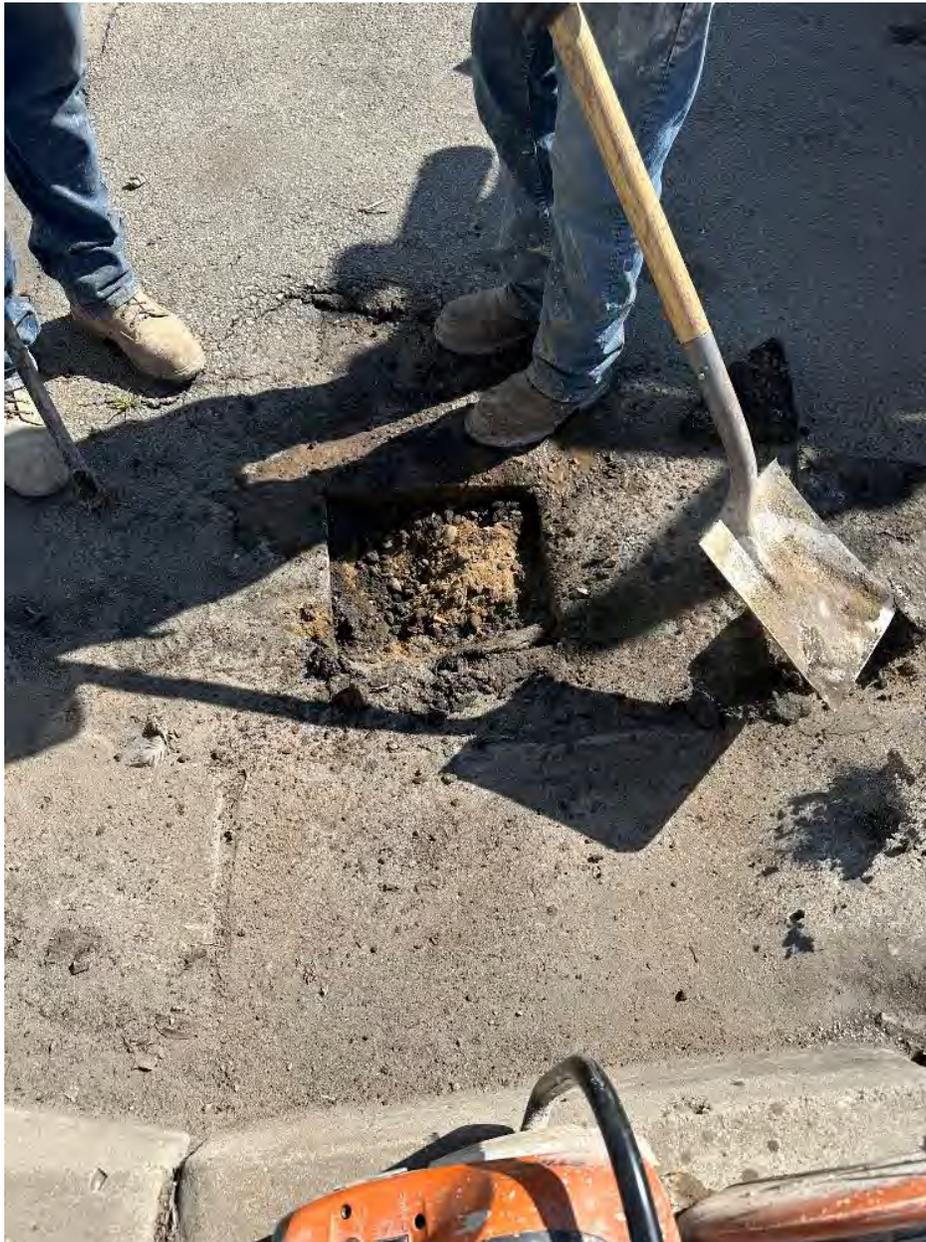
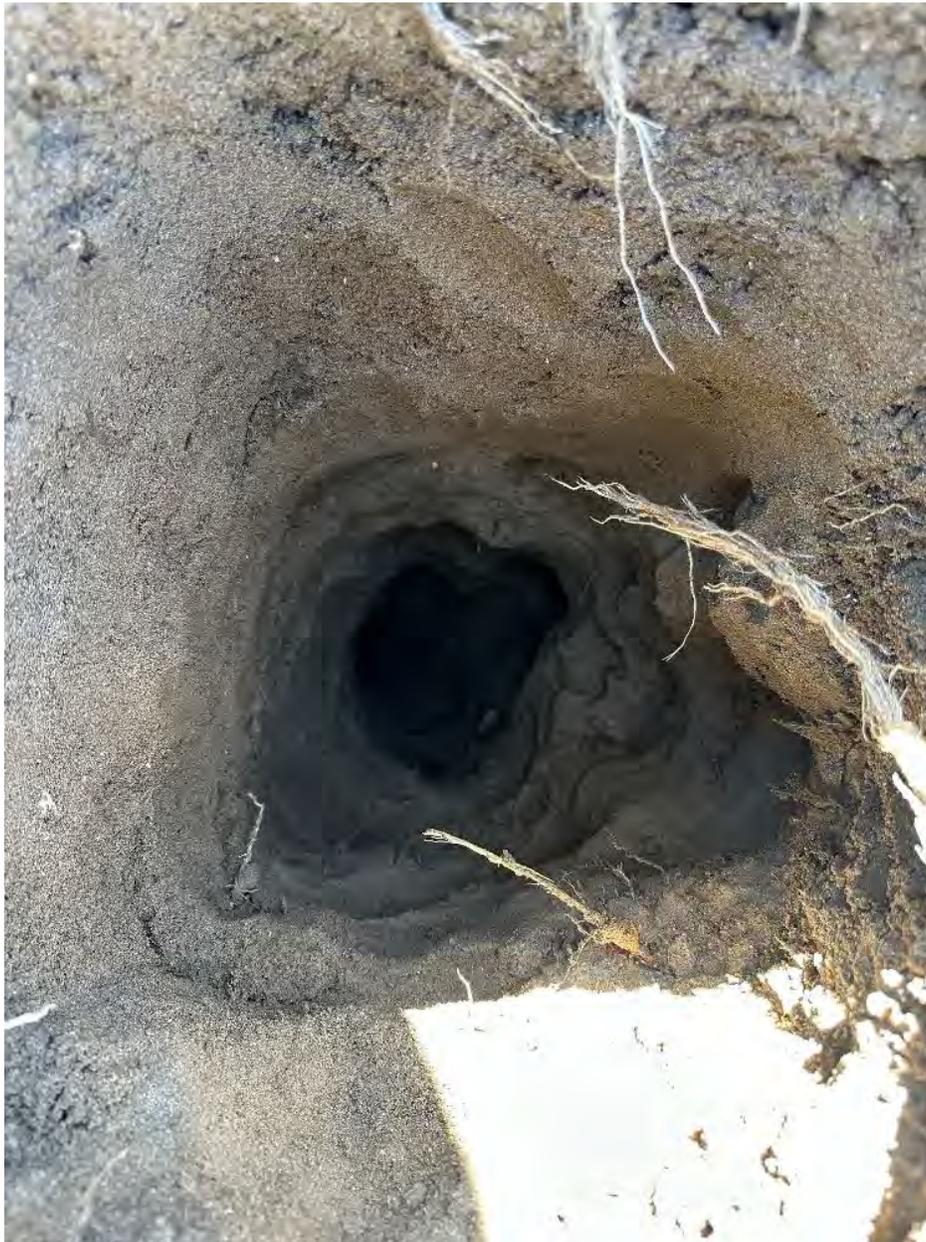
PHOTO 8: Pothole PH-4

We performed pothole PH-4 at the northern end of Revetment 10, as shown in Figure 2B. We observed 2½ inches of asphalt pavement over very loose poorly graded sand with shells. We did not observe a void between the pavement and the subgrade, nor in the sidewall of the excavation. We terminated the pothole at a depth of approximately 6½ feet below the ground surface.

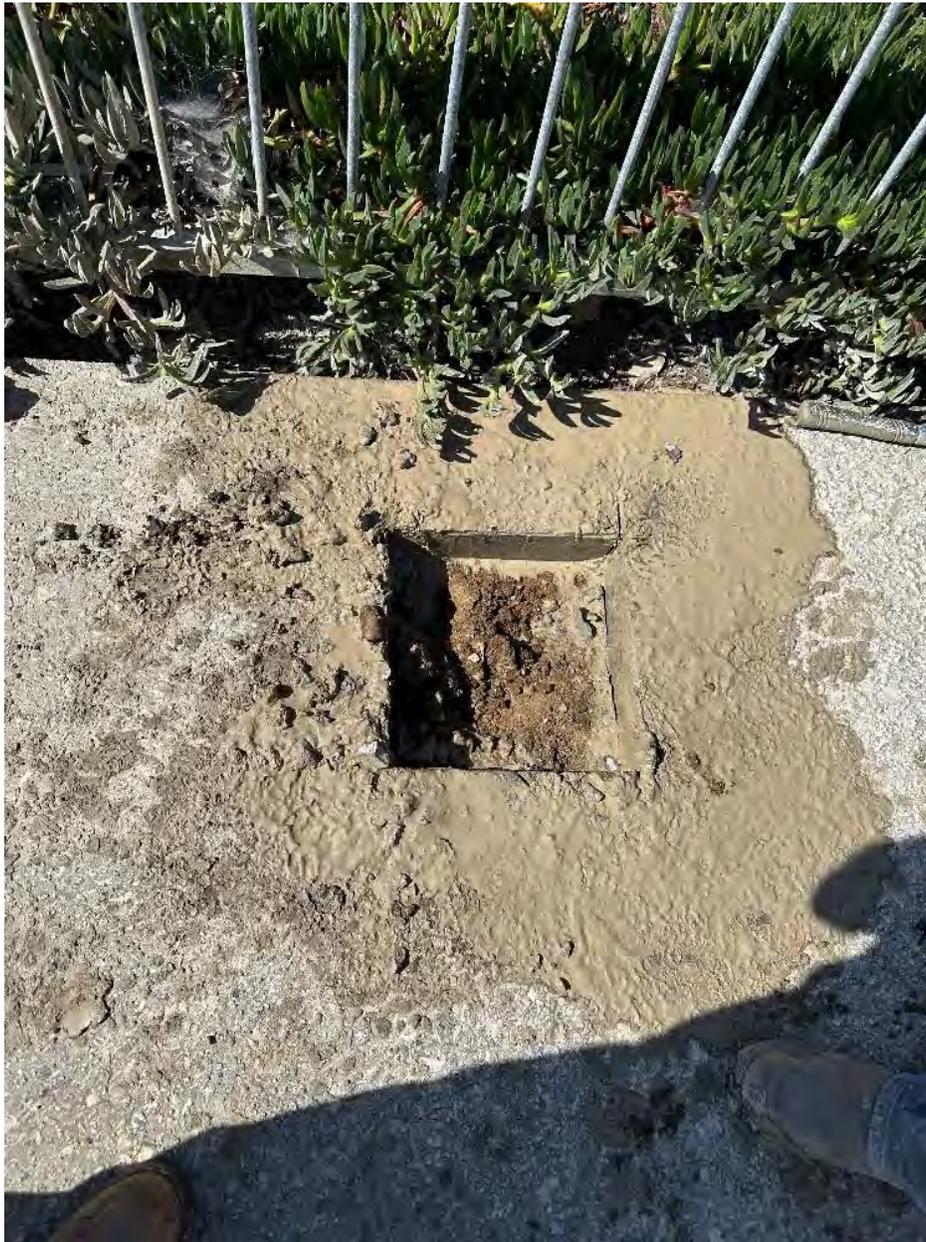
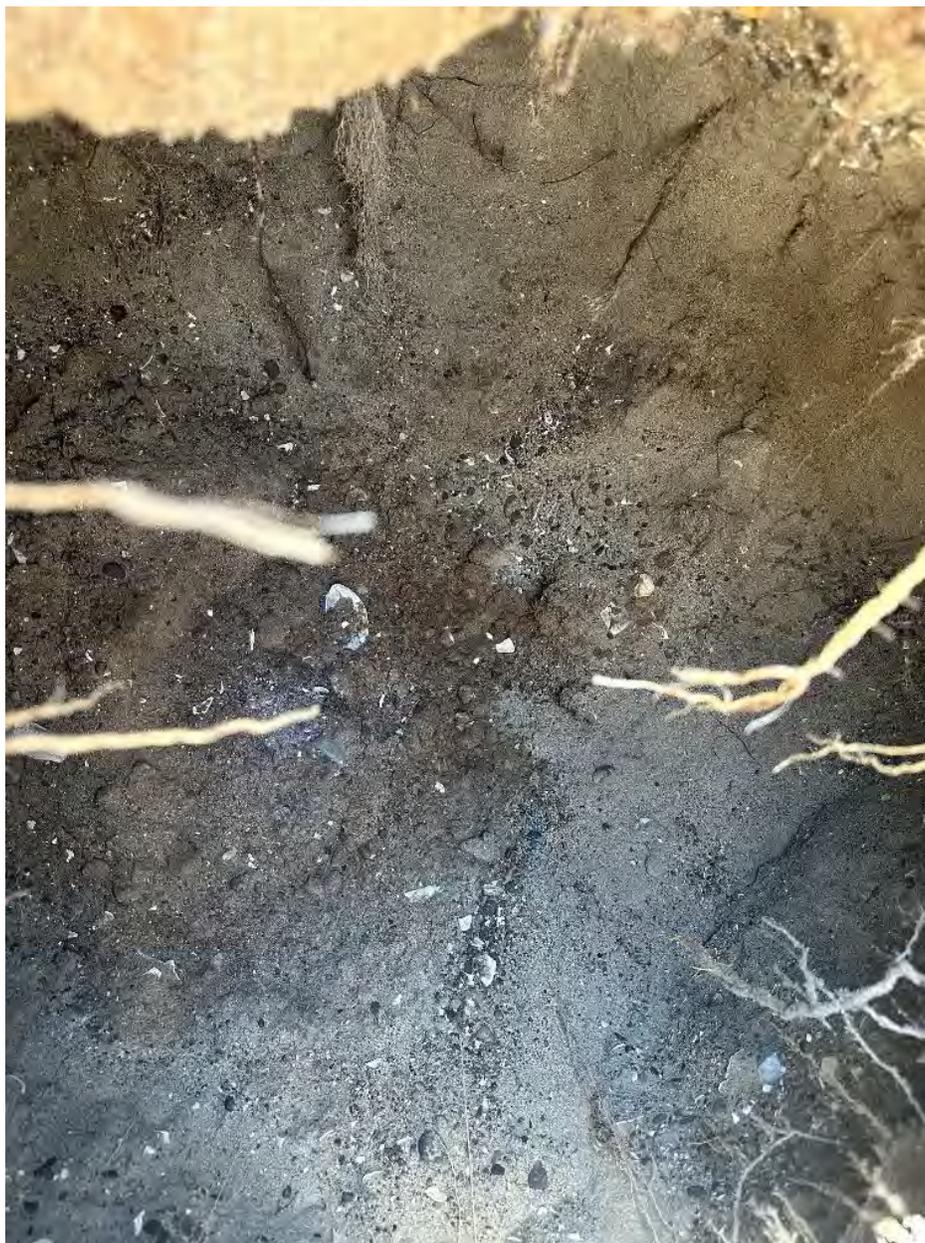
PHOTO 10: Pothole PH-5

We performed pothole PH-5 towards the middle of Revetment 10, as shown in Figure 2B. BRADY had noted a tilted railing and movement of the concrete sidewalk. We observed 5 inches of concrete over very loose poorly graded sand with shells. We did not observe a void between the pavement and the subgrade. We terminated the pothole at a depth of approximately 3¼ feet below the ground surface due to the sidewalls collapsing.

We did not observe significant voids below the concrete or asphalt pavement which generally confirms the conclusions by GeoVision. The tilted railing and observed movement in the sidewalk at Revetment 10 may be caused by slope movement due to the very loose sand and loss of revetment which provides bracing of the slope.

STATION	CONCEPTUAL GEOTECHNICAL RECOMMENDATIONS
0+00	
0+35	Rebuild revetment
0+81

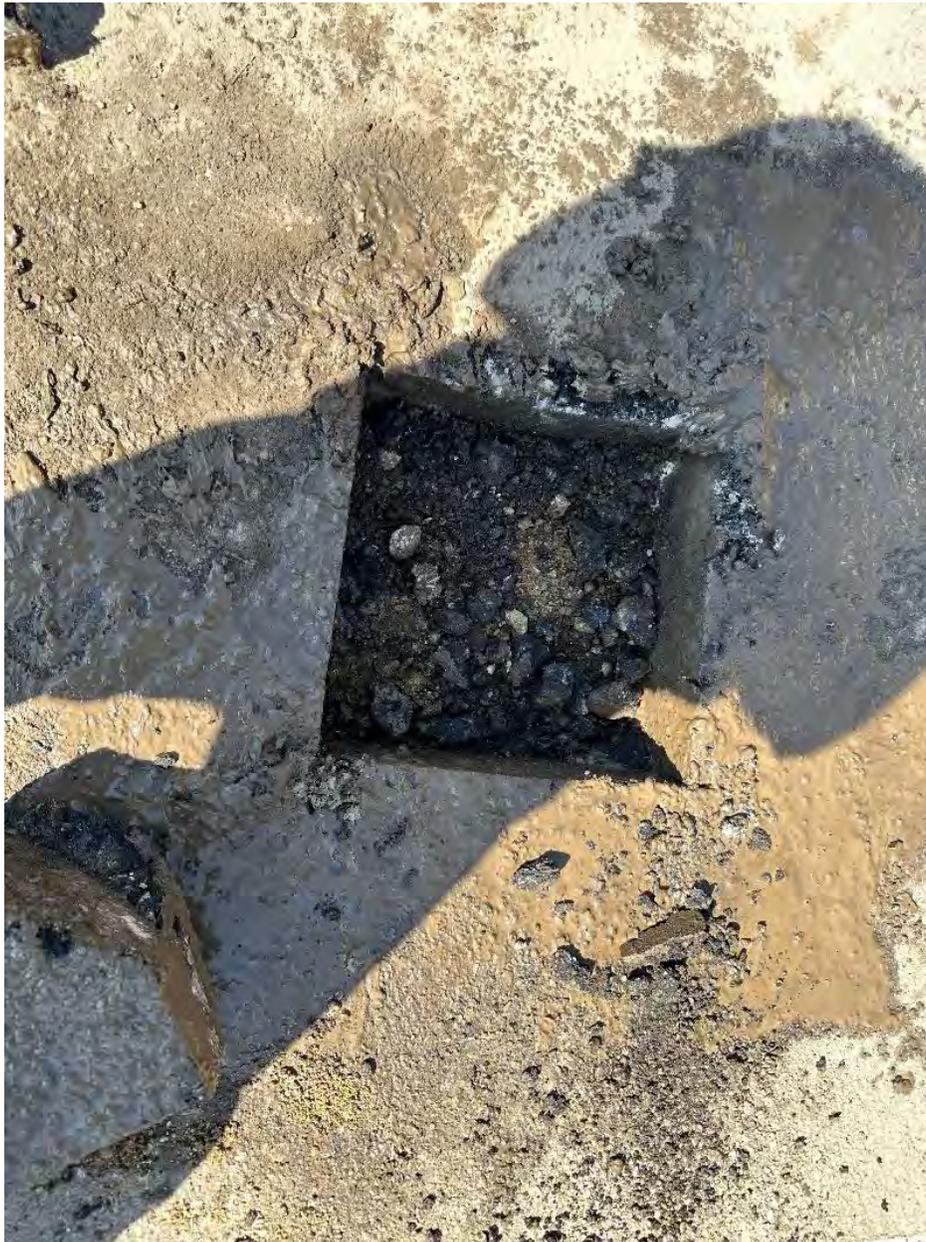
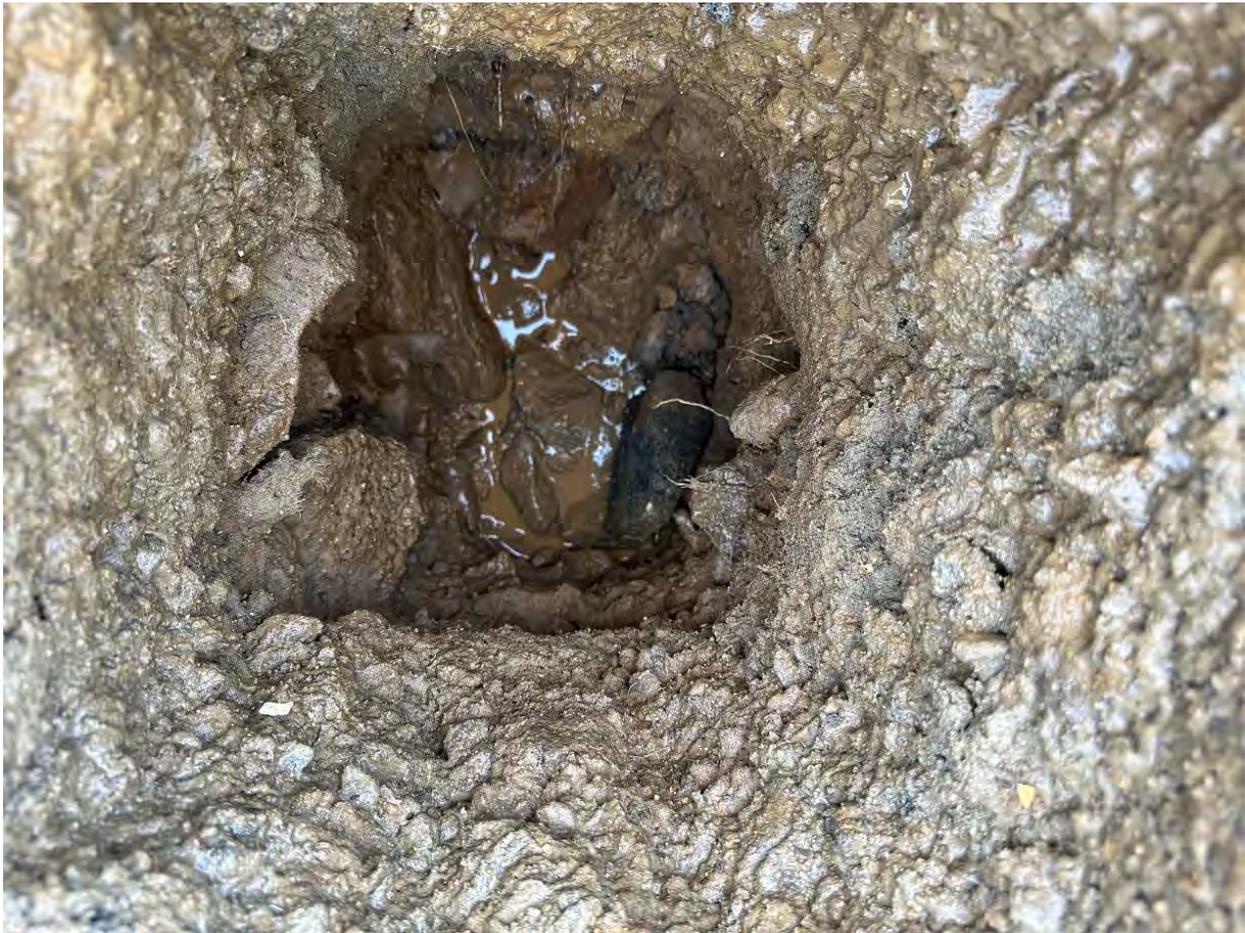
PHOTO 12: Pothole PH-6

We performed pothole PH-6 at the southern end of Revetment 12, as shown in Figure 2B. We observed 5 inches of asphalt pavement and 13 inches of aggregate base over large rock pieces. We did not observe a void between the pavement and the subgrade. We terminated the pothole at a depth of 2½ feet due to the rock. The anomalies identified by GeoVision may be small voids within the observed rock.
