CITY OF MORRO BAY HARBOR ADVISORY BOARD AGENDA

SUBJECT: Commercial Fishing Dock Repair Plan

Damage Evaluation Report
City of Morro Bay, CA - Harbor and Shoreline Infrastructure
File No. DMB012023R

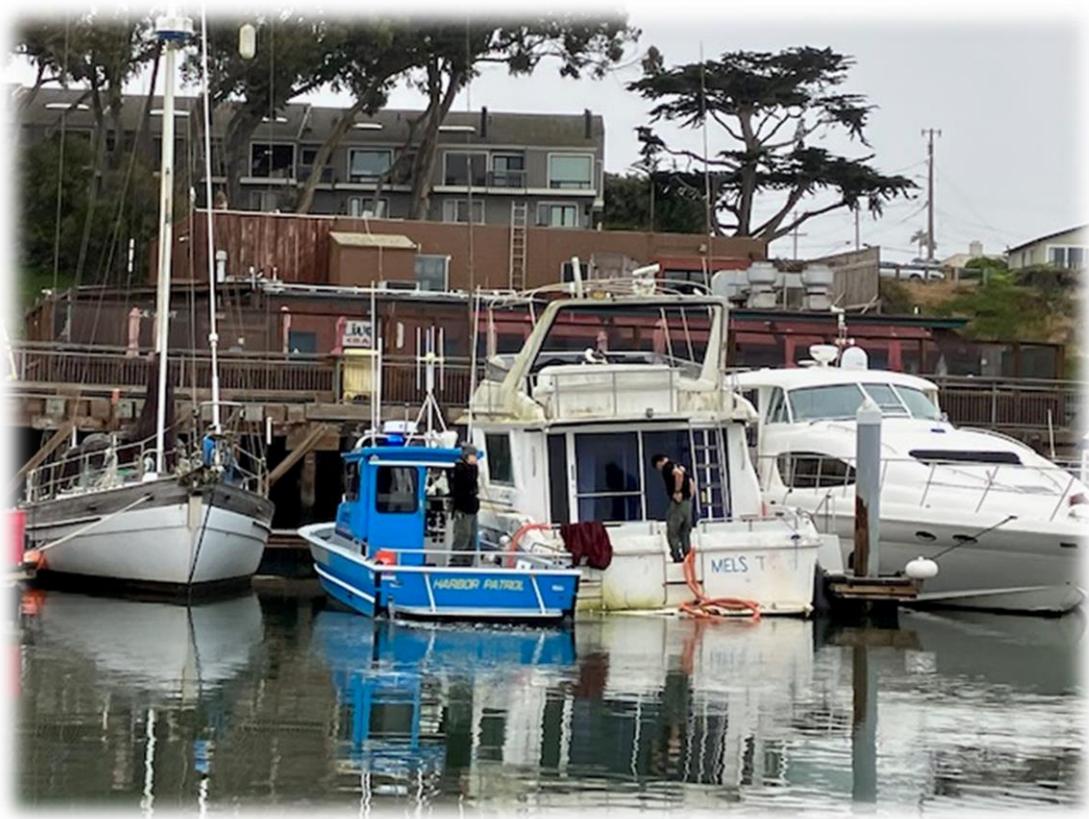
Sinking Vessel 7/3/23, Harbor Patrol responded to a report of a sinking vessel just after first light. The vessel was almost completely swamped over the port stern corner. USCG assisted in deploying de-water pumps and assessing the initial situation. Pumped out water for 3 hours until situation was stable and could be left with an electric pump in care of the dock manager and lease holder. The owner of the vessel was not present or available.

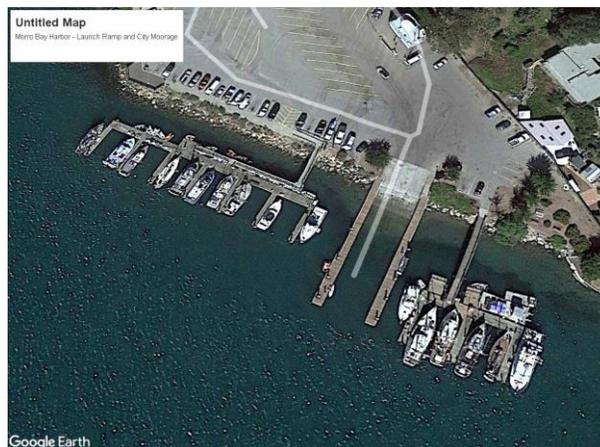
Launch Ramp Docks - Damage

Finger Dock 1/2: The pile hoop broke during the January 4/5 event and has been temporarily repaired.

- Finger Dock 3/4: The pile hoop broke during the January 4/5 event and has been temporarily repaired. Additionally, the finger dock has a pronounced curve along its length, indicating that the dock's structure has been compromised. Further, the edge of the head dock at slip 3 was impacted by the boat moored in that slip surging against the dock. Also, a portion of the cleat attachment plank on the opposite (landward) side of the head dock was broken out.

- Finger Dock 7/8: Floatation is missing and the dock is not level, with its outermost end partially submerged. Additionally, bumpers affixed to the slip 8 side of the finger dock are displaced.

- Finger Dock 11/12: Dock is twisted longitudinally, indicating its structure has been compromised, and floatation is missing from the outermost end.
- Finger Dock 13/14: Floatation is missing, the outermost end is partially submerged, and the dock is not level.

- Finger Dock 15/16: Floatation is missing from the outermost end. Additionally, the edge of the head dock at slip 15 was impacted by the boat moored in that slip surging against the dock, with the dock bumper displaced in that location.

- Finger Dock 17/18: Steel torsion beam is broken at a point approximately 15' from the outermost end, and the docks pile end is broken off. Additionally, floatation is missing, and the outermost half of the dock is submerged, with the innermost half being supported by the dock's attachment to the head dock.

- Finger Dock 19/20: Floatation is missing from the outermost end.

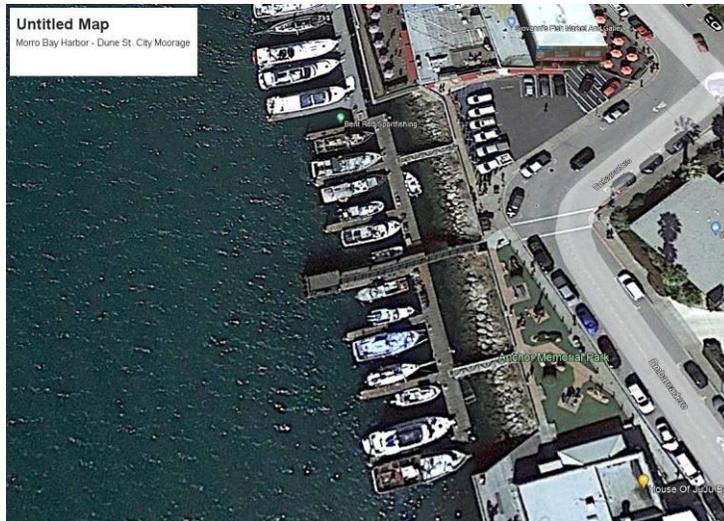
Dune St. Docks – Damage

Finger Dock 21/22: The dock is severely twisted, indicating that its structure is compromised. Additionally, the outermost end is distorted, with planks missing and floatation missing.

Finger Dock 23/24: Dock is twisted longitudinally, indicating its structure has been compromised, and floatation is missing.

Finger Dock 25/26: The dock is missing floatation.

Finger Dock 29/30: Internal structure at the pile hoop connection is broken, and floatation at the outermost end is compromised.

Total Dock Complex: The equipment installed to discourage sea lions from mounting the docks is damaged throughout the complex.

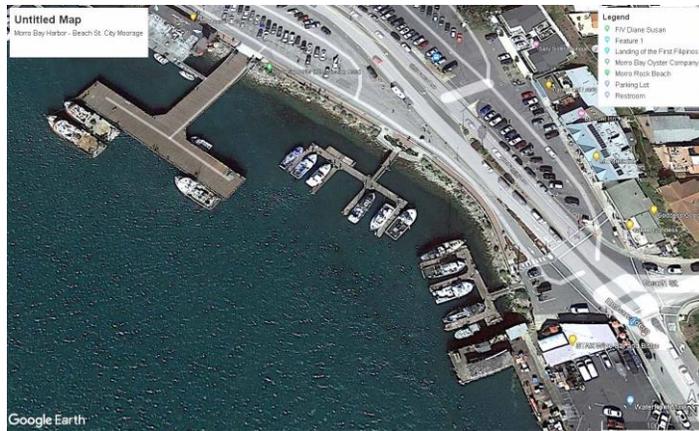
Beach St. South Docks – Damage

Finger Dock 35/36: There is a substantial curve over the length of the dock, indicating it is structurally compromised. Additionally, the outermost 10' to 12' of the fender plank on the north side is separated from the dock framing.

Finger Dock 37/38: The structural connection between the finger dock and the head dock is damaged on the south side of the connection.

Finger Dock 39: The finger dock-to-pile connection is broken, the dock-to-head dock connection is damaged, a mooring cleat on the outermost end of the dock is displaced, and floatation is missing.

Total Dock Complex: The equipment installed to discourage sea lions from mounting the docks is damaged throughout the complex.

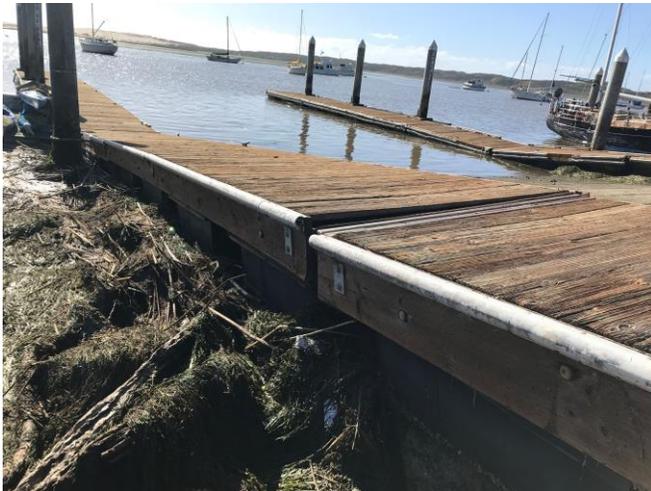
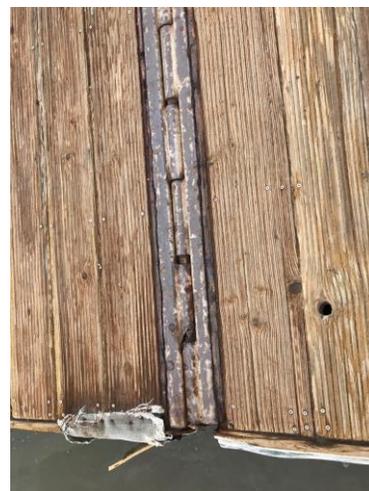
Launch Ramp - Damage

The north finger dock is missing floatation, and the hinge between the first and second dock sections from the top is damaged.

The south finger dock is missing floatation, and the hinge between the first and second section dock sections from the top is damaged.

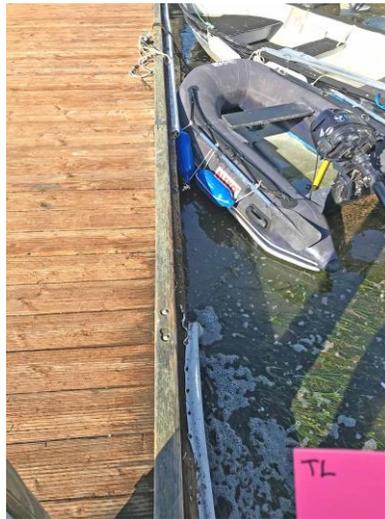
Tidelands Park Pump-Out Dock – Damage

The pump-out dock at Tidelands Park features dock edge bumpers. A portion of this bumperring was displaced during the January 9/10 extreme weather event.

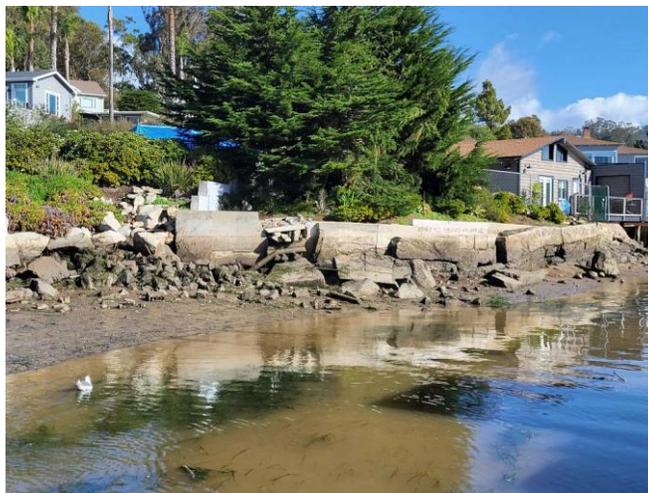
Tidelands Park Seawall and Revetment - Damage

This seawall was damaged prior to the January 4/5 and the January 9/10 extreme weather events. However, additional damage and displacement of portions of the wall occurred during the most recent events, as well as displacement of the rock revetment immediately to the north of the seawall.

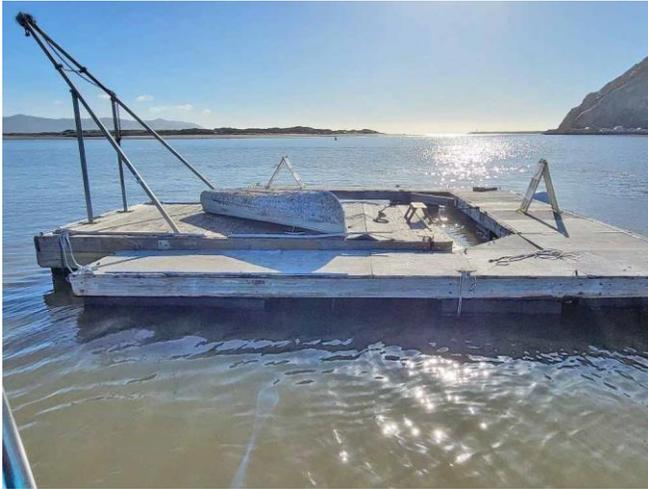
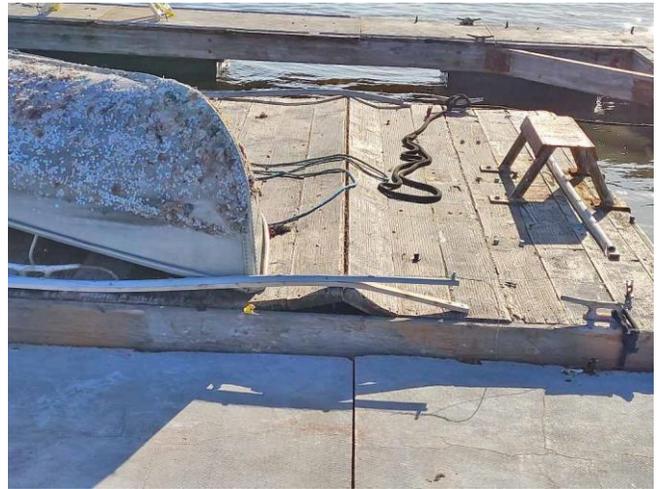
Buoy Dock and Hoist Float - Damage

The City's harbor infrastructure includes a buoy dock, which is permanently moored at the north end of the Bay. The structure includes a 'U' shape dock, with a stiff-leg hoist equipped float that resides inside the 'U'. This approximately 30' by 30' dock and the stiff-leg hoist float were racked during the January 4/5 and the January 9/10 extreme weather events, with some of the surface planking on the stiff-leg hoist float displaced.

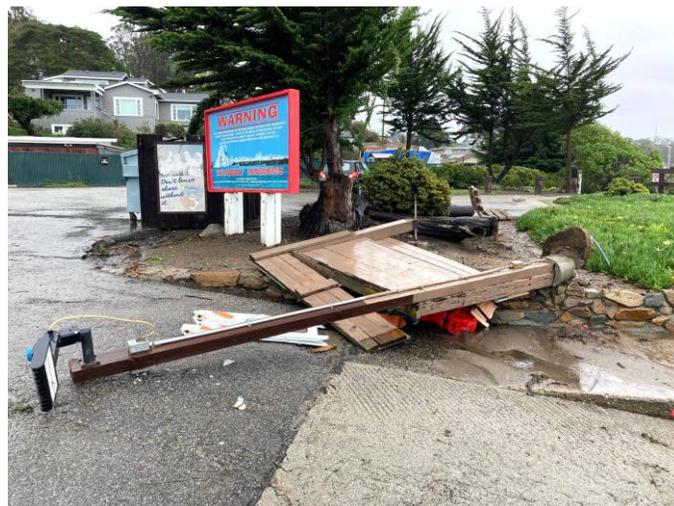
Launch Ramp Sign - Damage

At the top of the launch ramp on the south side, the City maintains a lighted sign with launch ramp use information, and safety information. This sign blew down during the January 9/10 extreme weather event.

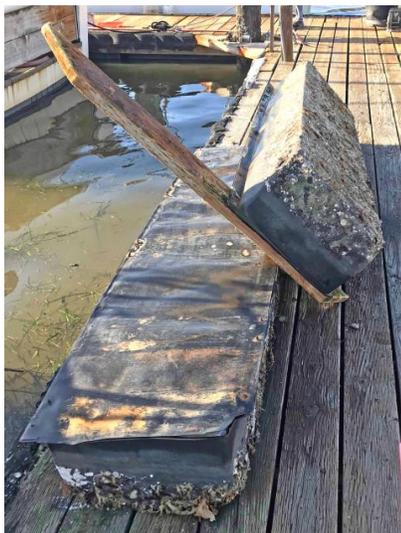
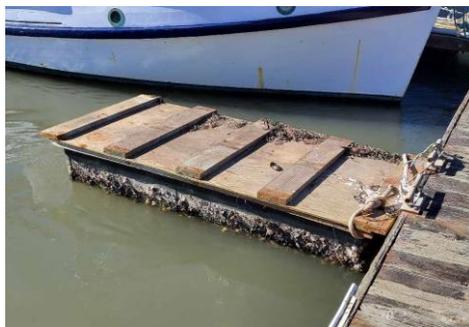
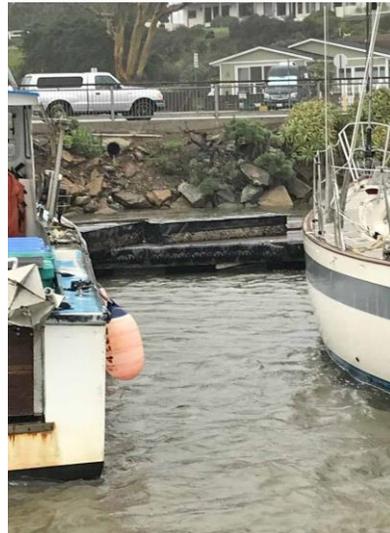
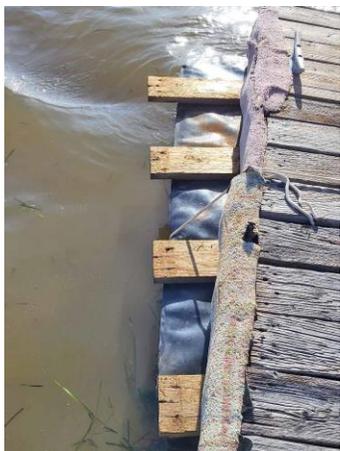
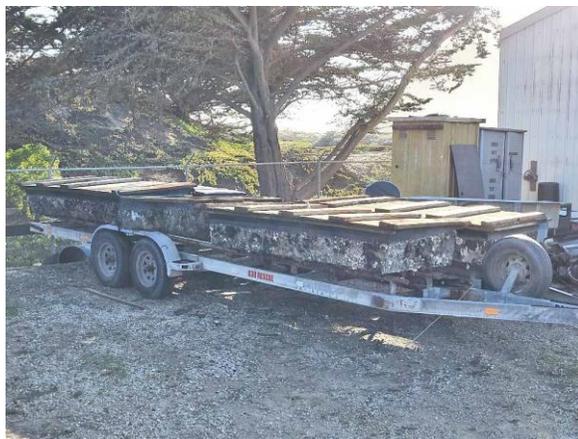
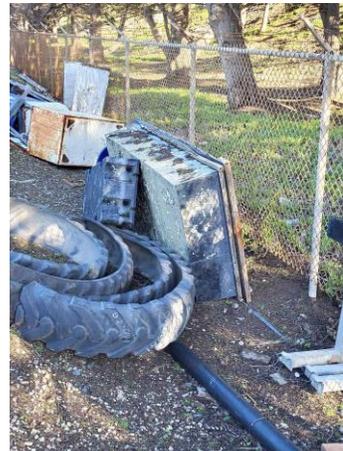
Floataion

As previously noted, City of Morro Bay dock floatation appears to be molded plastic tubs filled with foam, with a molded plastic cover attached to the tub at a molded flange. Additionally, a number of smaller molded plastic units, presumably foam filled, were also sighted. The larger molded plastic tubs

were affixed under the docks with steel fasteners. During the current examination, numerous displaced floats were observed, with more being retrieved from around the Bay as this report is being written.
