# PAX

December 13, 2018

**RE: Letter in Support of Removal of Tree, Shed, and Fire Hydrant from the ESHA for Fuel Tank Demolition Project at 3300 Panorama Drive, Morro Bay, California.**

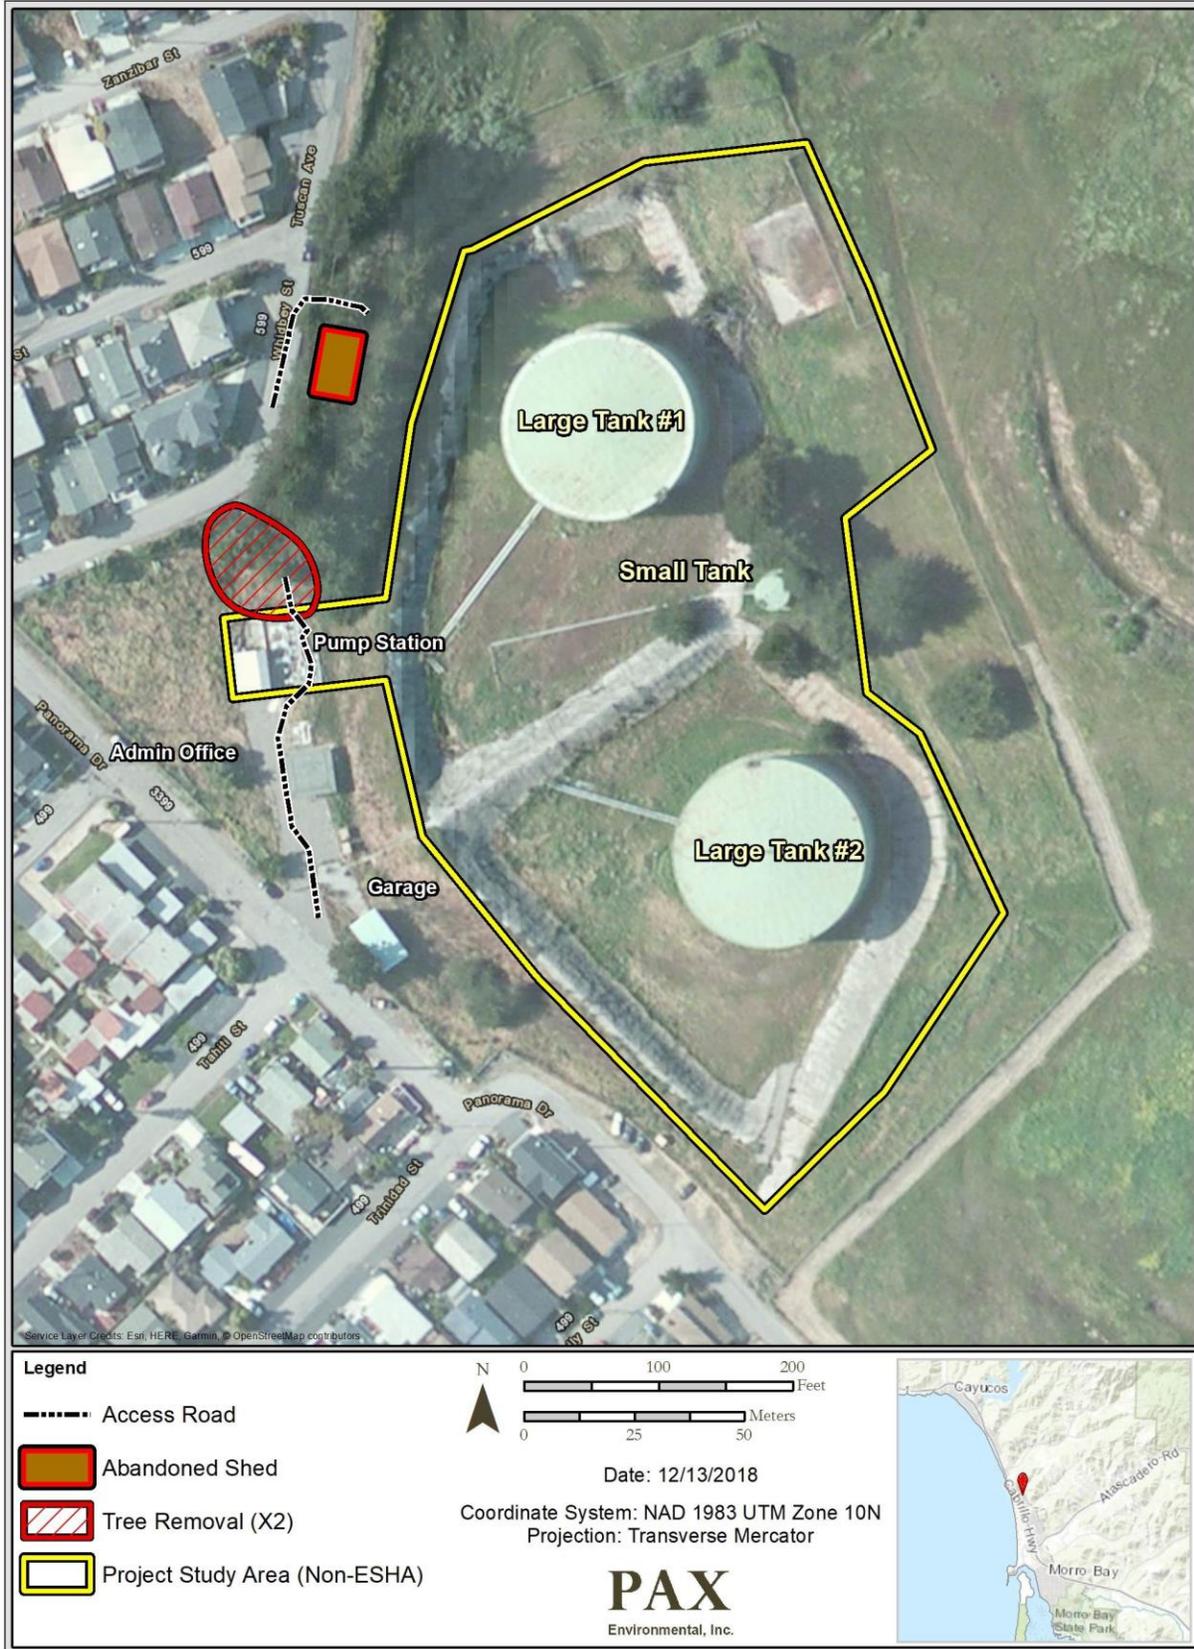
A shed (Photo 3), with dimensions 4.5' x 6.5' and 7' tall with a roof that is 5.5'x7.5', along with a nearby fire hydrant are planned for removal from the ESHA zone. The shed and fire hydrant can be accessed with minimal impact to the ESHA from Tuscan Ave (Figure 3) where any equipment and vehicles will be stationed. When removing the shed and fire hydrant they will be accessed by foot and only hand tools will be used. The water pipe to the fire hydrant can be capped and left in place. A bucket truck or any like equipment can be used to remove the structures from over the fence while staged on Tuscan Ave. Any signs of anthropological activity should be raked out and cleaned up. All shed removal activity should be monitored by a qualified biologist. The concrete pad that the shed sits on will not be removed. A recent biological survey of nearby trees has shown that there are no active bird nests, nesting behavior, or roosting, and the removal of the shed will occur outside of nesting season.

**Figure 3.** Tree and Shed Removal Areas and Approved Access Routes

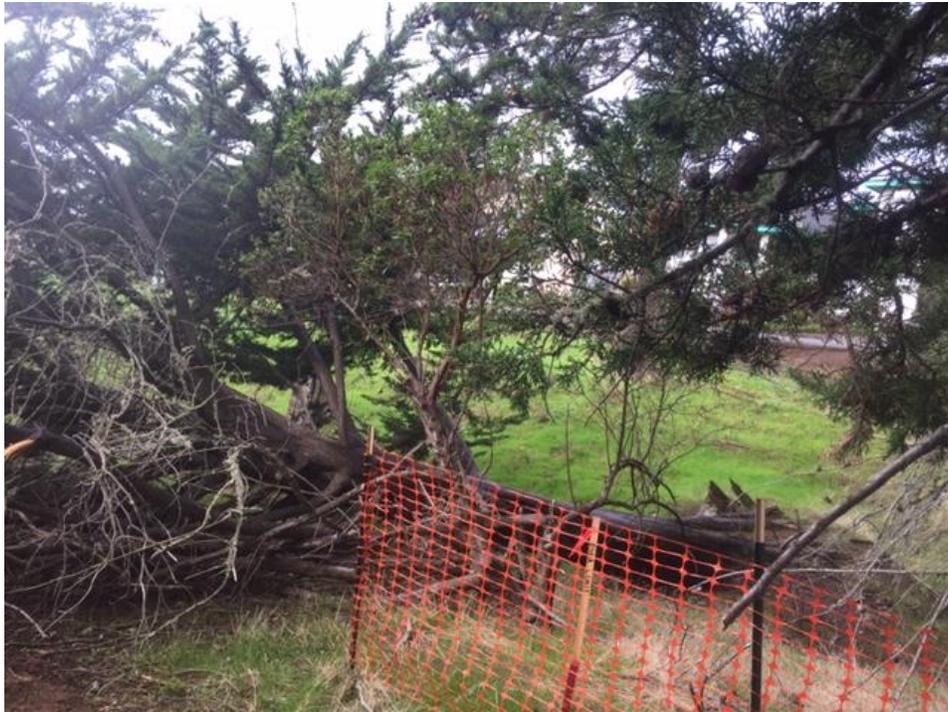
One Monterey Cypress tree (Photo 1) and one Monterey Pine (Photo 2) are proposed to be removed upon approval from the City of Morro Bay. The cypress has fallen and is interfering with the drainage from the site. The other Pine is dead and is not structurally sound. These trees exist within the ESHA zone and therefore should be removed using only the approved access route (Figure 3) and removed using only hand tools by foot. All large equipment and vehicles should be staged outside of the ESHA zone. When removing the trees, the cut pieces should be carried above ground and not dragged. Any signs of anthropological activity should be raked out and cleaned up. All tree removal activity should be monitored by a qualified biologist. A recent biological survey of these trees has shown that there are no active bird nests, nesting behavior, or roosting, and removal of the trees will occur outside of nesting season.

Photo 1. Fallen Cypress

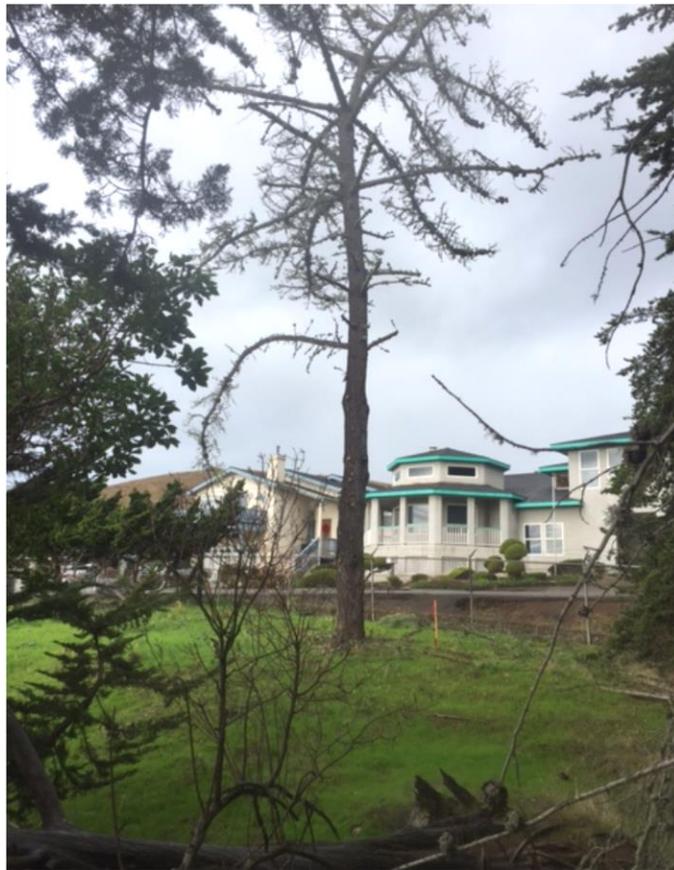
Photo 2. Dead Monterey Pine

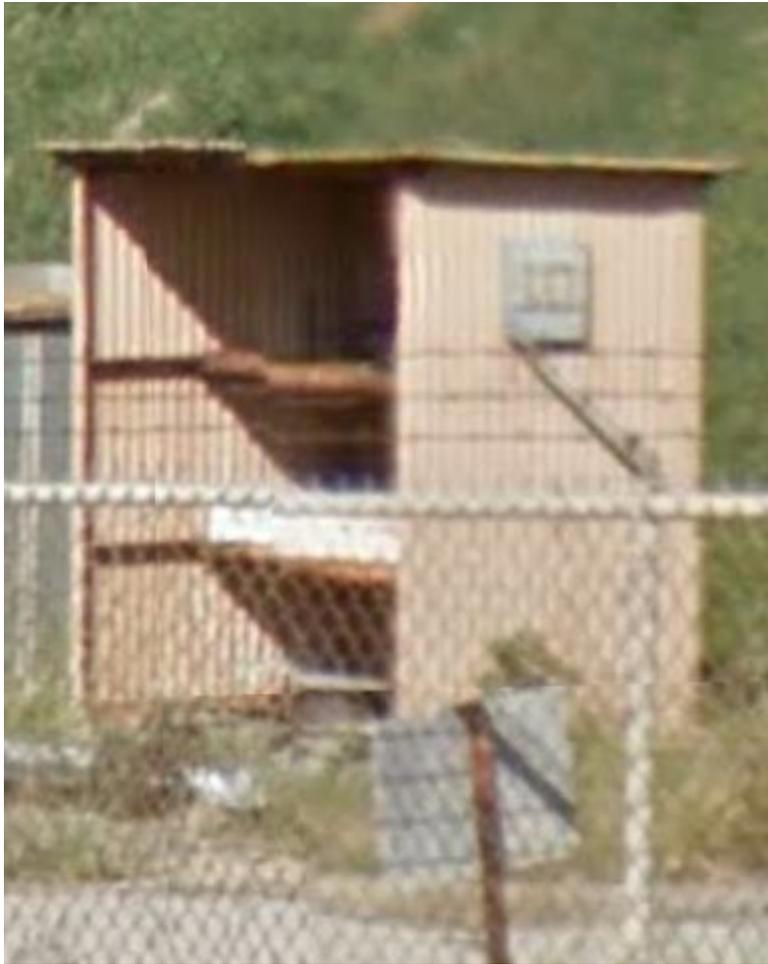
Photo 3. Shed
