**CITY OF MORRO BAY  
PUBLIC WORKS ADVISORY BOARD  
NOTICE OF SPECIAL MEETING**

**AMENDED  
SPECIAL MEETING AGENDA  
Wednesday, May 29, 2019  
Morro Bay Veterans Memorial Building- 5:30 P.M.  
209 Surf Street, Morro Bay, CA**

# THE CLOISTERS PHASE-1: LANDSCAPING EVALUATION, RECOMMENDATIONS & REPORT

**SUBJECT:** Annual Water Report 2018 and Recommendation for Allocation of Water Equivalency Units (WEU) for FY2019/20

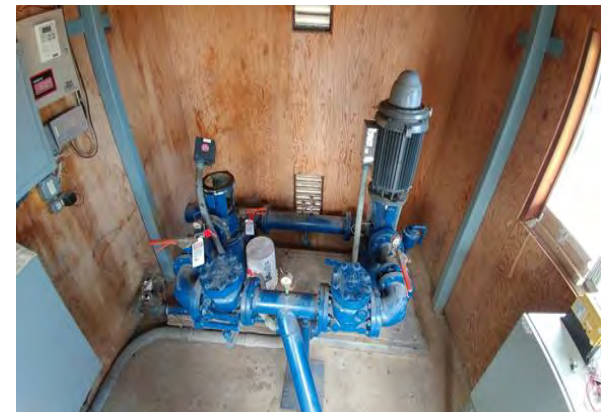
4. Water leak at 560 Embarcadero.
- Investigated a noisy pump at the Elena Booster Station and ultimately removed the pump motor due to failed bearings and sent it out for repair/rebuild.

Elena Booster Station Pump motor repair

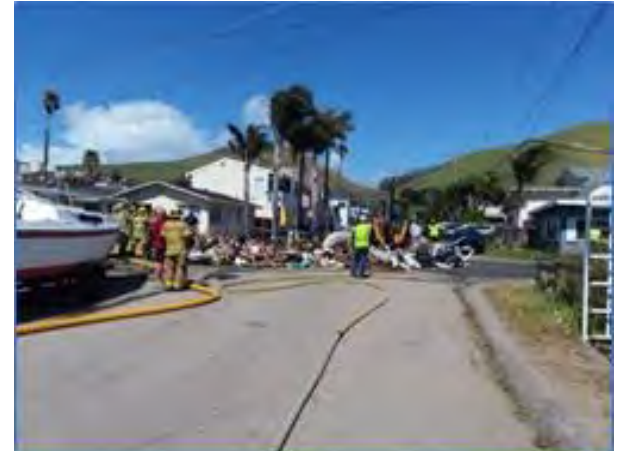
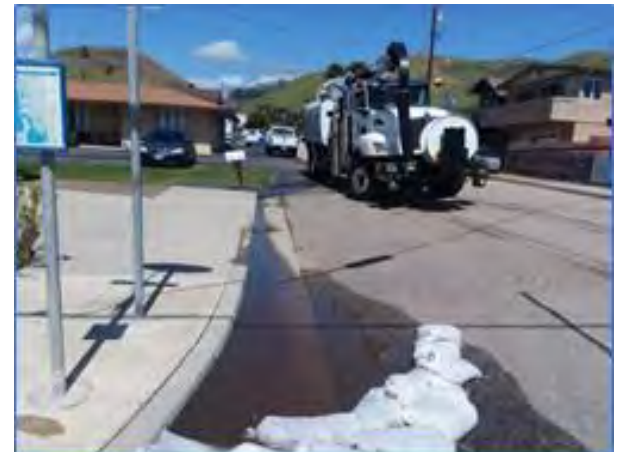
- Removed the portable flow meters from manholes throughout the Collections system.
- Tested lift station alarms.
- Performed routine lift station maintenance.
- Hydro cleaned approximately 25,362 feet of city main line.
- Routine video inspection of sewer mains.
- On-Call staff received (3) after hours call-outs.
  1. Lift station power outage.
  2. Rock restroom backup due to power outage.
  3. Private lateral blockage at 940 Morro Bay Blvd (customer responsibility).
- Completed several service requests for noisy manhole covers and customer lateral back-ups.
- Performed (5) Fats, Oils, and Grease source control inspections.
- Conducted two inspections on customer lateral connections to the city main sewer line.
  1. 745 Alta
  2. 205 Bradley

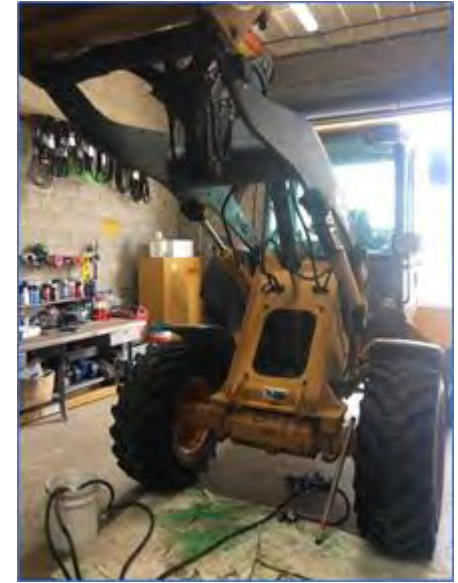
Front end loader hydraulic leak repair

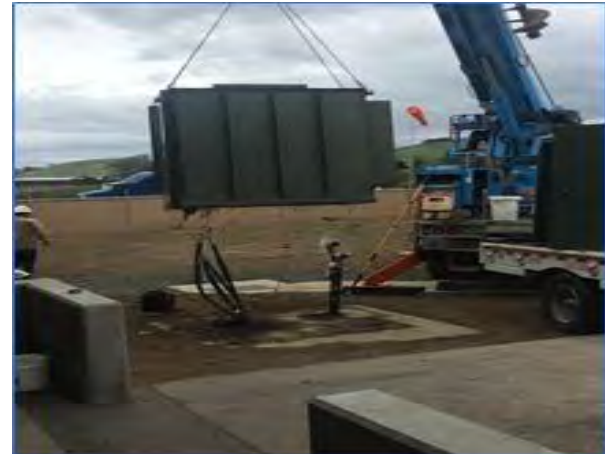
PG&E Transformer Replacement at the treatment Plant

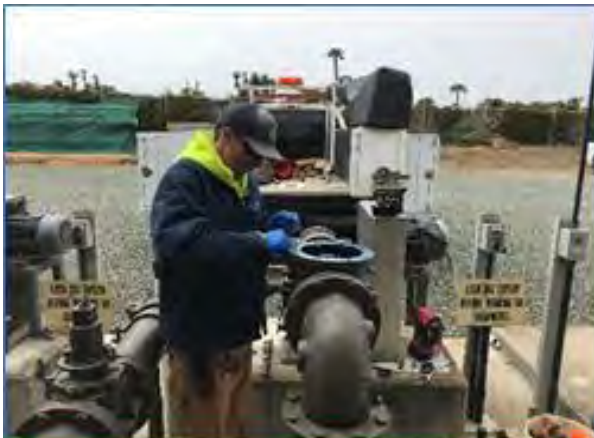
Check valve maintenance

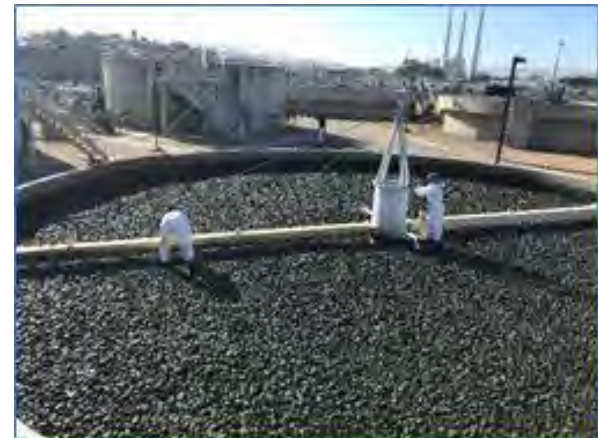
Staff performing trickling filter maintenance

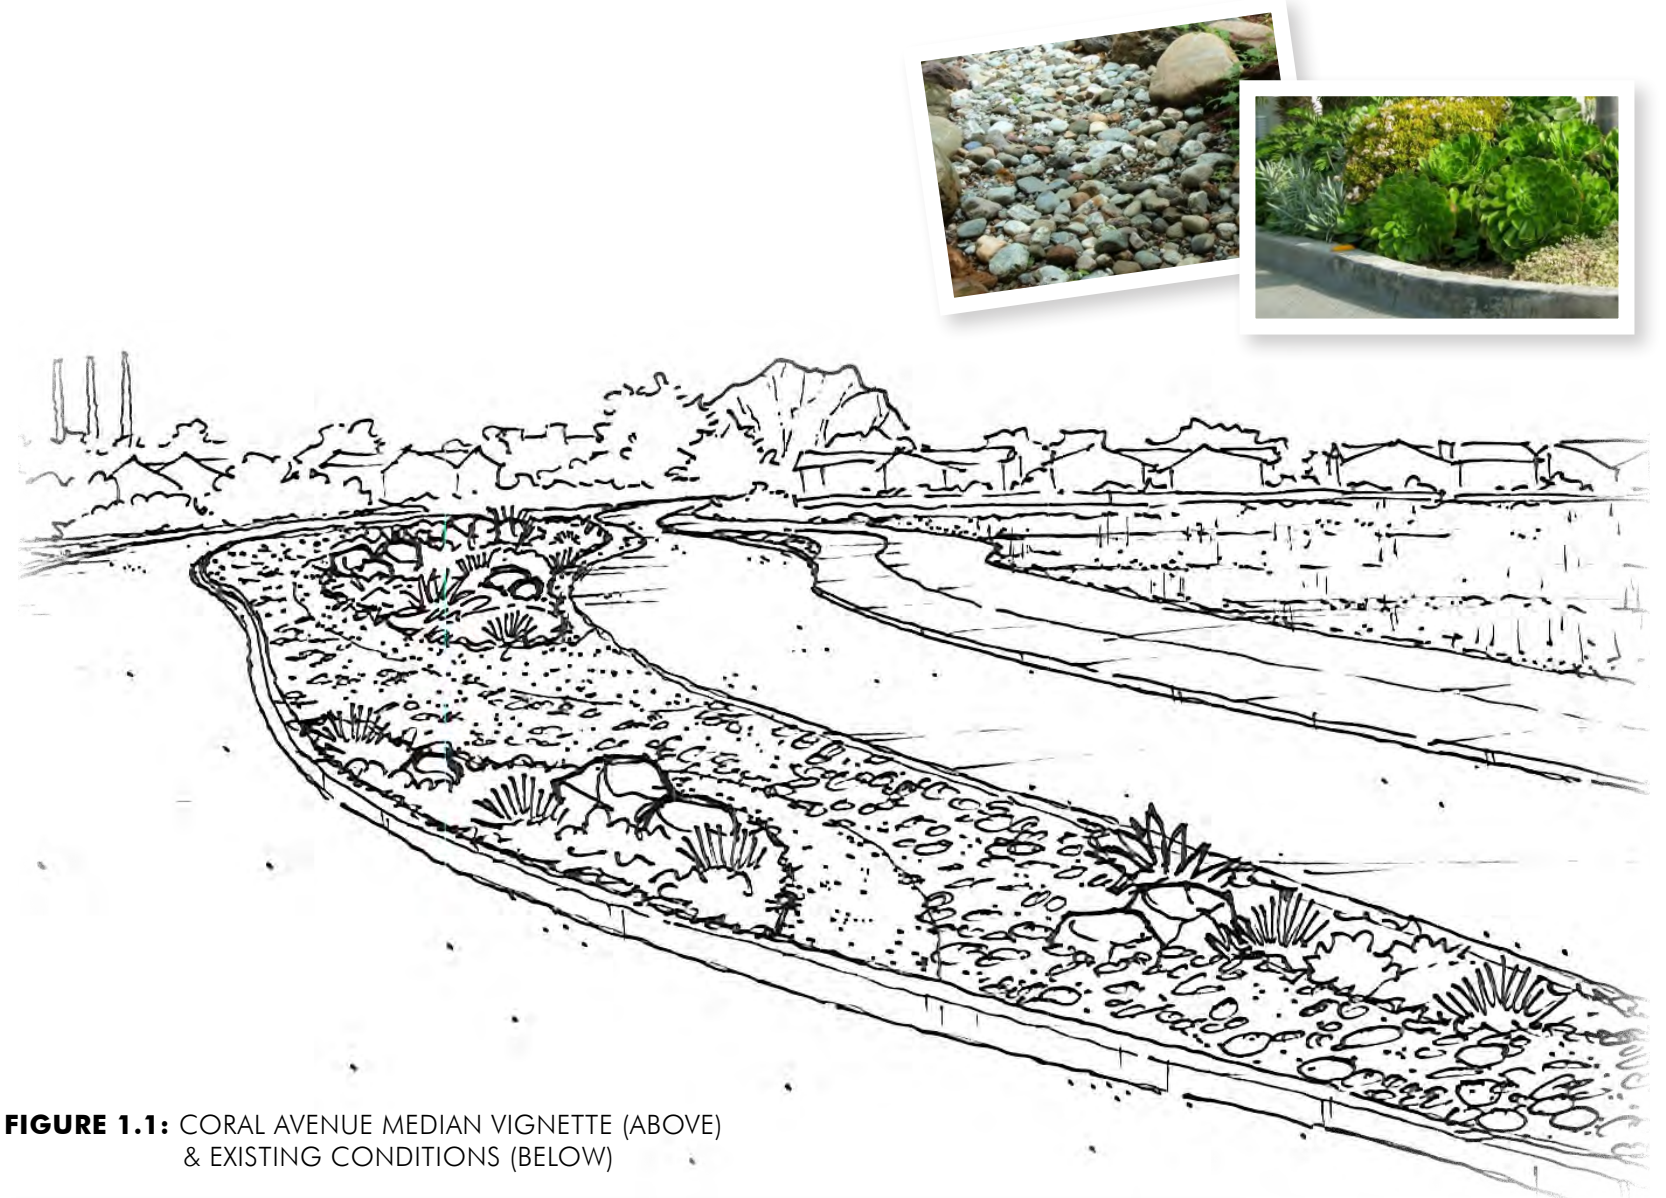
**FIGURE 1.1:** CORAL AVENUE MEDIAN VIGNETTE (ABOVE) & EXISTING CONDITIONS (BELOW)

Currently, there are three (3) median islands in Coral Avenue. The majority of the median plant material has become overgrown, woody, and in need of removal and replacement. Earth mounds prevent a clear line of sight and pose overall visibility and safety concerns. There is a lack of cohesive planting with many bare soil areas requiring infill plantings. Planting areas located at the traffic turning pockets are very narrow, difficult to irrigate and not conducive for long-term plant survival.

Remove all overgrown plant material. Choose replacement plant material from the recommended planting palette. See enlargement, Sheet 6.

Replace existing automatic irrigation valves and include drip filters and pressure regulators. Change spray systems to drip emitter systems. All existing controllers, wires, and irrigation mainlines shall be maintained and protected in place. See Sheet 19.

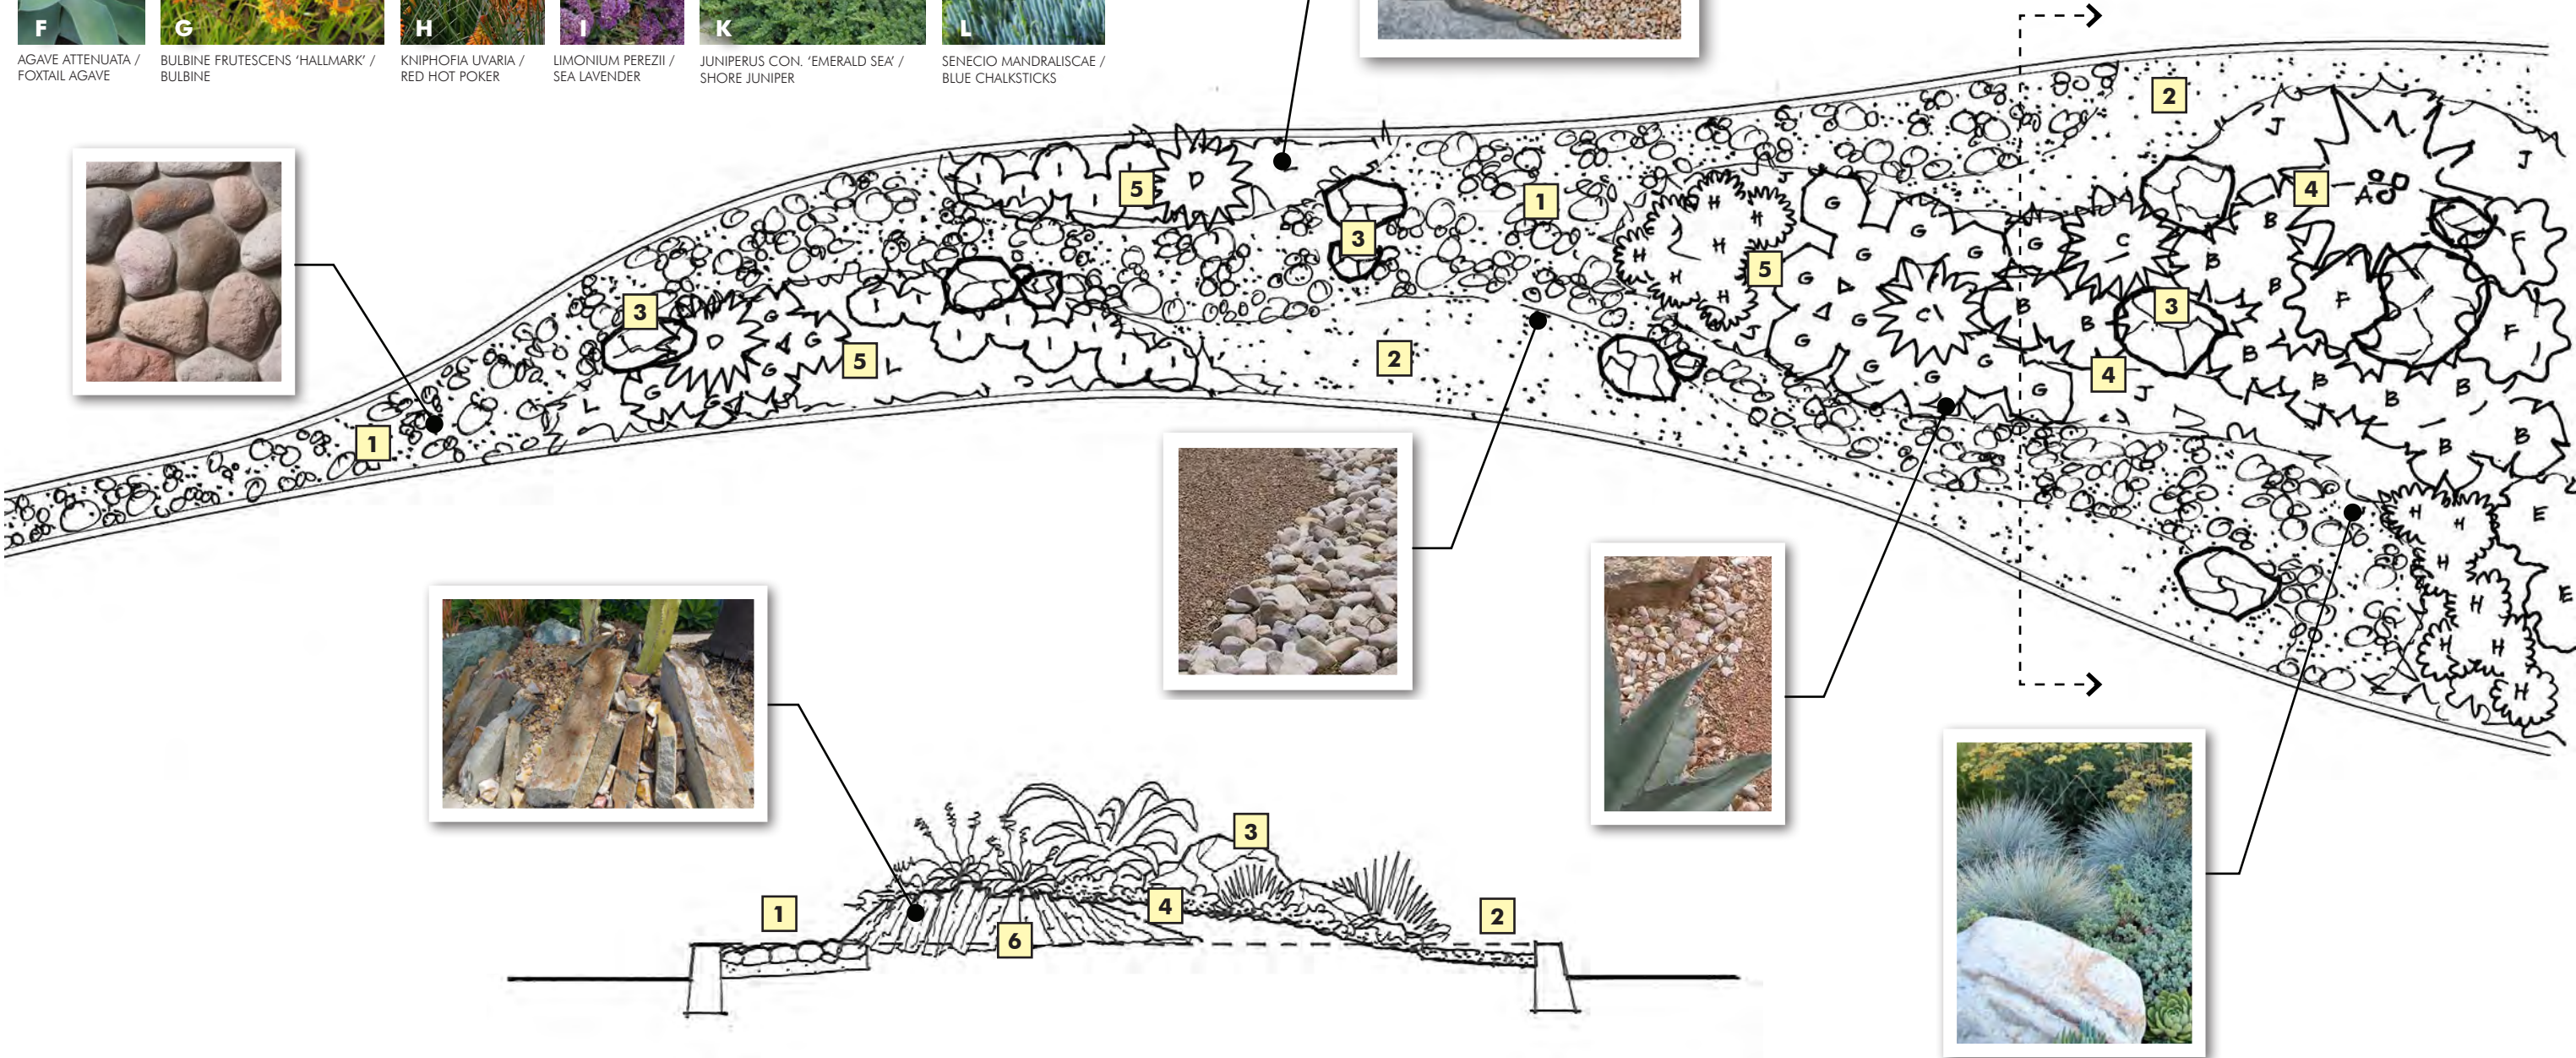
FIGURE 1.2: CORAL AVENUE MEDIAN LANDSCAPE SECTION

STONE VERTICALLY SET INTO SLOPE

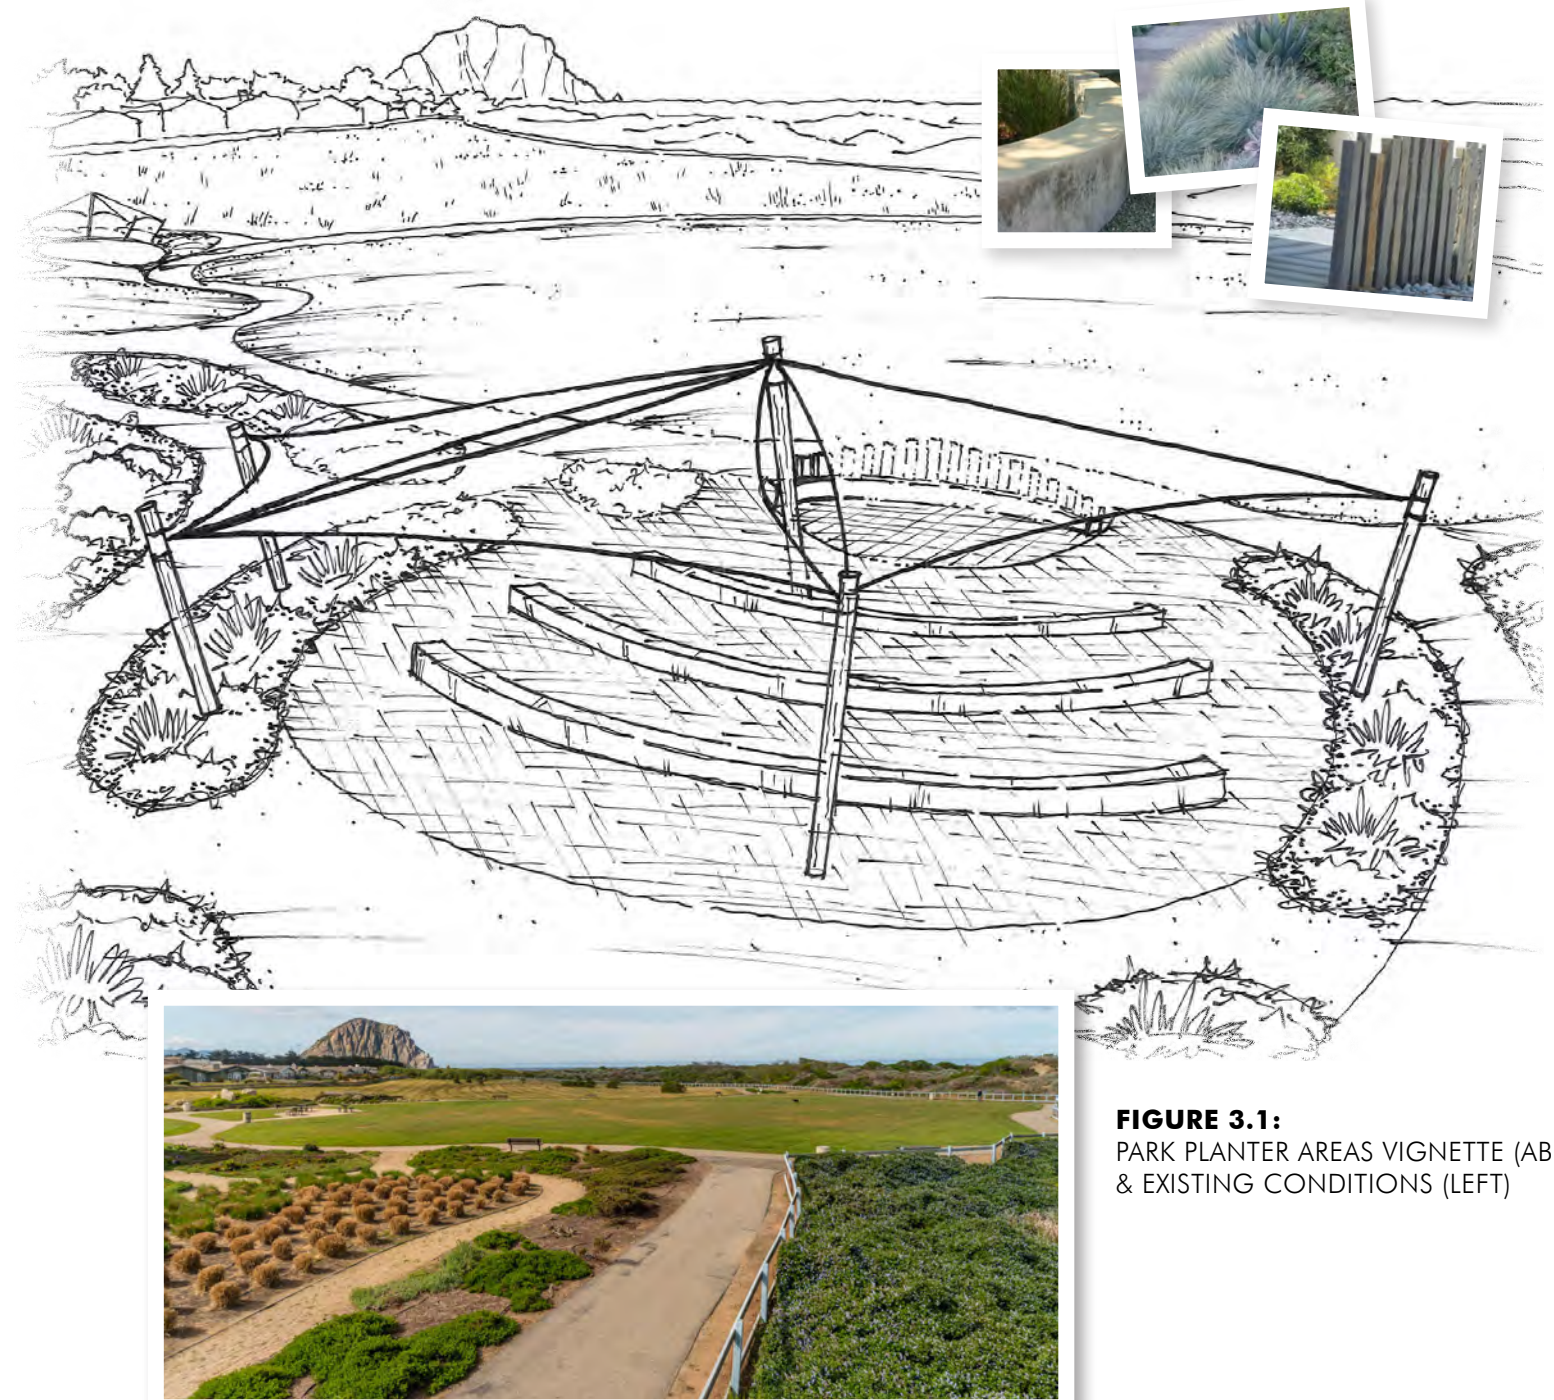
**FIGURE 3.1:**  
PARK PLANTER AREAS VIGNETTE (ABOVE)  
& EXISTING CONDITIONS (LEFT)

Repurposing the park planter areas would entail a redesign of the landscape. Decorative pavers should be used to replace the decomposed granite pathways to enhance the aesthetics and minimize maintenance. For example, the north garden could be transformed into a group gathering area for community events and enhanced with amphitheater-style type seating. See enlargements, Sheets 9 and 10. The south garden could be converted to a group barbeque area, including an overhead structure and raised planters.

Implementation of both the north and south garden areas should be completed in one (1) phase to provide for a cohesive final product. Overhead structures could be constructed in a later phase, if budgetary constraints dictate.

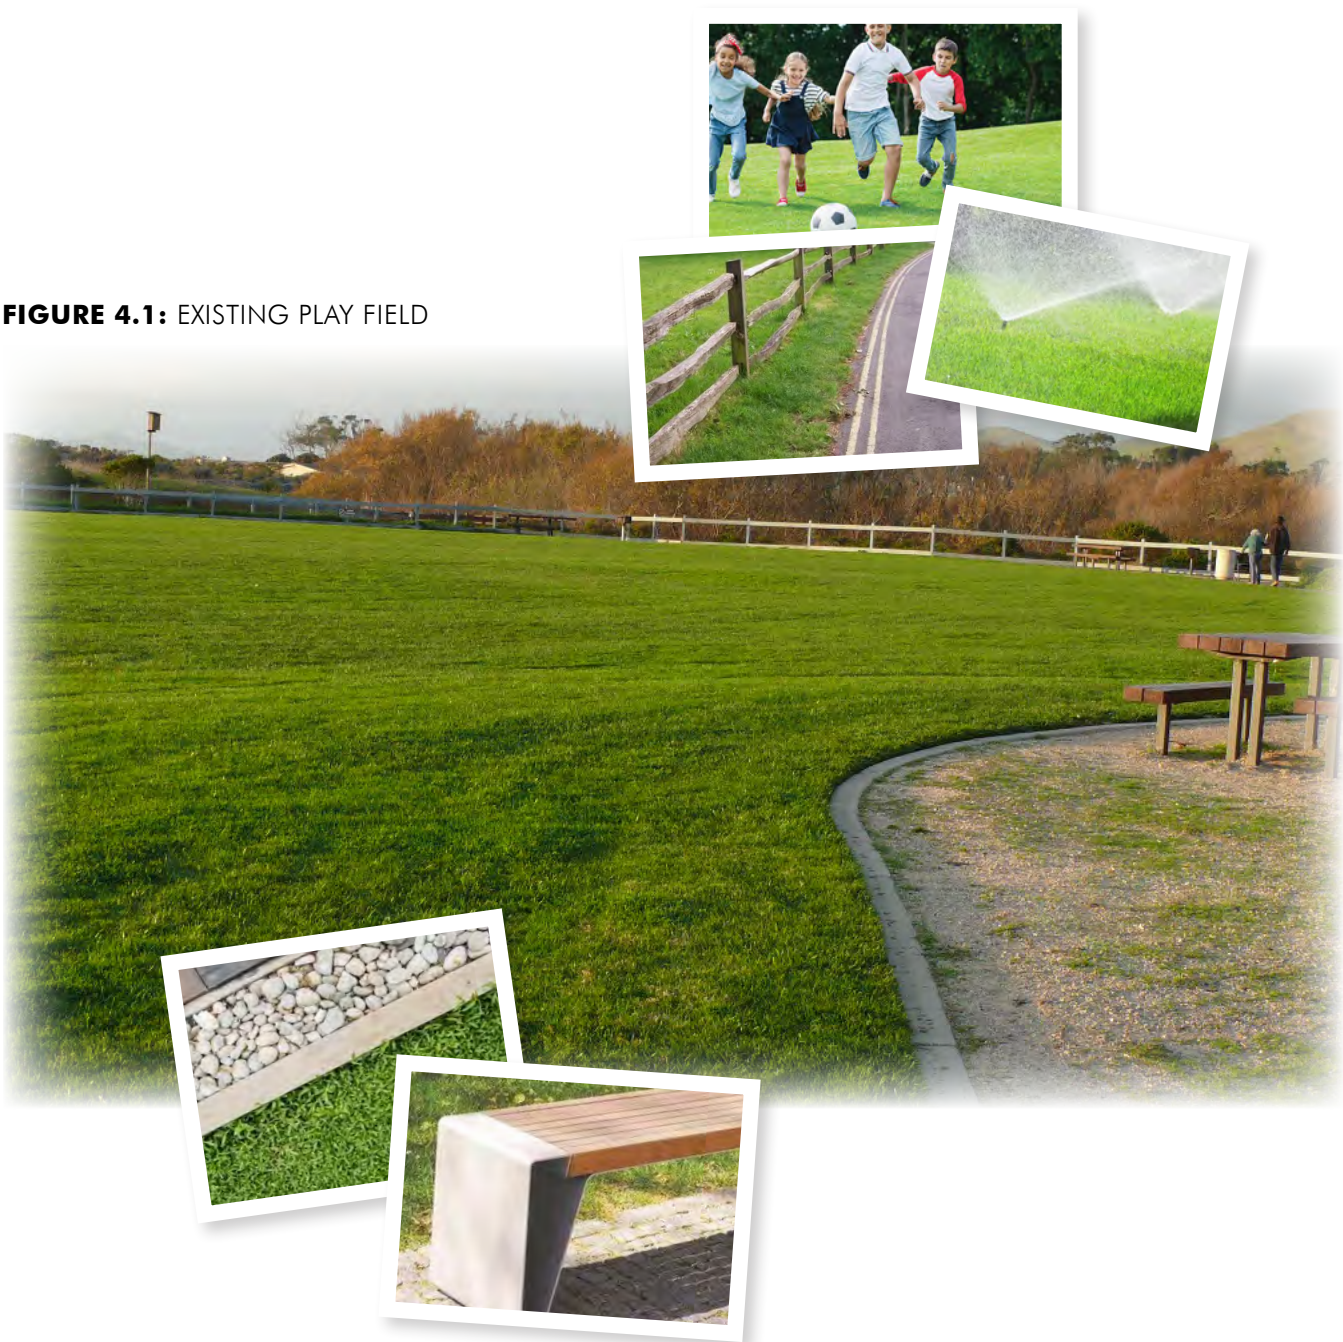
FIGURE 4.1: EXISTING PLAY FIELD

The open turfed play field is in very good condition and is well maintained, although there are signs of rodent activity in certain areas of the turf. The south east quadrant of the play field includes BBQs and picnic tables located on decomposed granite. The decomposed granite area is low and is ponding water.

Redesign the south east end of the turf irrigation system, and add and/or move spray heads to provide full coverage of the new turf. Apply a fertilizer It is highly recommended that a rodent control treatment system (e.g., EZ-FLO with Critter Max) be installed to assist in controlling the rodents. This is a liquid applied via the irrigation system. See Sheet 18.
