# **BIOLOGICAL RESOURCE ASSESSMENT REPORT**

## **MORRO BAY POWER COMPANY, LLC BATTERY ENERGY STORAGE SYSTEM CITY OF MORRO BAY, CALIFORNIA**

**Project No. 1902-1172**

**FEBRUARY 2021  
UPDATED AUGUST 2021**

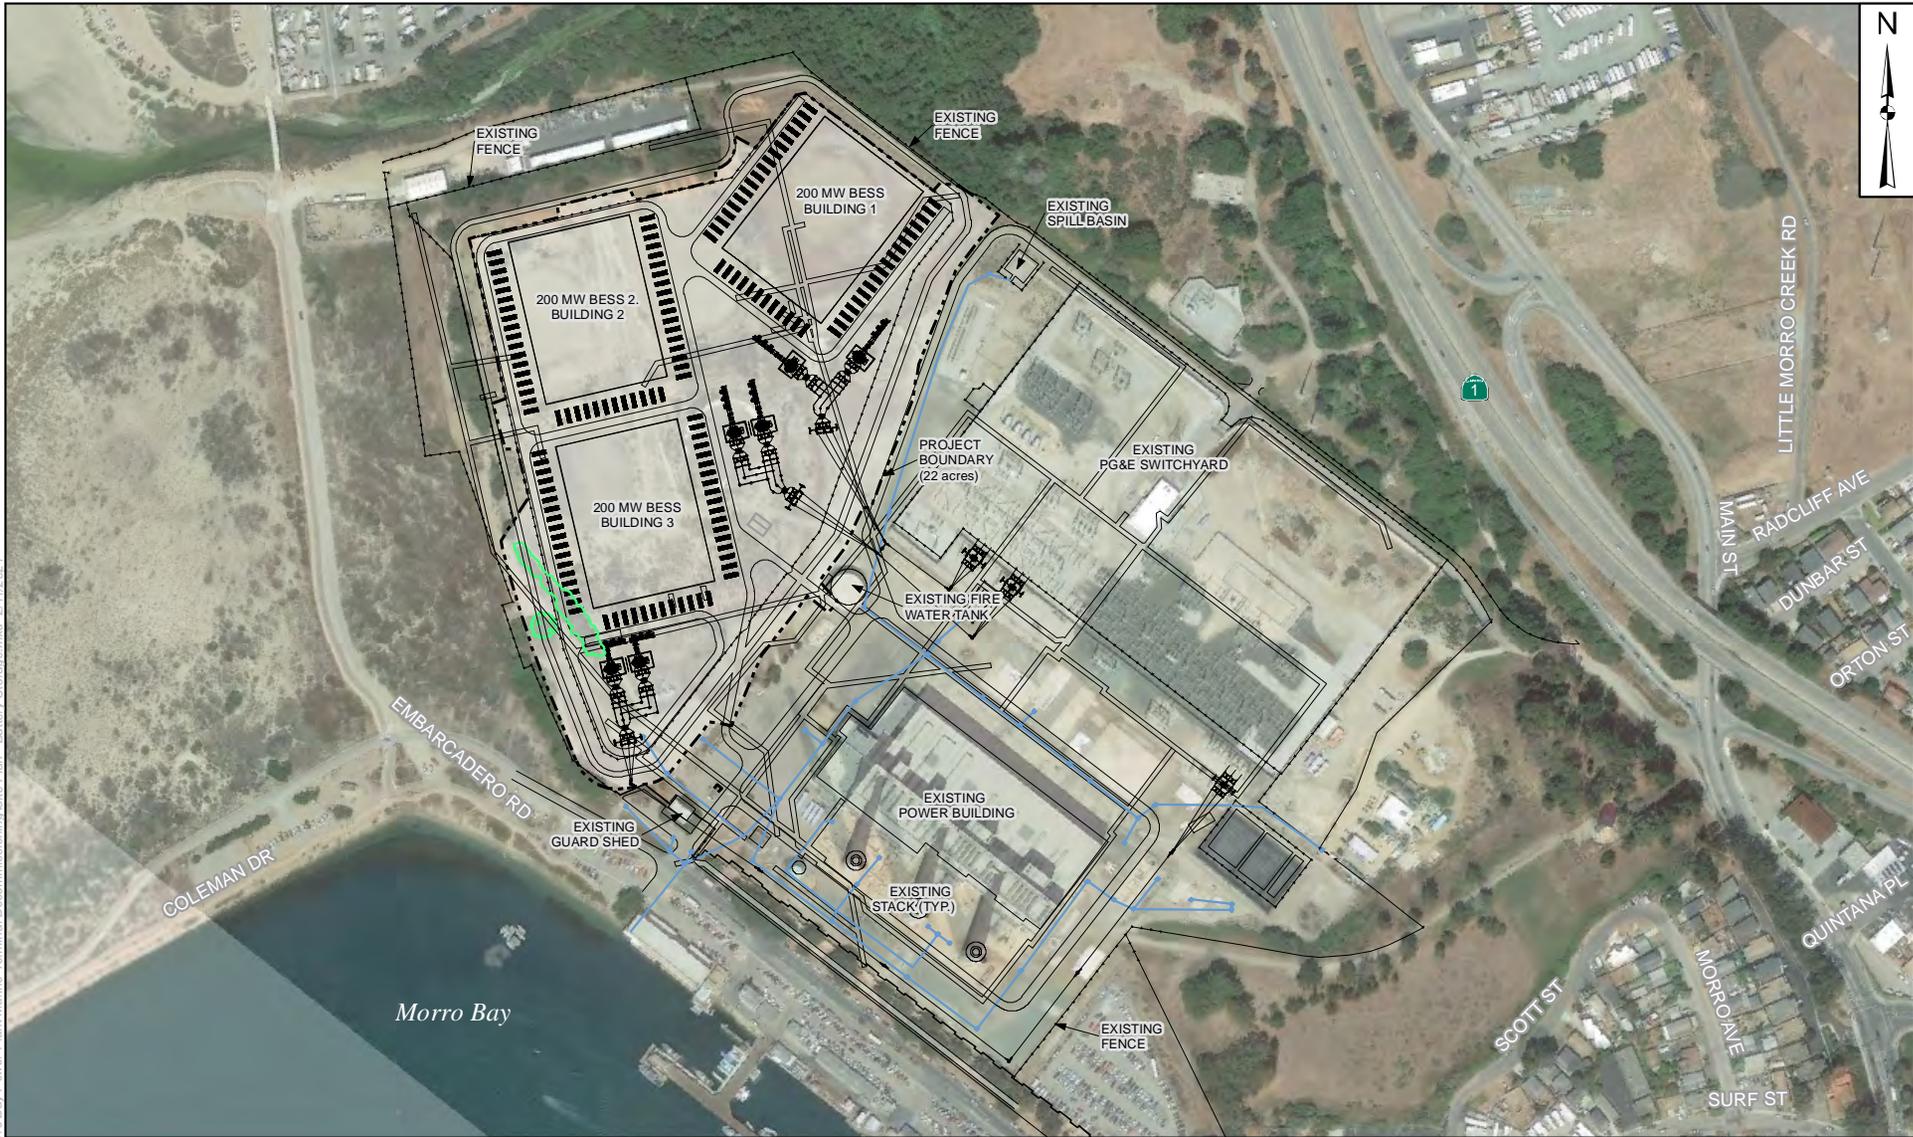
FIGURE  
1-1

- Site Feature
- Project Boundary
- Trees to be Removed
- Electrical Enclosure
- Stormdrain

Monterey cypress is a perennial evergreen tree in the Cypress Family (Cupressaceae) that is native to California and endemic to central coast of California, occurs in coastal pine forest habitats, and is a CNPS CRPR 1B.2 species. This species is widely planted and has been naturalized outside its native range (University of California, 2020). In the wild, this species is limited to two small populations, near Monterey and Carmel, California (Calflora, 2020, CNPS, 2020b). As observed during the field survey, there were several stands (shown on Figure 4-1 as Ornamental vegetation) and individual trees that appeared to be planted as landscape trees within the BSA. All trees were healthy and averaged in height from approximately ten to 20 feet tall. It is expected that six Monterey cypress will be removed as part of Project activities and is labeled on Figure 1-1. Refer to Section 5.0 for information on replacement trees plantings.

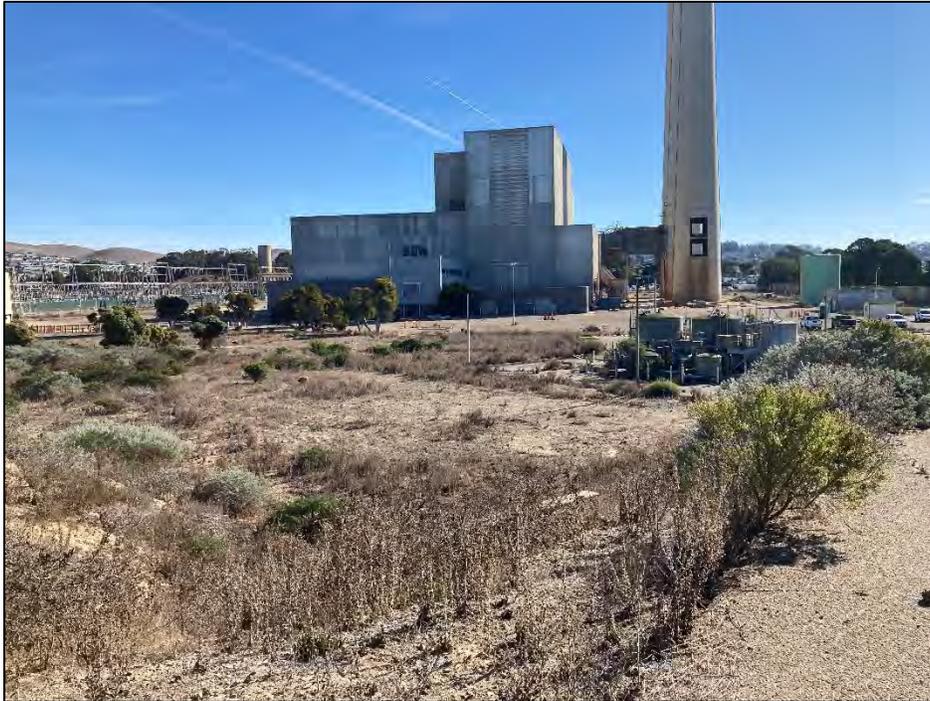
Photograph 1. Representative view of the Project Site conditions (aspect: southeast; December 16, 2020).

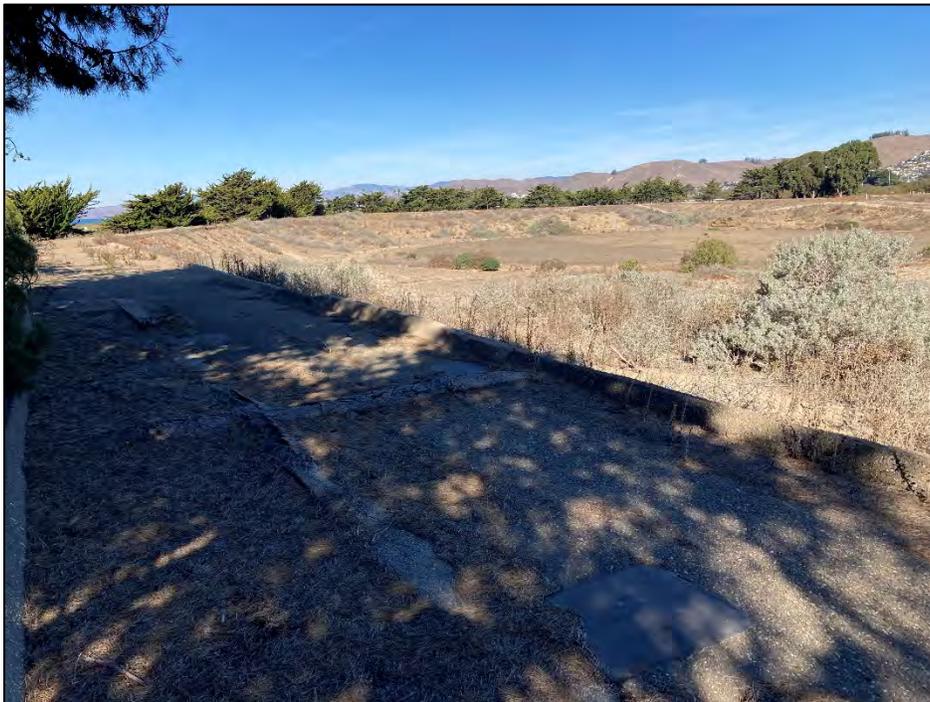
Photograph 2. Monterey pine and Monterey cypress adjacent to paved access roads and abandoned tank footprints (aspect: north; December 16, 2020).

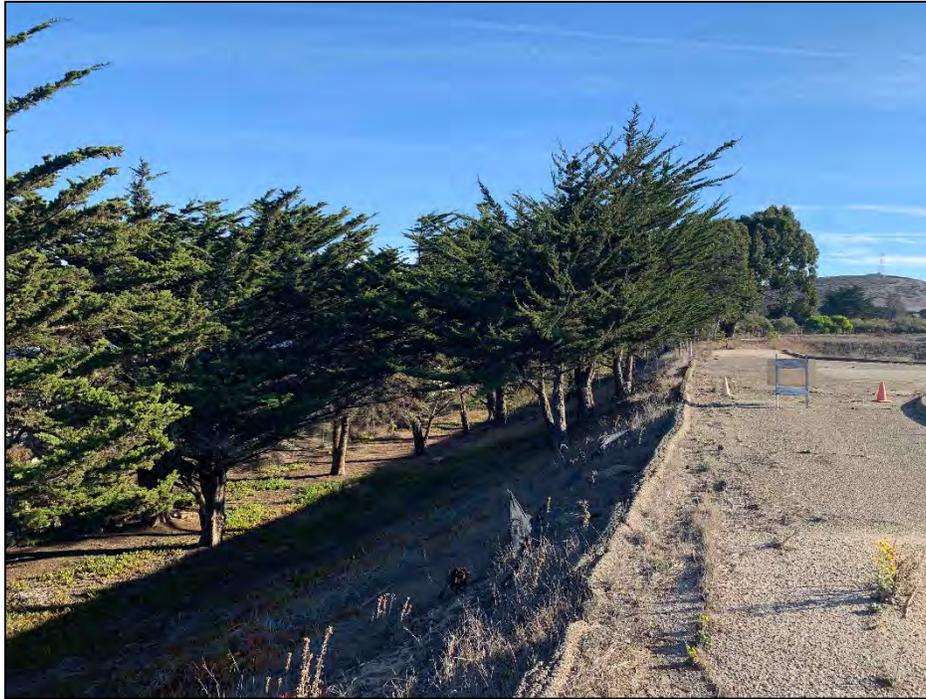
Photograph 3. Monterey cypress and paved access road in northern portion of the Project site (aspect: northeast; December 16, 2020).

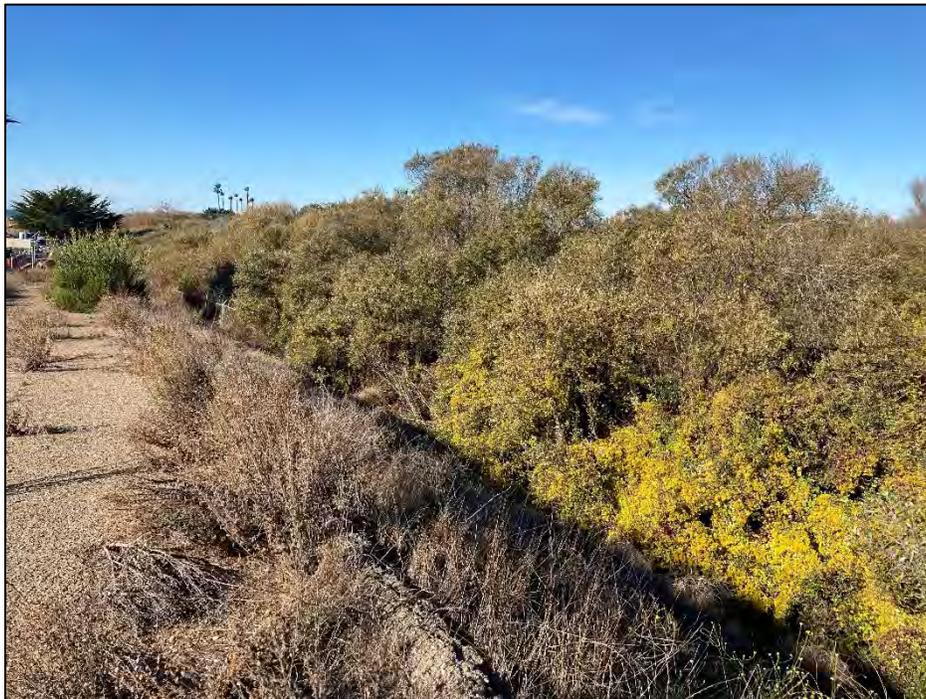
Photograph 4. Morro Creek with Arroyo willow thicket vegetation along the northern boundary of the Project site (aspect: northwest; December 16, 2020).

Arroyo willow thickets (*Salix lasiolepis* Shrubland Alliance) occurs along stream banks and benches, slope seeps, and stringers along drainages and is characterized by presence of arroyo willow as dominant or co-dominant within the shrub or tree canopy; canopy is open to continuous and the herbaceous layer is variable (Sawyer et al., 2009). As observed during the field survey, this alliance occurred along Morro Creek and Willow Camp Creek in the north and northeastern portion of the BSA. The quantitative vegetation assessment (Appendix D: data sheet MBPP003) identified native and non-native tree, shrub, and herbaceous species with arroyo willow as the dominant species. Component and intermittent species observed includes blackberry (*Rubus ursinus*), poison oak (*Toxicodendron diversilobum*), and Monterey cypress (*Hesperocyparis macrocarpa*). Arroyo willow thicket associated with riparian habitat is designated as ESHA by the City of Morro Bay.

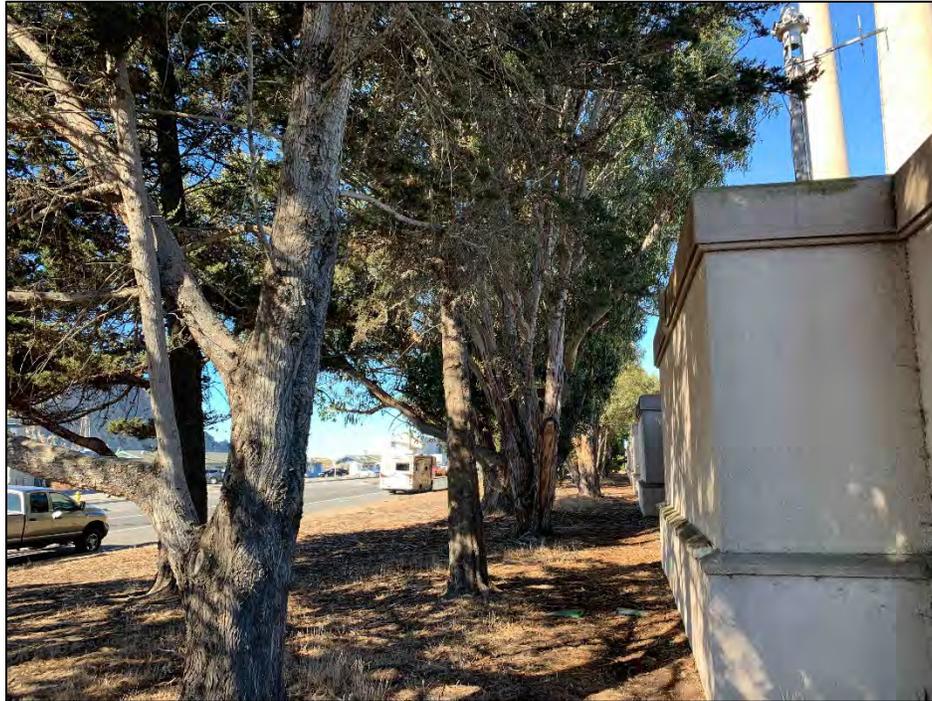
Photograph 5. Eucalyptus and Monterey cypress along Embarcadero Road and Project site boundary (aspect: northwest; December 16, 2020).

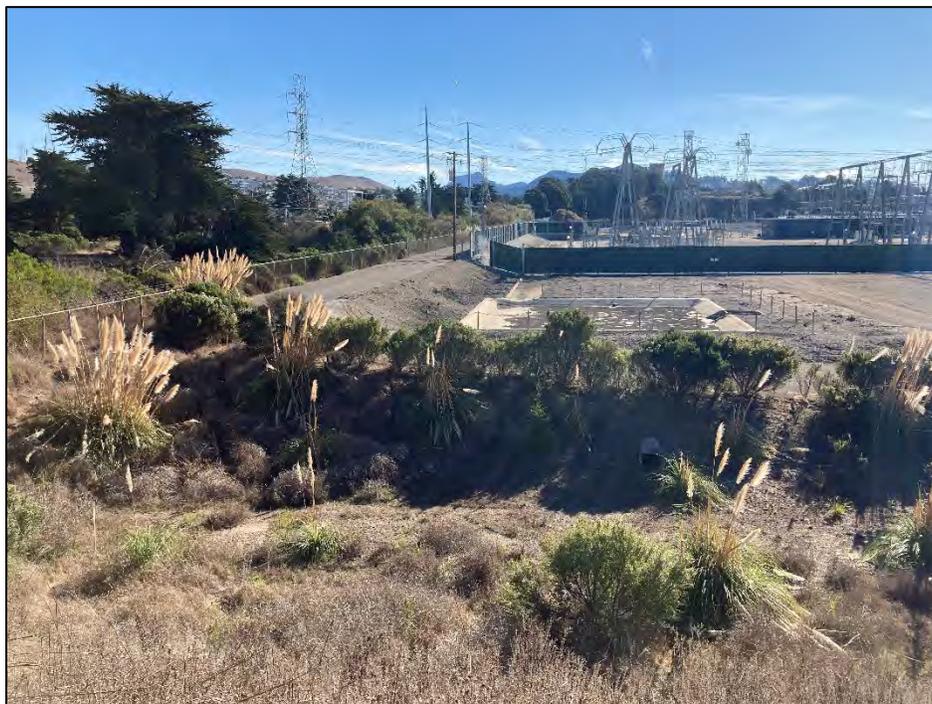
Photograph 6. Representative Ruderal vegetation and Developed areas within the Project site (aspect: southeast; December 16, 2020).

Within this Report, Ruderal/Developed habitat is a term used to describe those areas that have been disturbed by past land-use practices, recent ground disturbance or are currently developed. Ruderal/Developed habitat includes office facilities, paved and unpaved roads, industrial and commercial structures, and areas of vegetation along these features and within abandoned facilities. As observed during the December 2020 field survey, this vegetation type consisted primarily of remnant annual grasses, pampas grass (*Cortaderia jubata*), telegraph weed, ice plant, coyote brush, and scattered volunteer eucalyptus. Developed areas within the Ruderal/Developed habitat type generally do not support vegetative cover due to the presence of impervious surfaces.

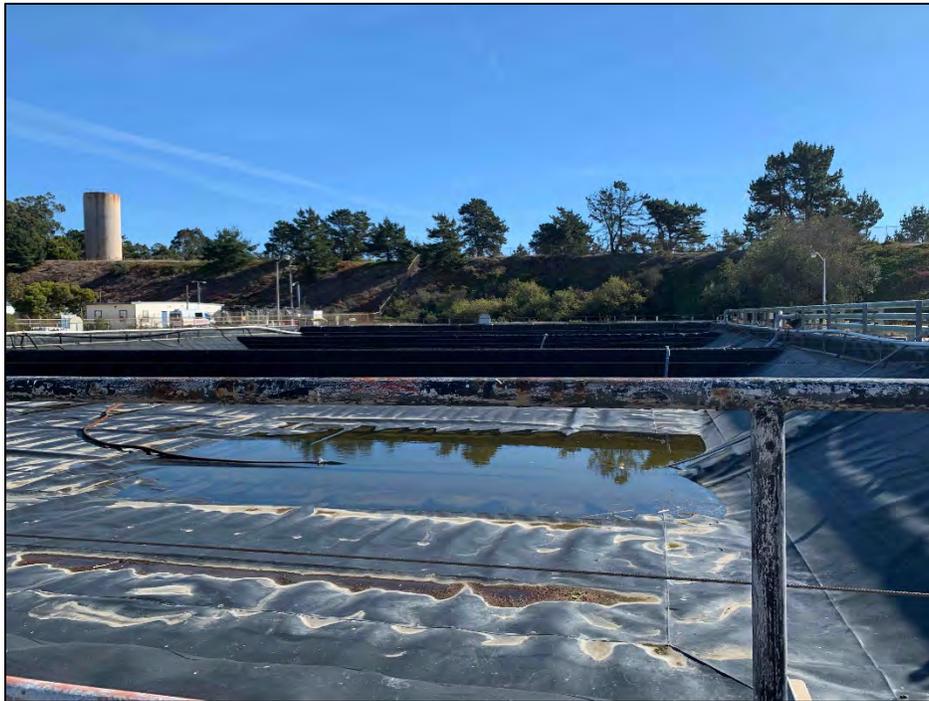
Photograph 7. Current MBPP infrastructure, ponded water visible (aspect: southeast; December 16, 2020).

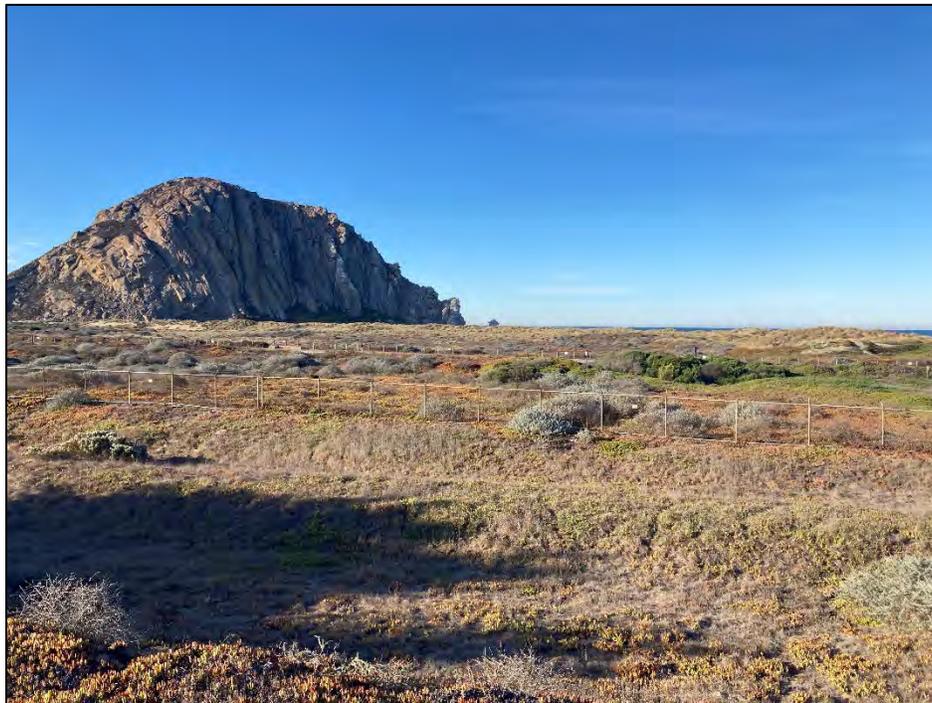
Photograph 8. Ruderal vegetation within the Project site (foreground) with Mixed dune outside of an existing fence and outside of Project site (aspect: west; December 16, 2020).

A distinct stand of vegetation comprised of an assemblage of upland coastal species was observed along the northwestern boundary of the BSA. This area has been the focus of past restoration efforts, and existing vegetation varies in degree of establishment. Past studies completed in this location designated this assemblage of vegetation as Mixed dune (Padre, 2015a). As observed during the December 2020 field survey, the composition of species within the Mixed dune vegetation species was similar to previously assessed conditions, and consisted of ice plant, beach bur (*Ambrosia chamissonis*), coyote brush, and remnant annual grasses (Appendix A – Site Photographs, Photo 8). This alliance (referred to as Central Dune Scrub) is considered sensitive by the CDFW and is designated as ESHA (referred to as Back Dune/Dune Scrub) by the City of Morro Bay. Impacts to Mixed dune may be considered significant under CEQA.

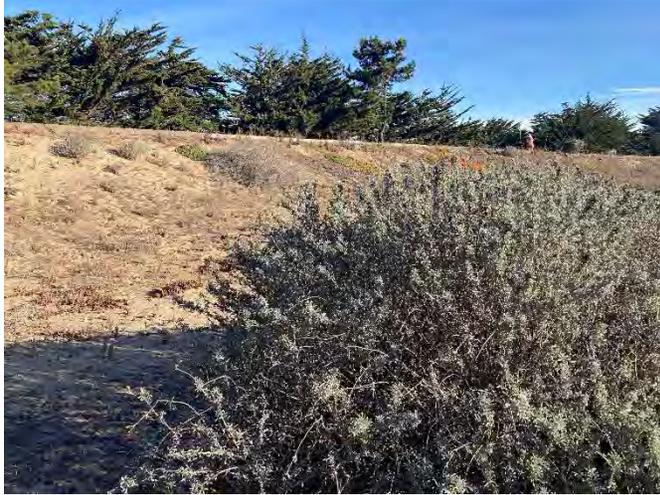
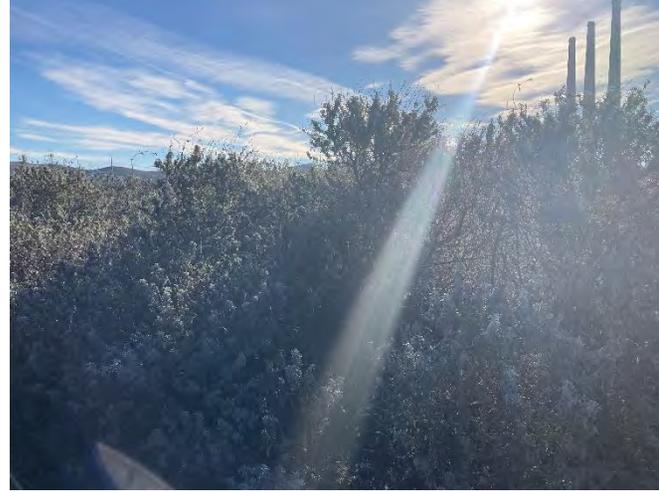
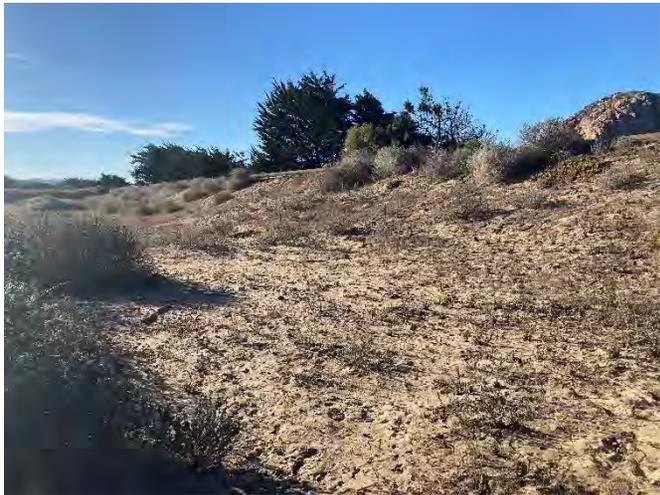
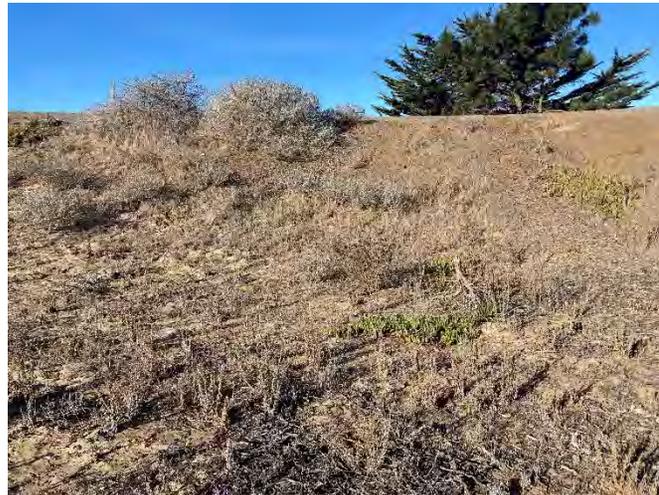
Project: 1902-1172 Biological Resources Assessment; MBPP BESS Project  
Vegetation Rapid Assessment Attachment  
Stand/Plot ID: **MBPP001**

Classification: Silver bush lupine scrub (MCV2)

Silver bush lupine scrub (*Lupinus chamissonis* Shrubland Alliance) occurs on stabilized dunes, river mouths, and coastal spits, bluffs and terraces (Sawyer et. al., 2009) and is characterized by the presence of silver bush lupine as dominant or co-dominant in the shrub layer, canopy is open to continuous, herbaceous layer is open to intermittent. As observed during the field survey, silver bush lupine occurs in stands intermittently throughout the former tank farm area where the Ruderal/Developed habitat has experienced natural recruitment. The quantitative vegetation assessment (Appendix D: data sheet MBPP001) identified dune lupine as the dominant species, with minimal understory comprised of remnant annual grasses and ice plant. An additional species of lupine was observed as a component of this Alliance or as distinct stands; however, the lupine species was not identifiable during the December 2020 field survey. The Silver bush lupine scrub has established on fill soils within Ruderal/Developed habitat that has been disturbed during operation and decommissioning of the MBPP. As such, Project impacts to this alliance should be evaluated within the context of the stands' limited and fragmented distribution throughout the former tank farm area. This alliance is considered sensitive by the CDFW (rarity ranking S3) and impacts to sensitive habitats may be considered significant under CEQA.

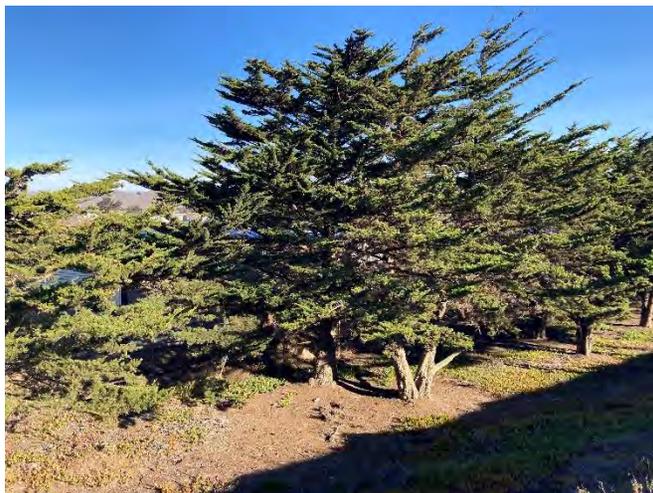
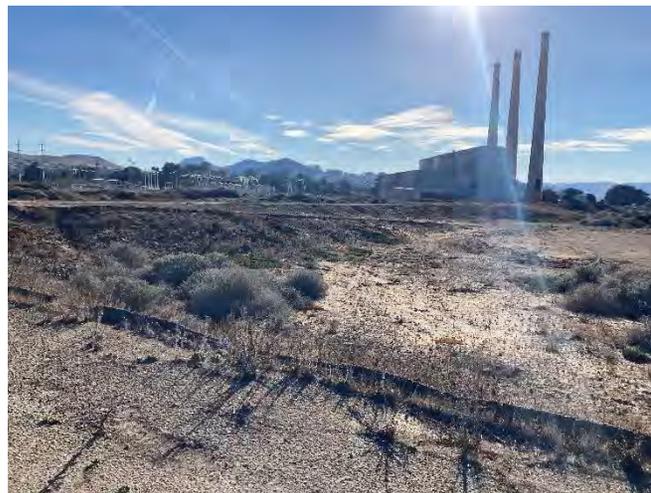
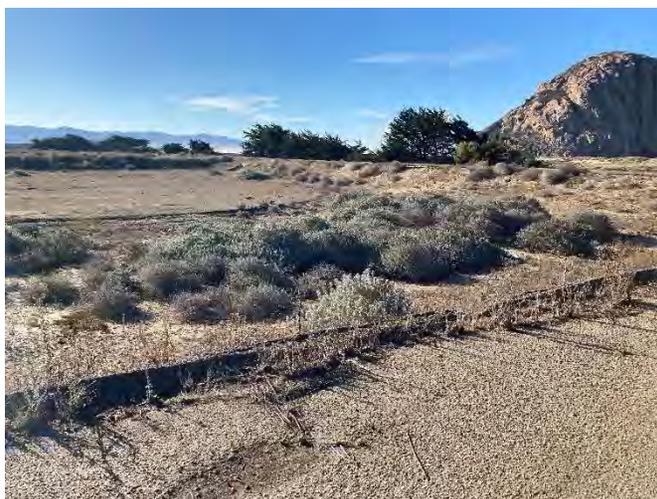
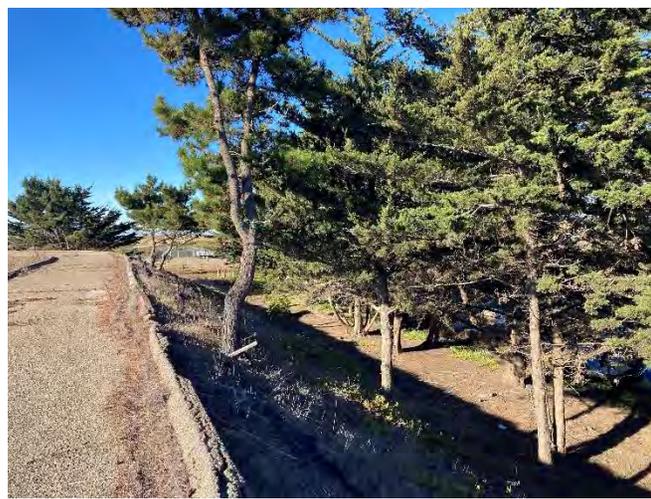
Project: 1902-1172 Biological Resources Assessment; MBPP BESS Project  
Vegetation Rapid Assessment Attachment  
Stand/Plot ID: **MBPP002**

Classification: Monterey cypress stand (Site-Specific; Ornamental)

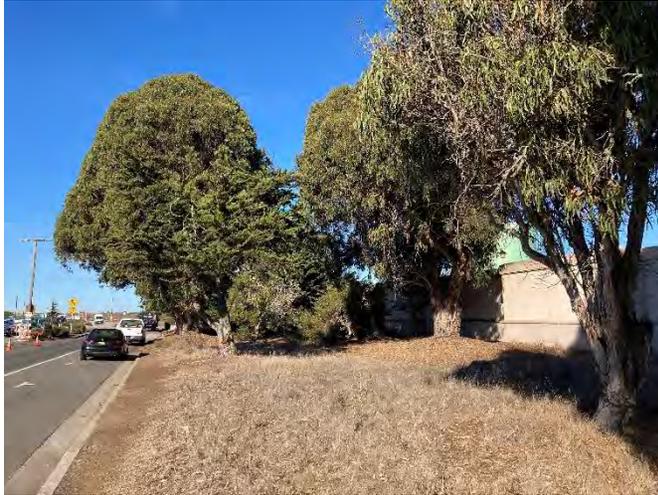
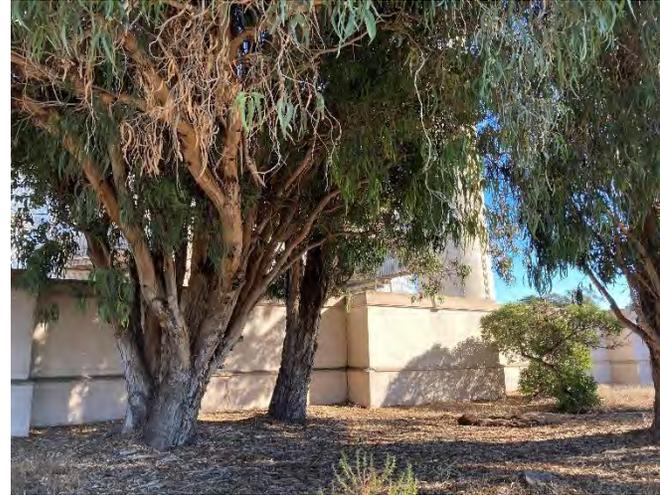
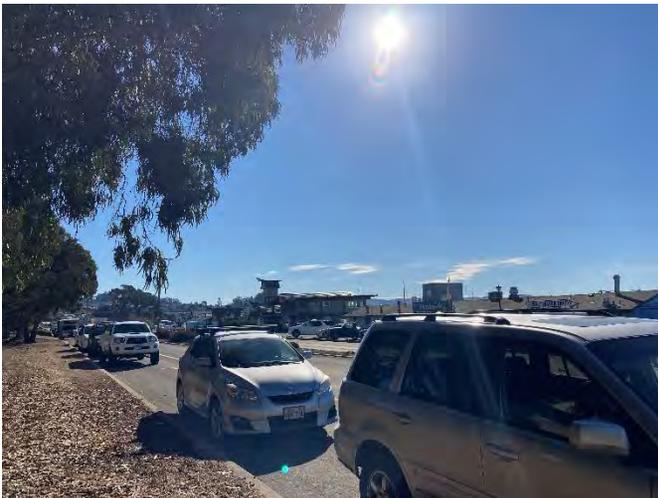
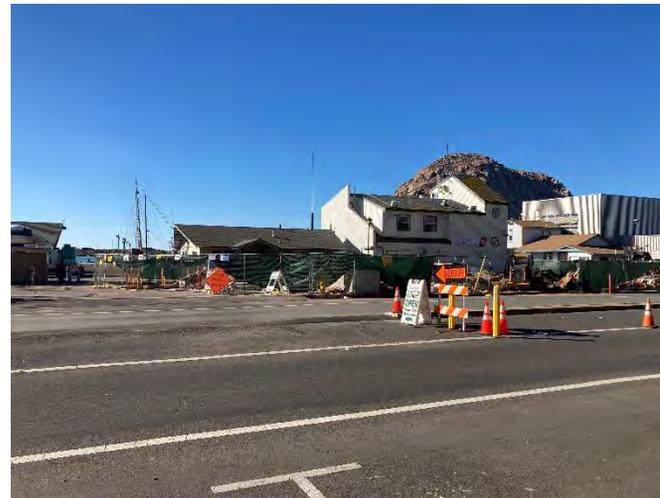
Project: 1902-1172 Biological Resources Assessment; MBPP BESS Project  
Vegetation Rapid Assessment Attachment  
Stand/Plot ID: **MBPP004**

Classification: Eucalyptus groves (Site-Specific; Ornamental)

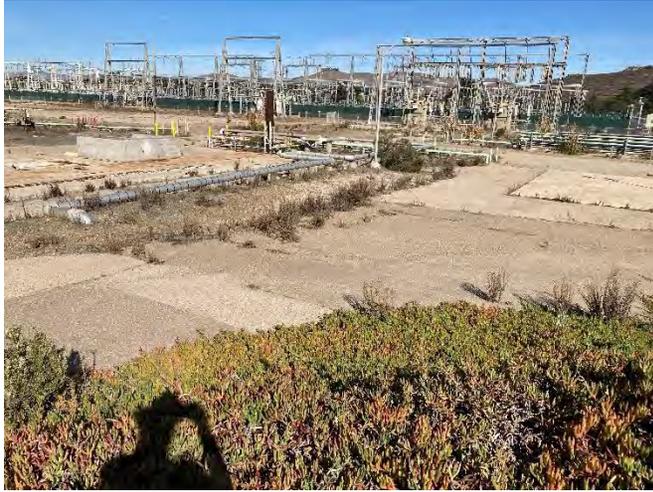
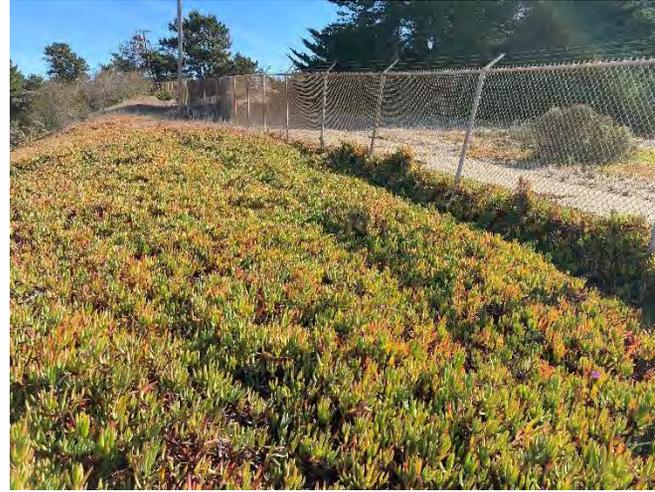
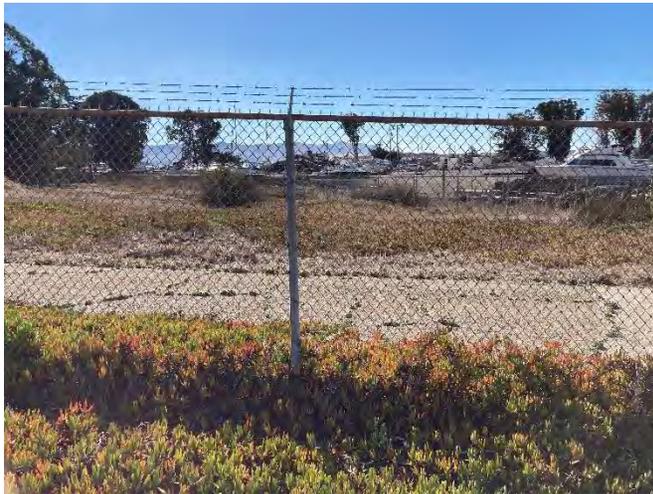
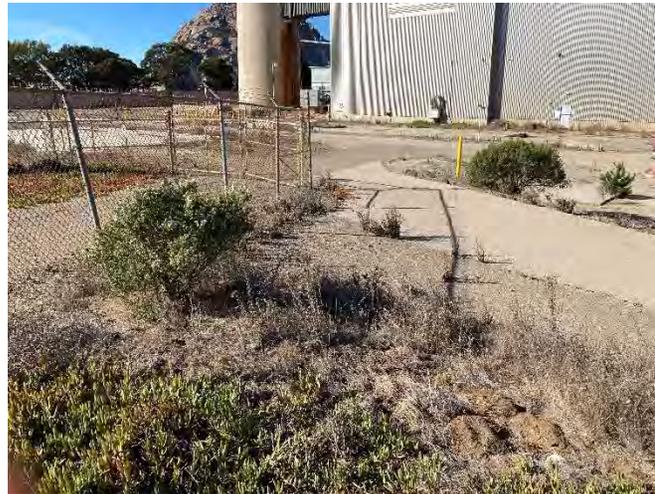
Project: 1902-1172 Biological Resources Assessment; MBPP BESS Project  
Vegetation Rapid Assessment Attachment  
Stand/Plot ID: **MBPP006**

Classification: Ice plant mats (MCV2)

Ice plant mats (*Carpobrotus edulis* or Other Ice Plants Semi-Natural Herbaceous Stands Alliance) occur on bluffs, disturbed land, sand dunes of immediate coastline, coastal and alkaline terraces characterized by the presence of ice plant as dominant in the herbaceous canopy, emergent trees and shrubs may be present; canopy is intermittent to continuous (Sawyer et al., 2009). As observed during the field survey, this alliance occurred primarily in the southeastern portion of the BSA. The quantitative vegetation assessment (Appendix D: data sheet MBPP006) identified native and non-native, shrub and herbaceous species with ice plant (*Carpobrotus edulis*) as the dominant species. Component species included telegraph weed (*Heterotheca grandiflora*), coyote brush (*Baccharis pilularis*), and remnant annual grasses. This alliance is not considered sensitive by the CDFW and is not protected under CEQA.
