CITY OF MORRO BAY HARBOR ADVISORY BOARD AGENDA

SUBJECT: Commercial Fishing Dock Repair Plan

Damage Evaluation Report
City of Morro Bay, CA - Harbor and Shoreline Infrastructure
File No. DMB012023R

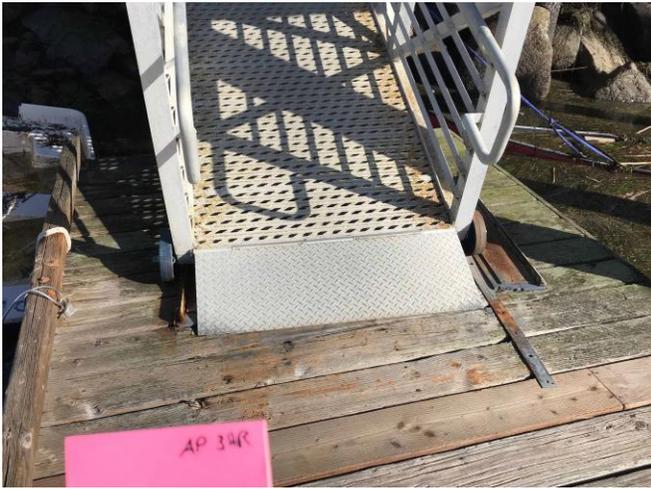
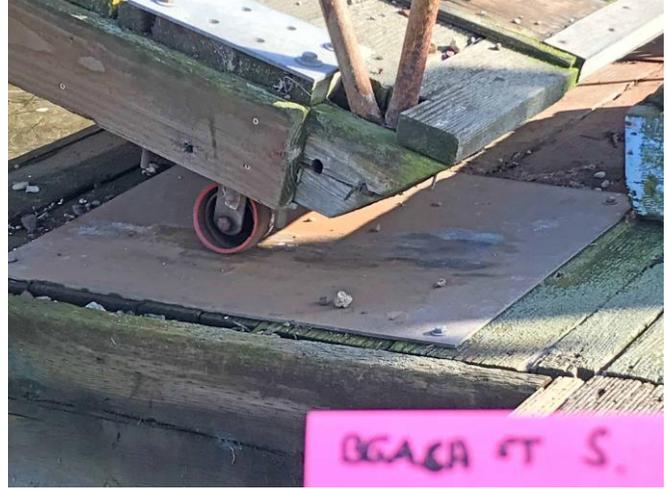
The bottom of the access ramp down to the three-hour dock at Mariner's Park, adjacent to the Associated Pacific building, was displaced from the steel channel guides in which the rollers at the bottom of the ramp ride.

Also, the vinyl tire on the north side bottom roller on the Beach St. South access ramp was damaged.

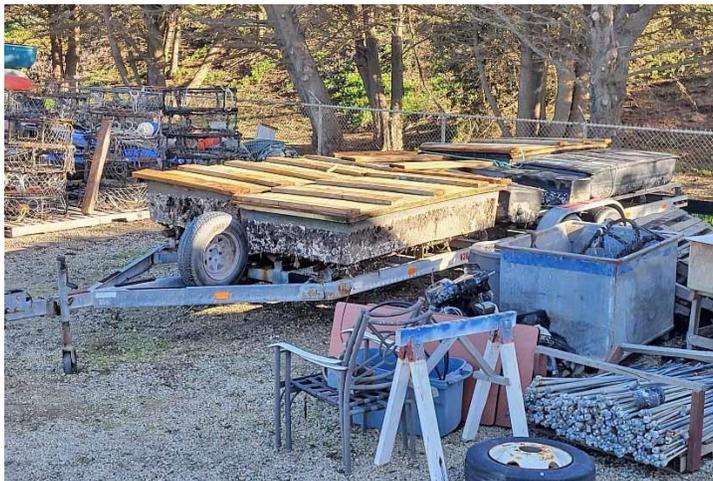
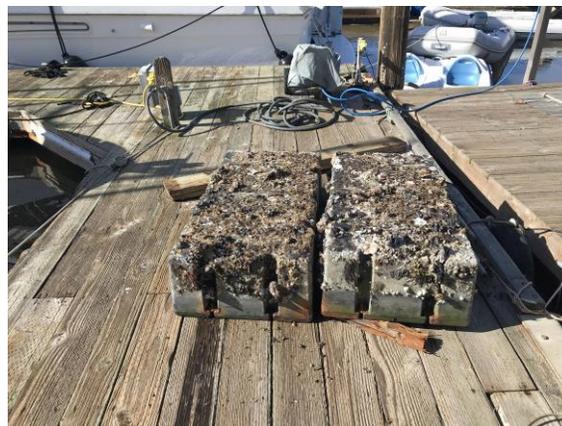
As previously noted, City of Morro Bay dock floatation appears to be molded plastic tubs filled with foam, with a molded plastic cover attached to the tub at a molded flange. Additionally, a number of smaller molded plastic units, presumably foam filled, were also sighted. The larger molded plastic tubs

were affixed under the docks with steel fasteners. During the current examination, numerous displaced floats were observed, with more being retrieved from around the Bay as this report is being written.

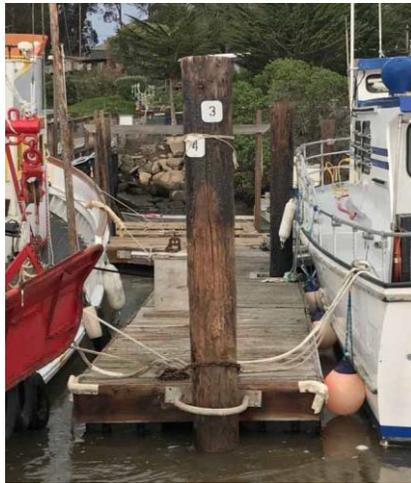
Finger Dock 1/2: The pile hoop broke during the January 4/5 event and has been temporarily repaired.

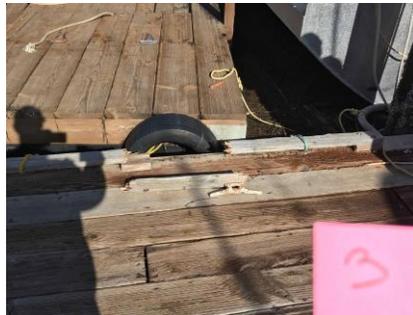
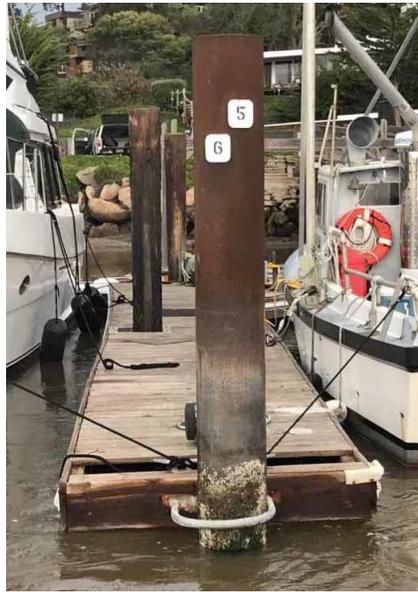
- Finger Dock 3/4: The pile hoop broke during the January 4/5 event and has been temporarily repaired. Additionally, the finger dock has a pronounced curve along its length, indicating that the dock's structure has been compromised. Further, the edge of the head dock at slip 3 was impacted by the boat moored in that slip surging against the dock. Also, a portion of the cleat attachment plank on the opposite (landward) side of the head dock was broken out.

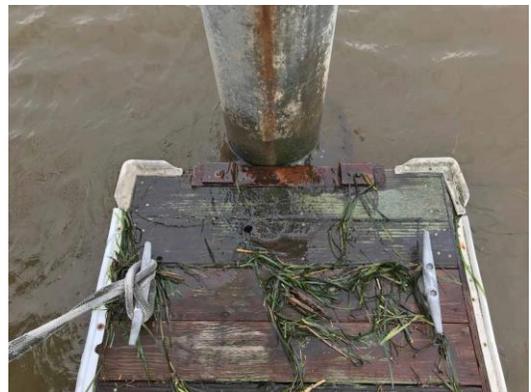
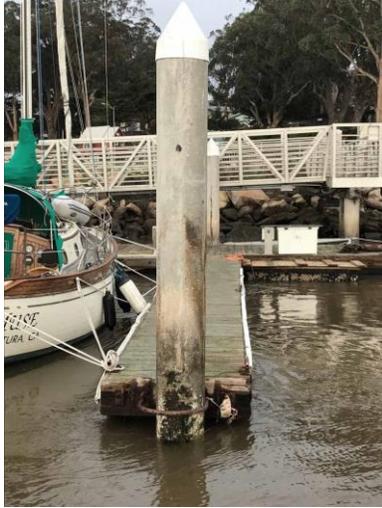
- Finger Dock 7/8: Floatation is missing and the dock is not level, with its outermost end partially submerged. Additionally, bumpers affixed to the slip 8 side of the finger dock are displaced.

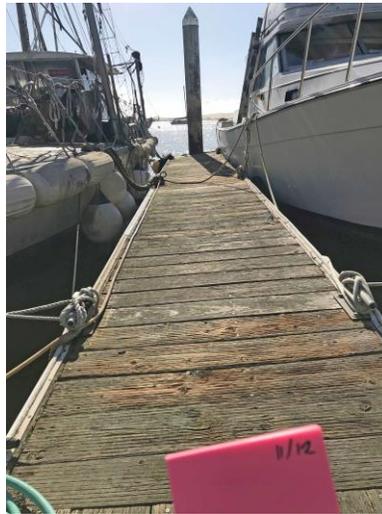
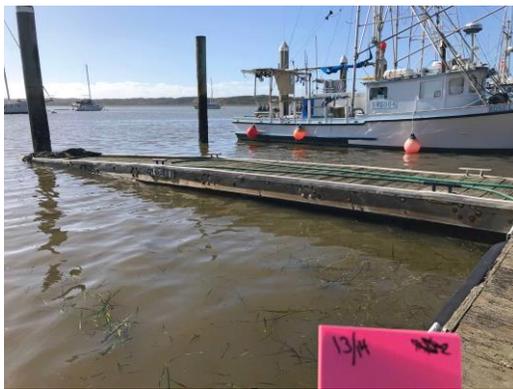
Finger Dock 11/12

- Finger Dock 11/12: Dock is twisted longitudinally, indicating its structure has been compromised, and floatation is missing from the outermost end.
- Finger Dock 13/14: Floatation is missing, the outermost end is partially submerged, and the dock is not level.

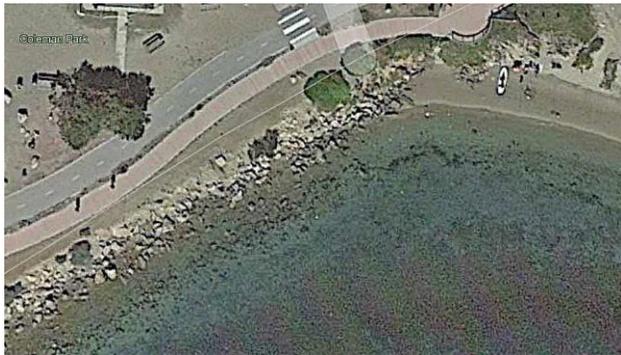
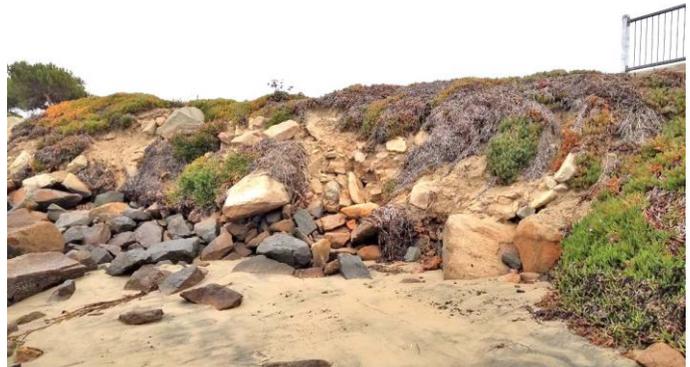
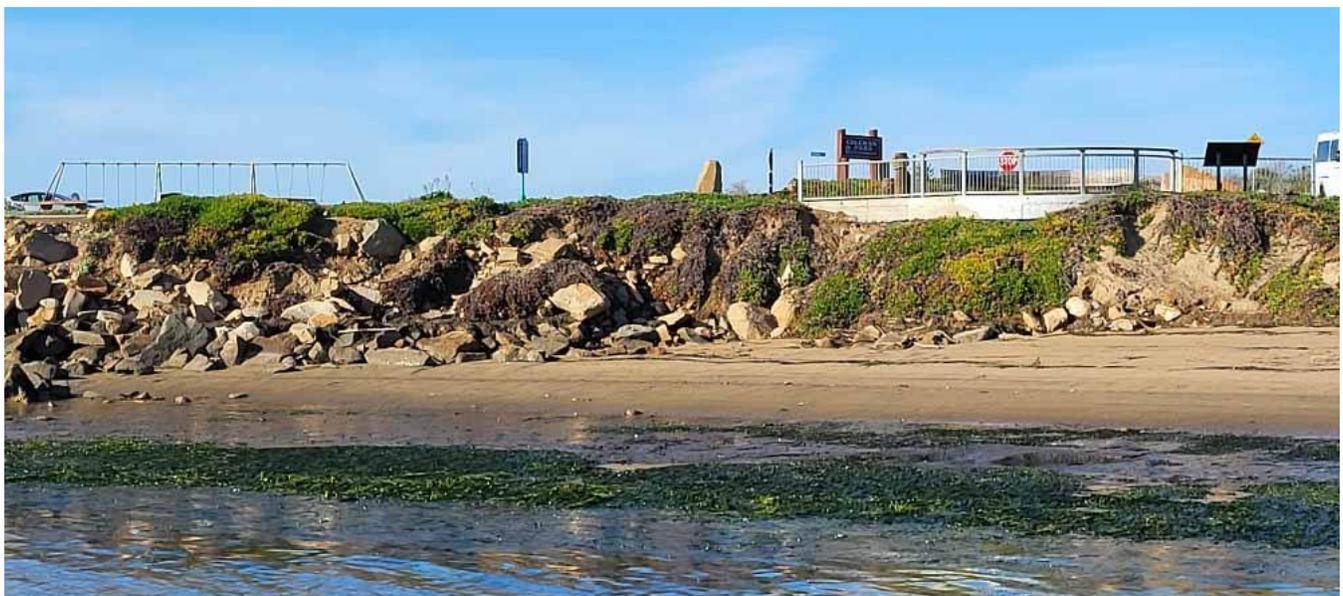
Revetment on the South Side of the Morro Rock Causeway, east end:

This local revetment was damaged by both the January 4/5 and the January 9/10 extreme weather events. Damage consists of revetment rock displaced downward, some now on the adjacent beach, with areas now missing rock.
