INSPECTION AND ASSESSMENT OF REVTMENTS AND SEAWALLS MORRO BAY, CA

January 23, 2025

Richard Brady & Associates

Subject: Inspection and Assessment of Revetments and Seawalls, Morro Bay, CA

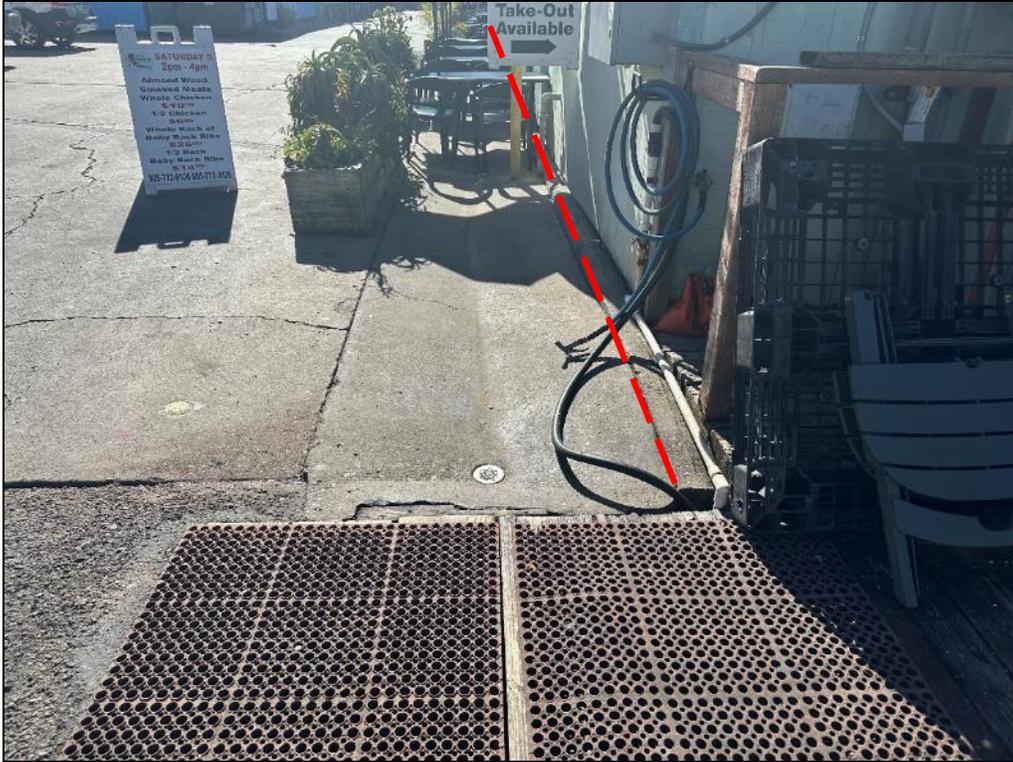
Above deck, a v-ditch for diverting runoff is installed behind the wall, see Photo 10. Some cracking in the concrete behind the wall was noted, however there did not appear to be significant ponding or subsidence. The GPR data identifies linear features evenly spaced behind the wall which suggests the wall has a tieback system.

Photo 10. STA 0+00 from above deck looking south. The red dashed line indicates the location of the seawall below the interface of the concrete and timber deck.

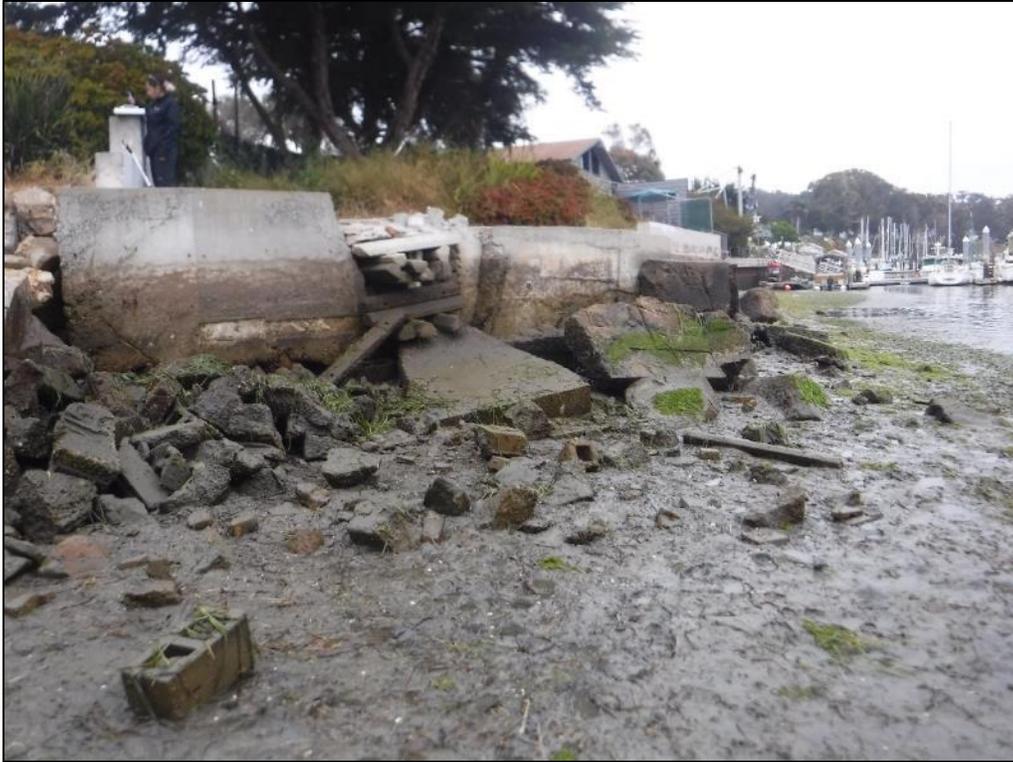
Seawall 2 is in *critical* condition with “overstressing and breakage resulting in localized failure(s) of primary structural components”. The wall has various stages of construction, the original wall has failed, and the various types of repairs have also failed. What appears to be the original concrete wall is 1 ft thick and extends from approximately 5 ft to 1 ft MLLW and was likely cast over rock and mud. Large concrete sections have failed and are laying in front of the wall (Photo 15 and Photo 16). The wall is undermined (Photo 17), settlement has occurred, and rotation seaward was observed.

Photo 15. Overall photo of Seawall 2 looking east from STA 0+00.

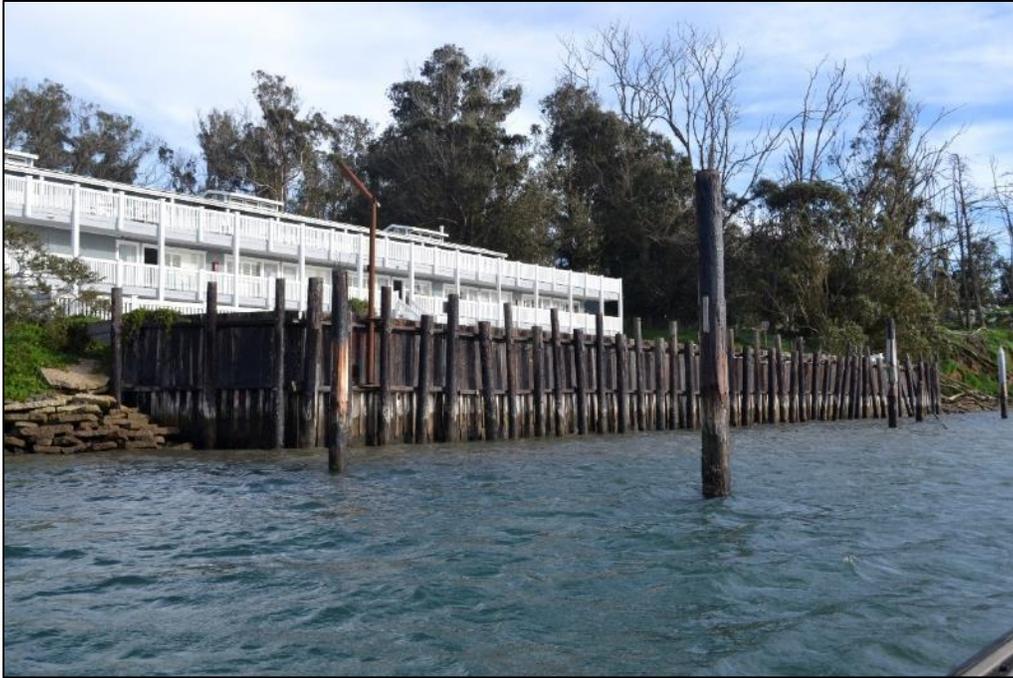
Seawall 3 is located behind the Inn at Morro Bay extending the length of the parking lot and is 213 ft long. Record drawings were not available for review and therefore the specifics and details of construction are unknown. Review of historical aerial images suggest the wall was built between 1963 and 1969, see Photo 18. The wall is constructed of timber sheet piles, a timber wale and steel tie back system, with round timber piles placed in front of the wale, see Photo 19.

Photo 19. Overall photo of Seawall 3 looking southeast.

The wall is beyond repair and the entire wall should be removed and replaced. The sheet pile wall could be replaced with a rock revetment, which is a more economical solution. However, if it is desirable to replace in-kind so that vessels can access the structure again, a new concrete sheet pile wall and tie back system is recommended. Drainage improvements such as capture, detention, or channelization would be

required to eliminate damage to the new wall from stormwater runoff. Dredging would be required to reclaim the material lost through the failed wall and allow vessels to berth. Both options would require input from CCC.

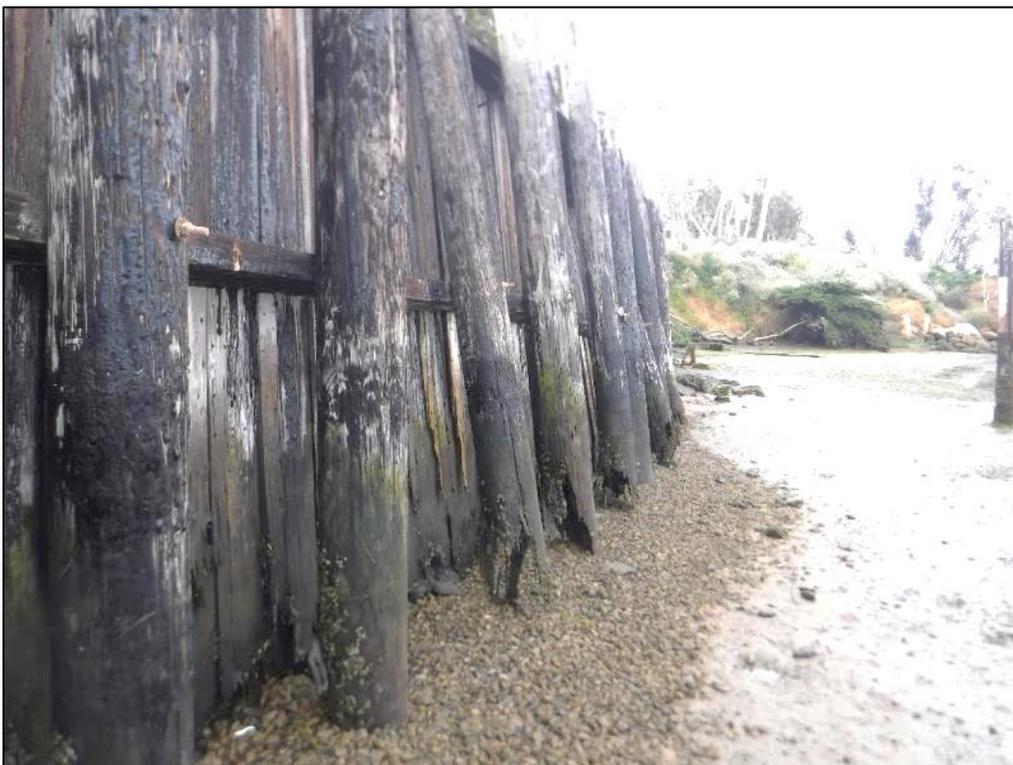
Seawall 3 is in *critical* condition with “overstressing and breakage resulting in localized failure(s) of primary structural components”. Decay and marine borer damage has degraded the lower portion of the sheet piles resulting in voids and the retained soil migrating through the wall, see Photo 20 and Photo 21. Due to its location at the bottom of a hill, the wall is subject to significant runoff during rain events. The combination of the wall’s inability to retain soil and erosion due to runoff has resulted in substantial voids behind the wall, exposing the tie back system, and failure of the AC paving, see Photo 22. A fence has been installed to mitigate public access from this hazard, see Photo 23. Over time the soil behind the wall will continue to erode and the failed area will continue to grow further into the existing parking lot.

Photo 20. STA 1+00 looking south.

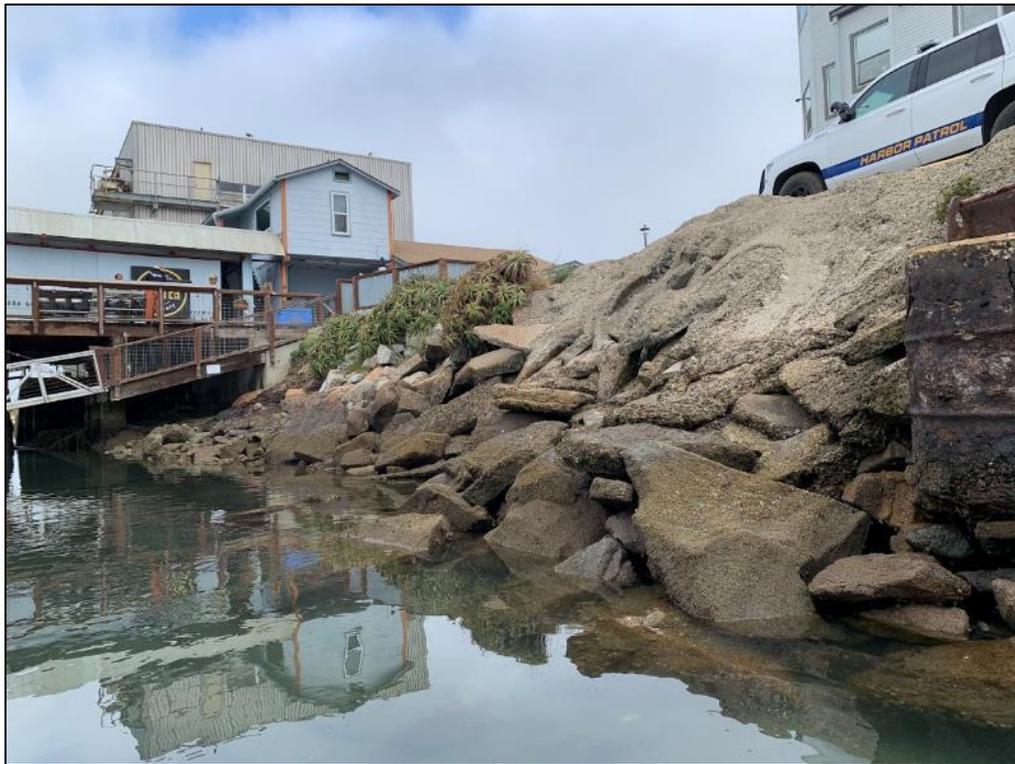
Photo 34. Revetment 3 STA 0+30 Looking north.

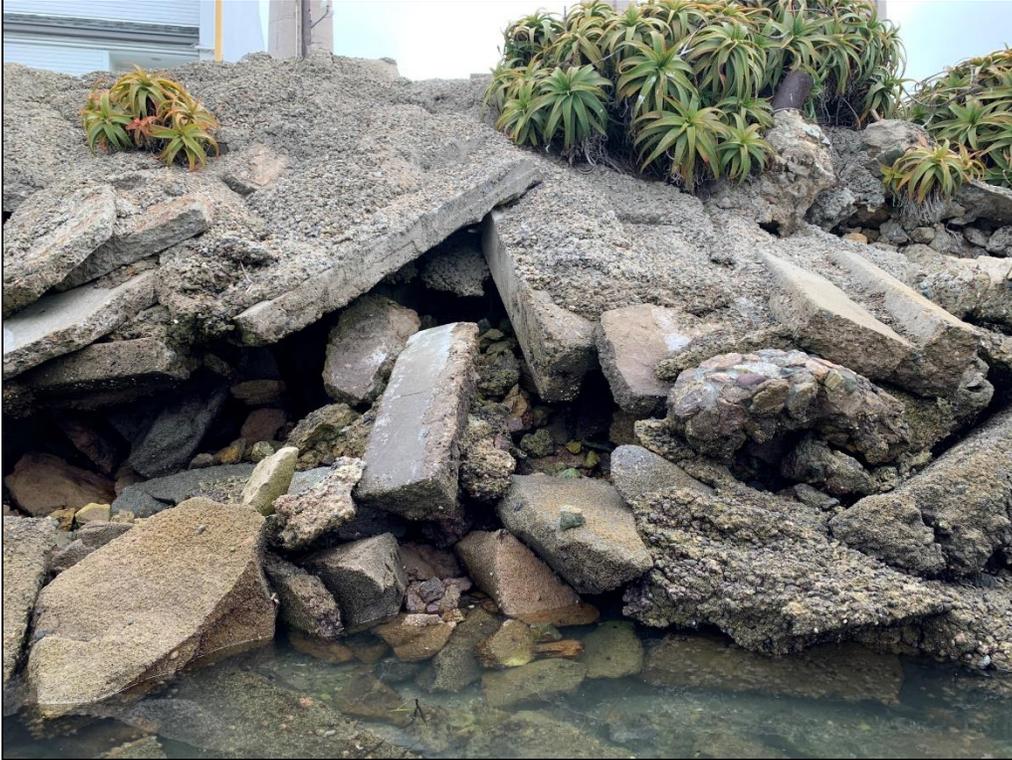
Photo 35. Revetment 3 STA 0+70 Revetment consists of concrete debris and concrete placed at the top of the slope.

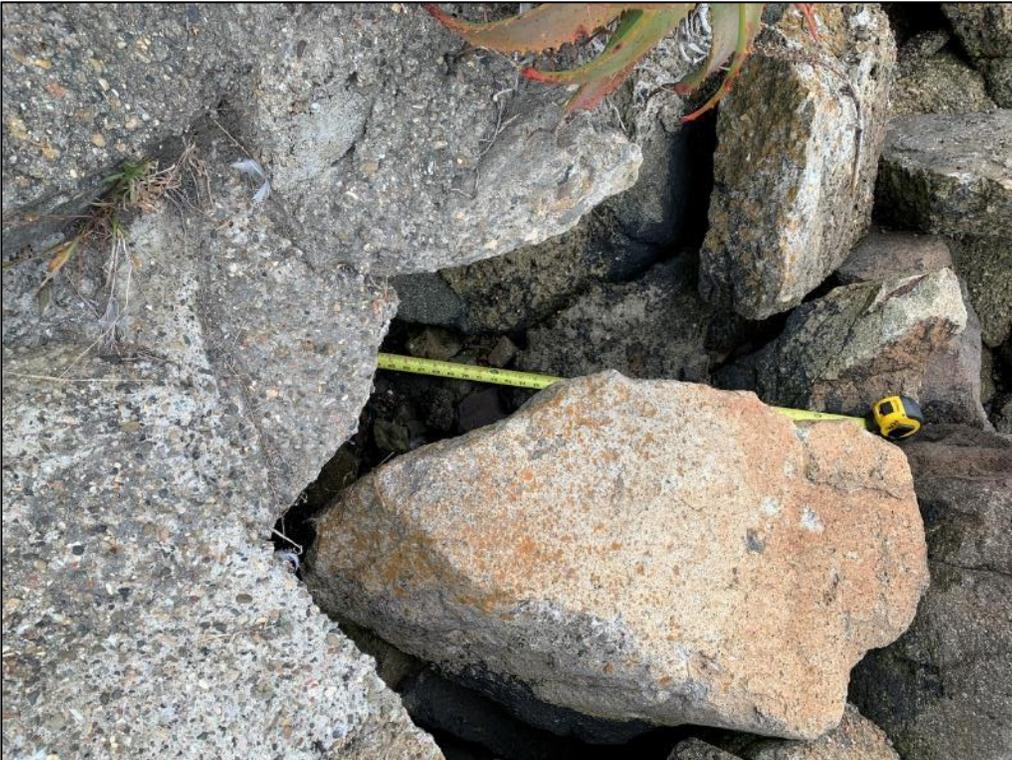
Photo 36. Revetment 3 STA 0+70 Location of a 6-ft deep void.

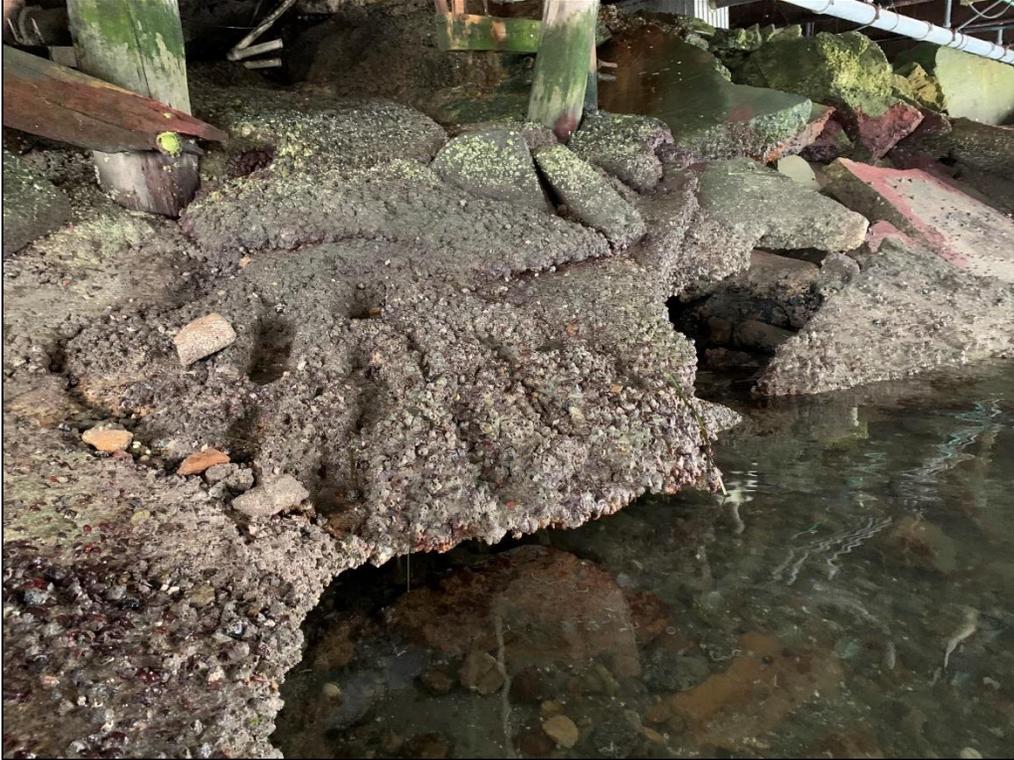
Photo 37. Revetment 3 STA 1+36 A 6 ft long area of undermined concrete at +4 ft MLLW.

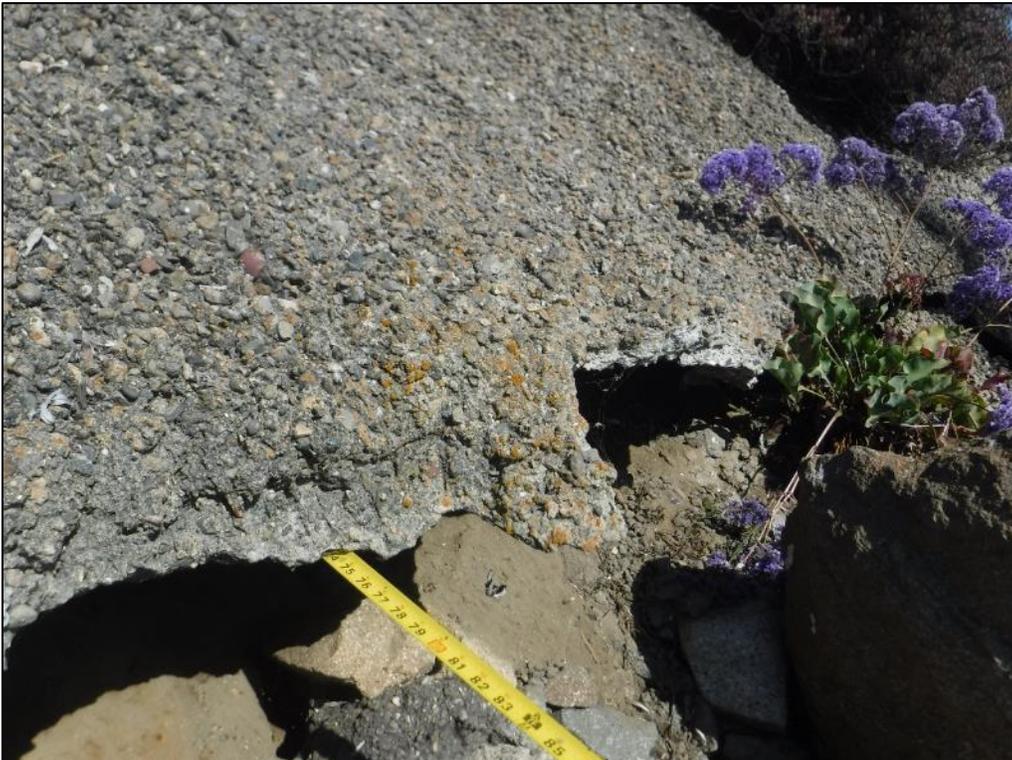
Photo 44. Revetment 4 STA 5+00 The voids below the added concrete at elevation +8 ft MLLW is greater than 6ft deep.

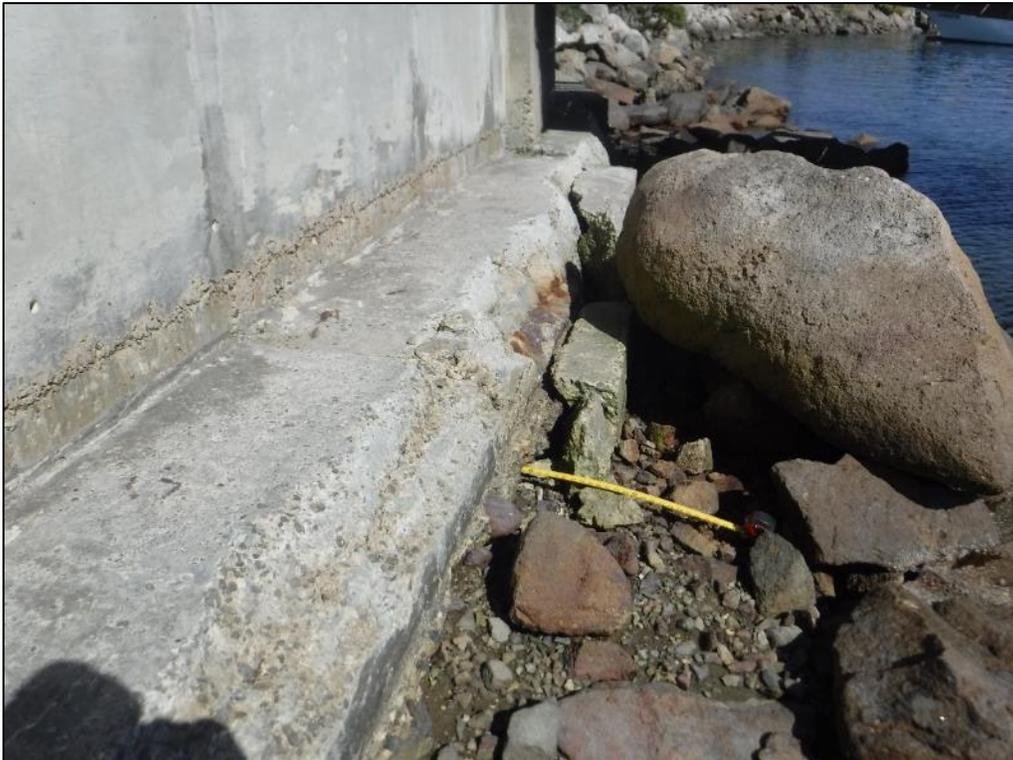
Photo 46. Revetment 4 STA 2+60 Footing undermined up to 2 ft deep.

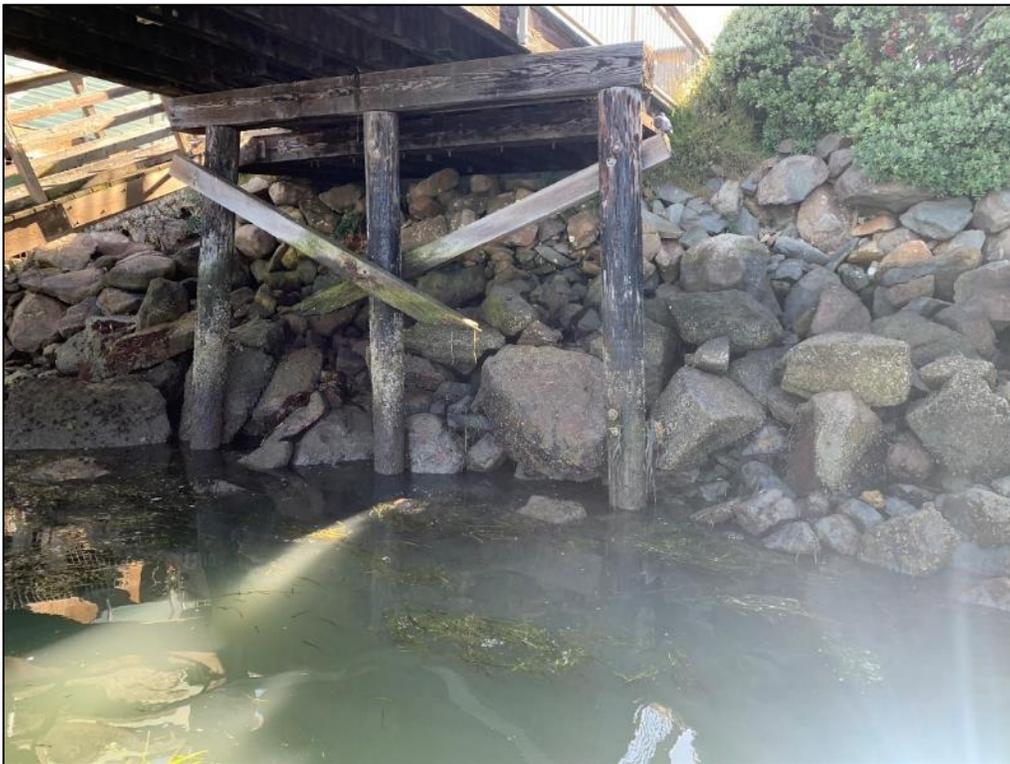
The first pile bent for the public access pier, consisting of three timber piles, holds some of the larger rocks back while smaller rocks migrate down the slope. This results in a steep drop off to the waterside of the piles, see Photo 50. The piles are not designed to resist this loading. Large rock has migrated down the slope leaving voids in the middle of the slope exposing the subgrade of soil and gravel. Photo 51 is taken where rock was missing, there was a 2 ft high void, and the gravel subgrade was exposed.

Photo 50. Revetment 6 STA 0+33 Looking north at Bent 1 of the public access pier and the revetment behind it.

The table in Appendix B recommends that the revetment be refurbished. This effort will need to be coordinated with repairs to the public access pier. Ideally the revetment should be deconstructed, new piles at Bent 1 driven, the filter layer placed, and the rocks restacked. Improvements to surface drainage are necessary to mitigate long-term effects of runoff.

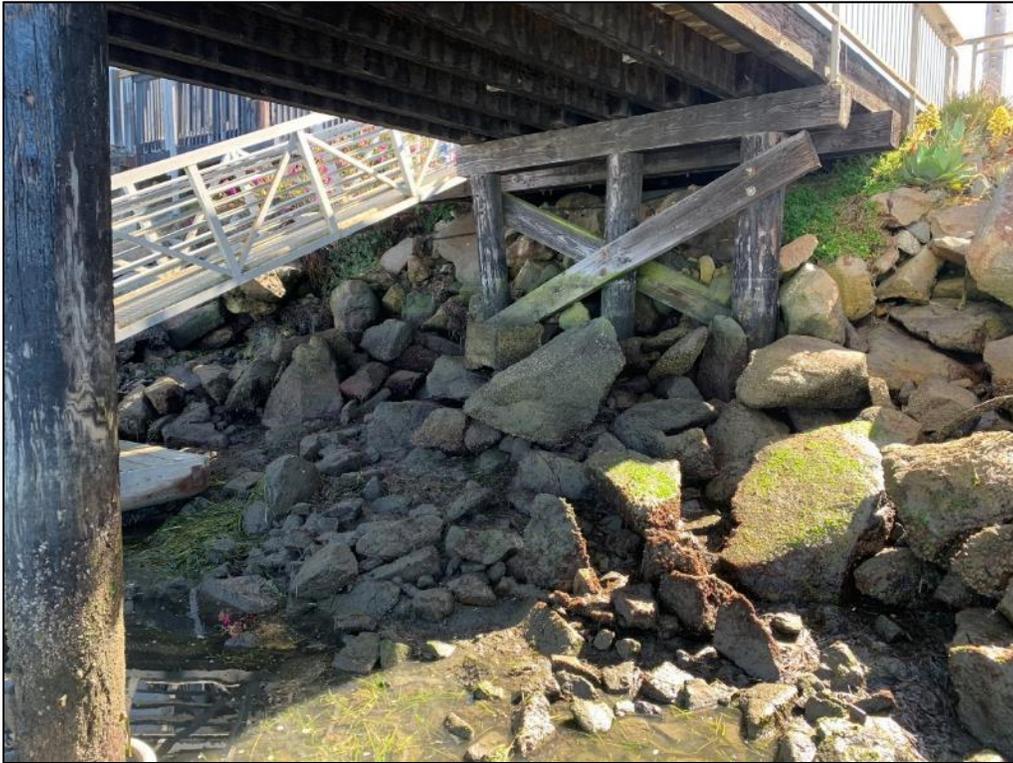
The first pile bent for the public access pier consists of three timber piles and cross bracing. This bent is restraining some of the larger rocks on the uphill side resulting in a steep drop off to the waterside of the piles, see Photo 52. The piles are not designed to resist this loading. Large rock has migrated down the slope leaving voids in the middle of the slope exposing the subgrade of soil and gravel. In some places the top section is left unsupported. In Photo 53 a large void was noted below the drainpipe leaving it unsupported and exposing the gravel sublayer.

Photo 52. Revetment 7 STA 0+40 Looking north.

Reference Appendix B for recommendations. The revetment should be refurbished. This effort will need to be coordinated with repairs to the public access pier and the public access walkway to the south. Ideally the revetment should be deconstructed, new piles at bent 1 driven, the filter layer placed, and the rocks restacked. Improvements to surface drainage are necessary to mitigate long-term effects of runoff.

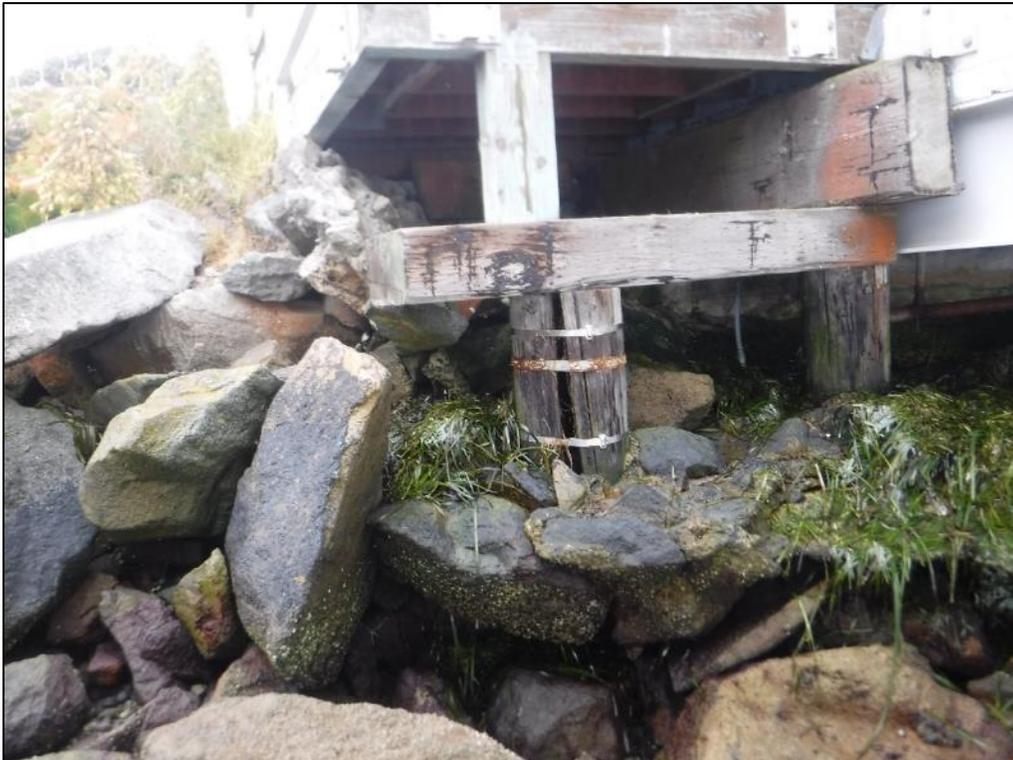
On the south end of the revetment there is a public walkway providing access around the waterside of the building. The portion of the walkway extending west is supported by a timber pile placed on top of rock revetment and concrete. This section of the revetment is undermined, see Photo 54.

Photo 54. Revetment 7 STA 0+56 Split timber pile supporting deck for Rose's Bar and Grill leashhold site.

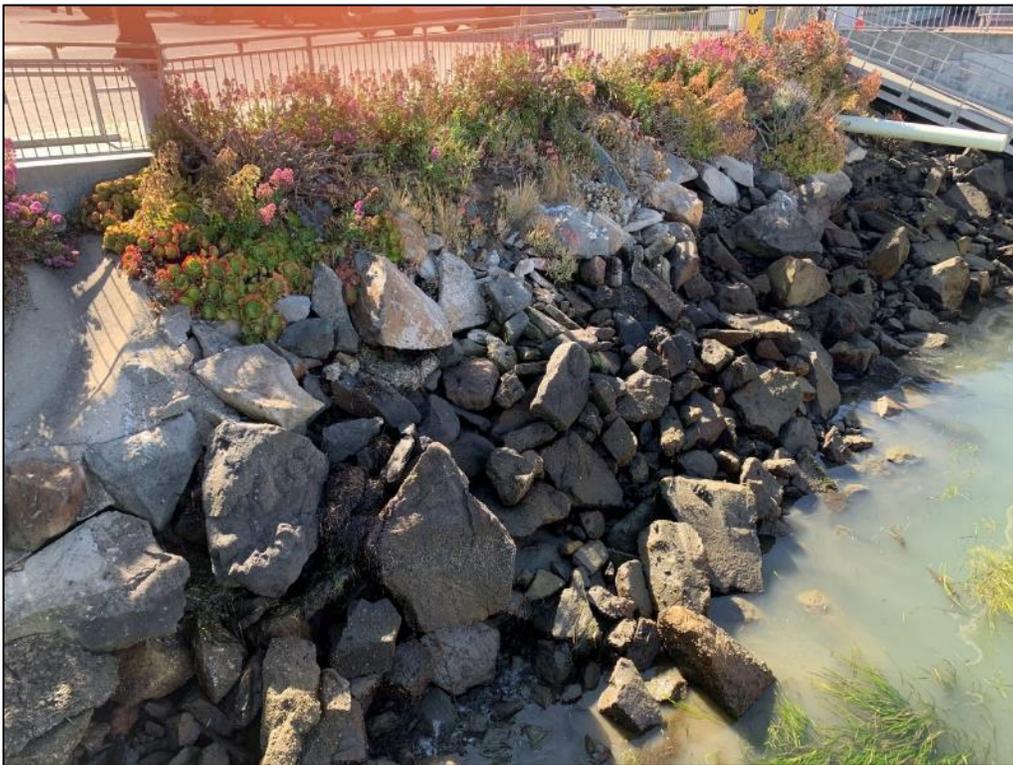
Revetment 8 is in *poor* condition with *major* to *moderate* damage noted. The revetment consists of ¼-ton rock with some 12-in and smaller and some larger rock mixed in, see Photo 55. There is vegetation at the top and it did not appear that the rock extends to the top of the slope.

Photo 55. Revetment 8 STA 0+00 Looking west.

Reference Appendix B for recommendations at this revetment. The revetment should be refurbished to protect the sidewalk and gangway abutment. Improvements to surface drainage are necessary to mitigate long-term effects of runoff.

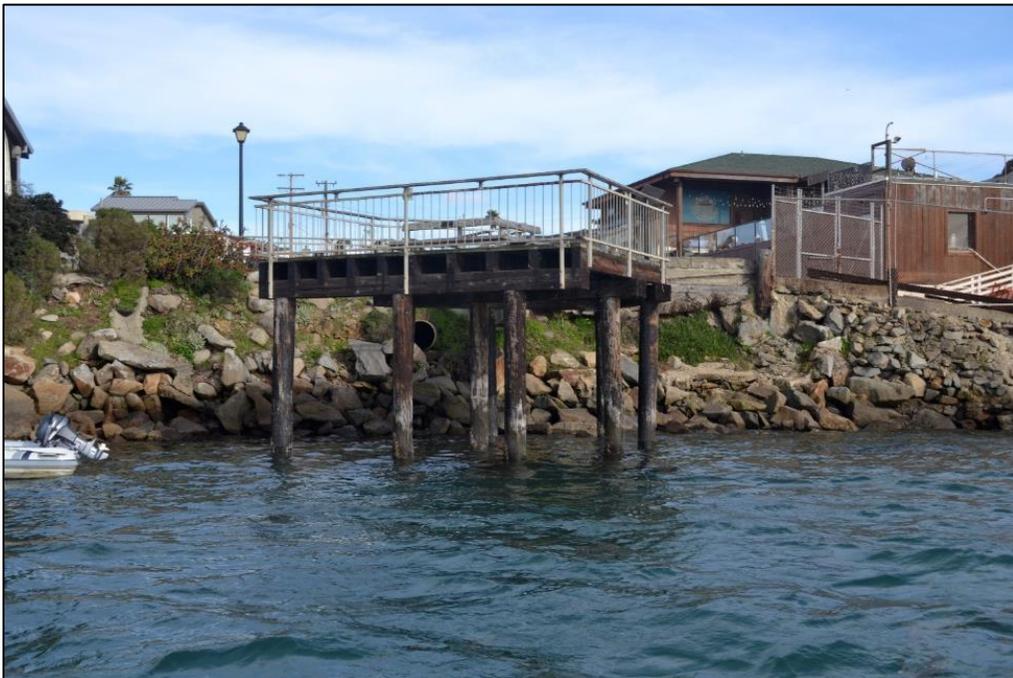
Revetment 9 is located between the Morro Bay Marina and extends 93 ft to the Three Stacks and a Rock Brewing Company, near the intersection of Embarcadero and Marina Street. There is a timber pile supported public access pier extending from the middle of the revetment, see Photo 59. Behind the revetment is a paved parking area and concrete sidewalk.

Photo 59. Revetment 9 Looking east.

Reference Appendix B for recommendations at this revetment. The portion of the revetment to the north of the pier can be refurbished while the portion to the south of the pier should be rebuilt. Repairs will have to be coordinated with the leasehold to the south. Improvements to surface drainage are necessary to mitigate long-term effects of runoff.

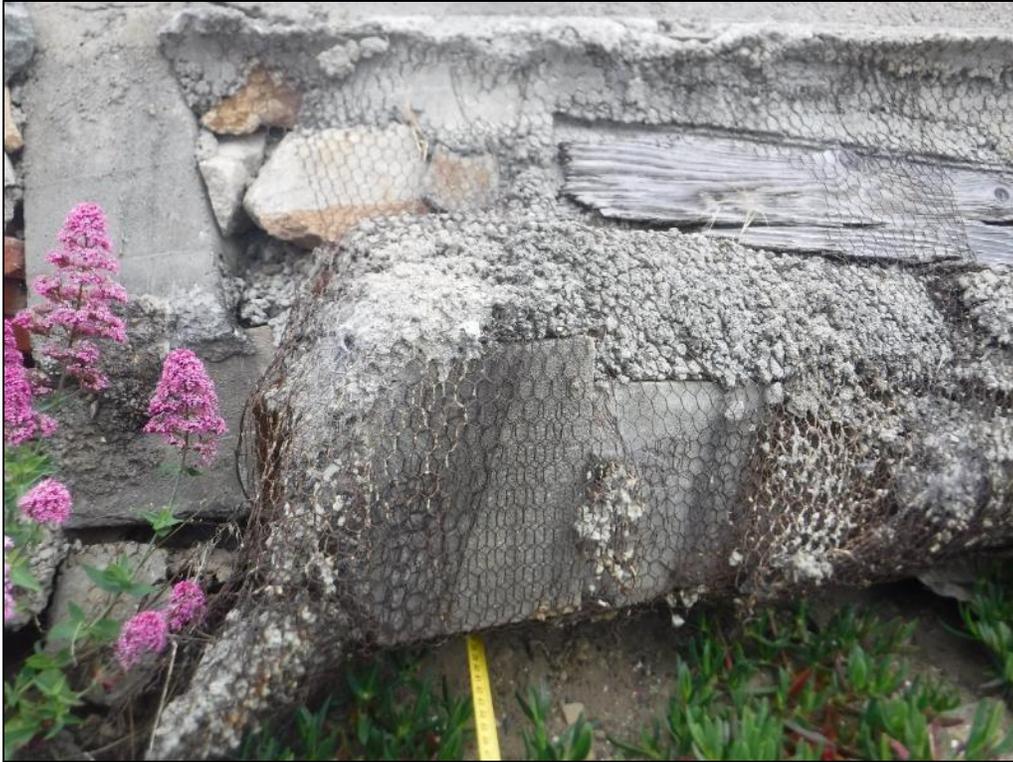
To the south of the pier, the slope is very steep and large rock is not present at the top, see Photo 61. The makeshift wall is undermined up to 3.5 ft deep and up to 2 ft high in one area (Photo 62) and 20-in deep

Photo 62. Revetment 9 STA 0+60 Makeshift concrete wall undermined by 3.5 ft.

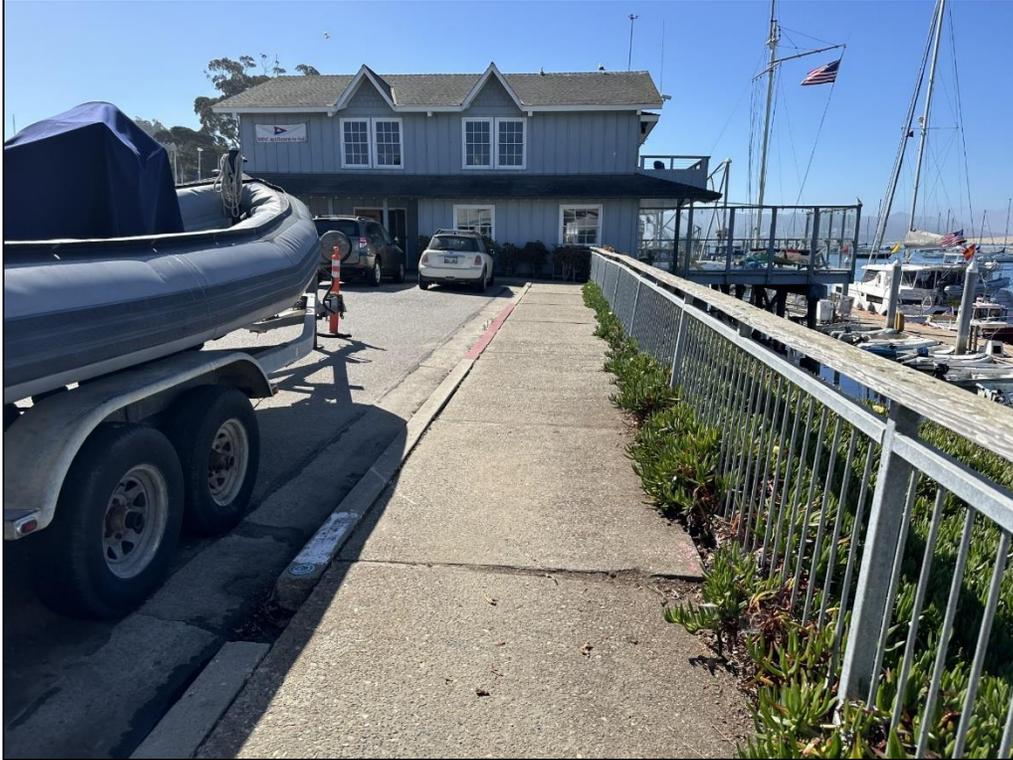
Photo 64. Revetment 10 STA 0+00 Looking south.

Reference Appendix B for recommendations at this revetment. Revetment 10 should be rebuilt. Construction will need to be coordinated with the surrounding leaseholds.

In the meantime, the ice plant should be removed since it has shallow roots, which are not effective in stabilizing steep or deep slopes. Since it appears the top of the slope is missing its rock protection, the ice plant could contribute to erosion by sliding down the slope and taking large portions of soil with it. Improvements to surface drainage are necessary to mitigate long-term effects of runoff.

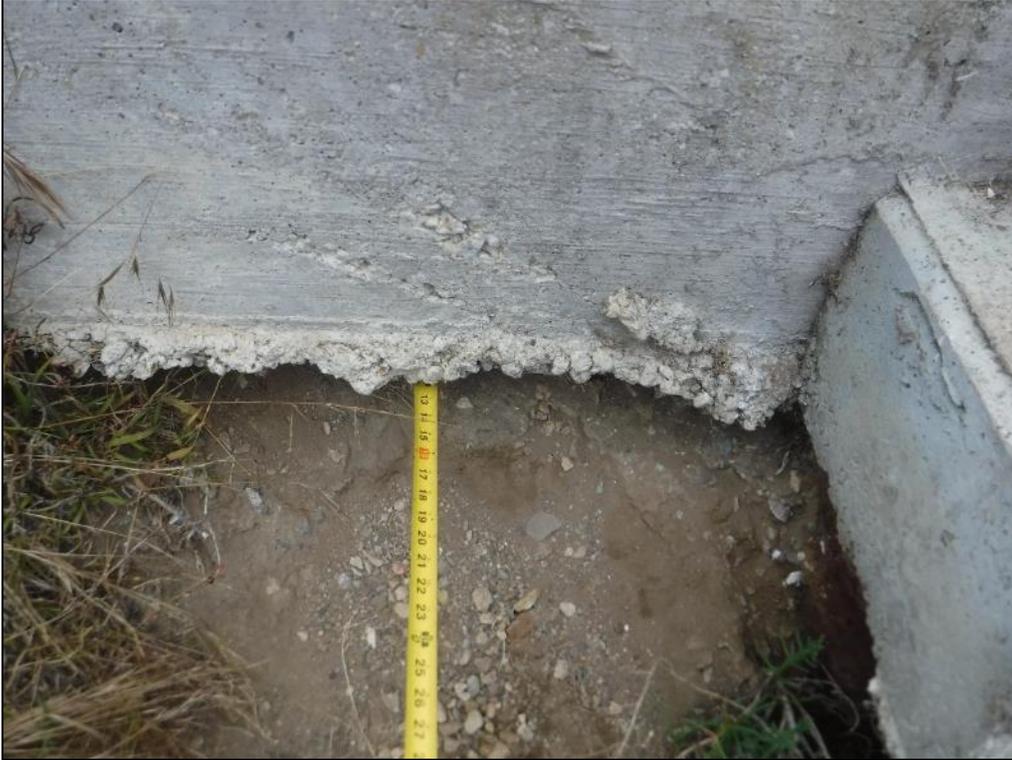
Photo 73. Revetment 12 STA 6+38 A close up of the concrete ramp seen in Photo 72 undermined 1 ft deep.

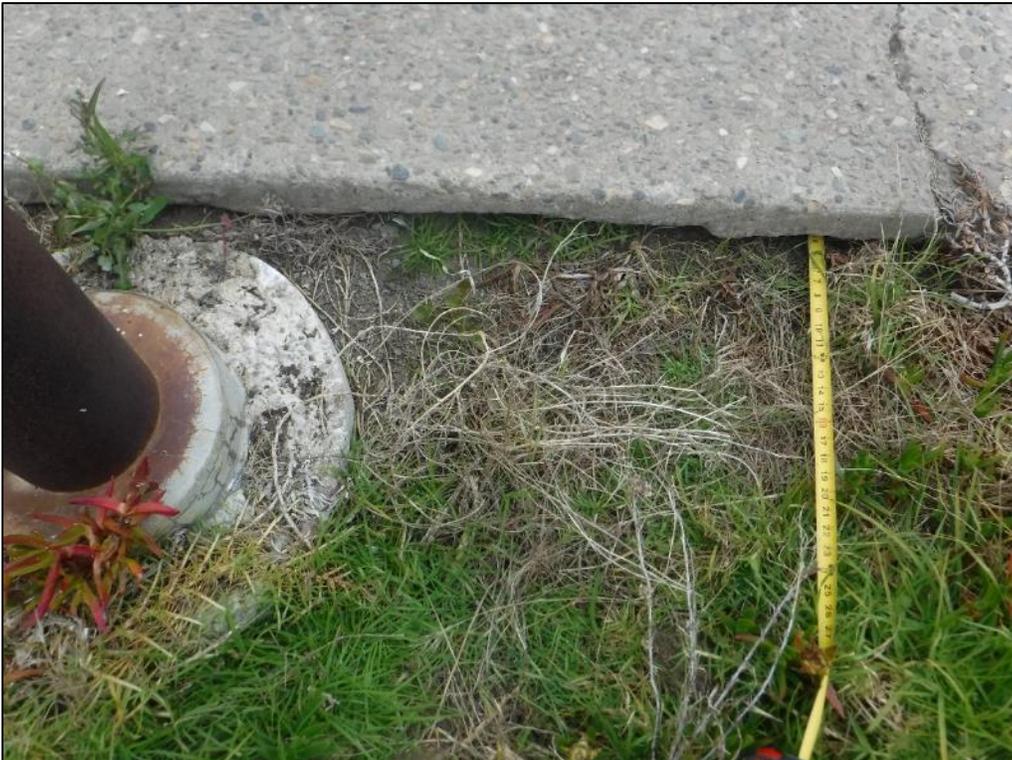
Photo 74. Revetment 12 STA 8+00 Concrete sidewalk undermined 4-in deep.

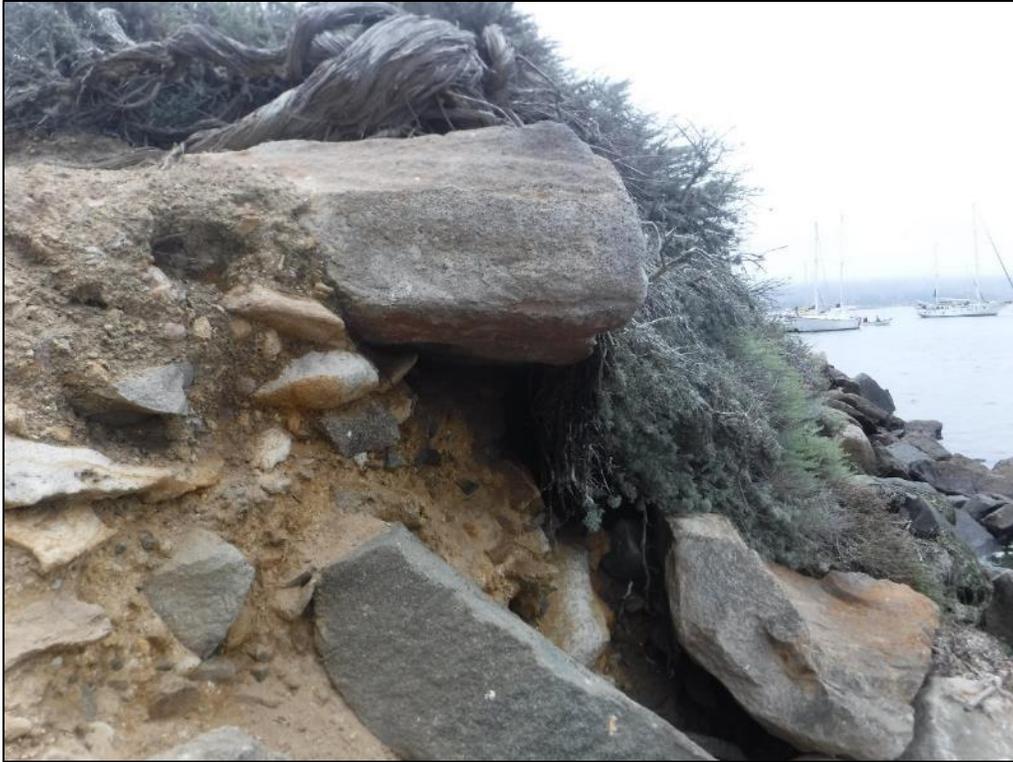
Photo 75. Revetment 12 STA 11+00 Erosion, undermining, and loss of large rock material resulting in a very steep section at the top of the slope.

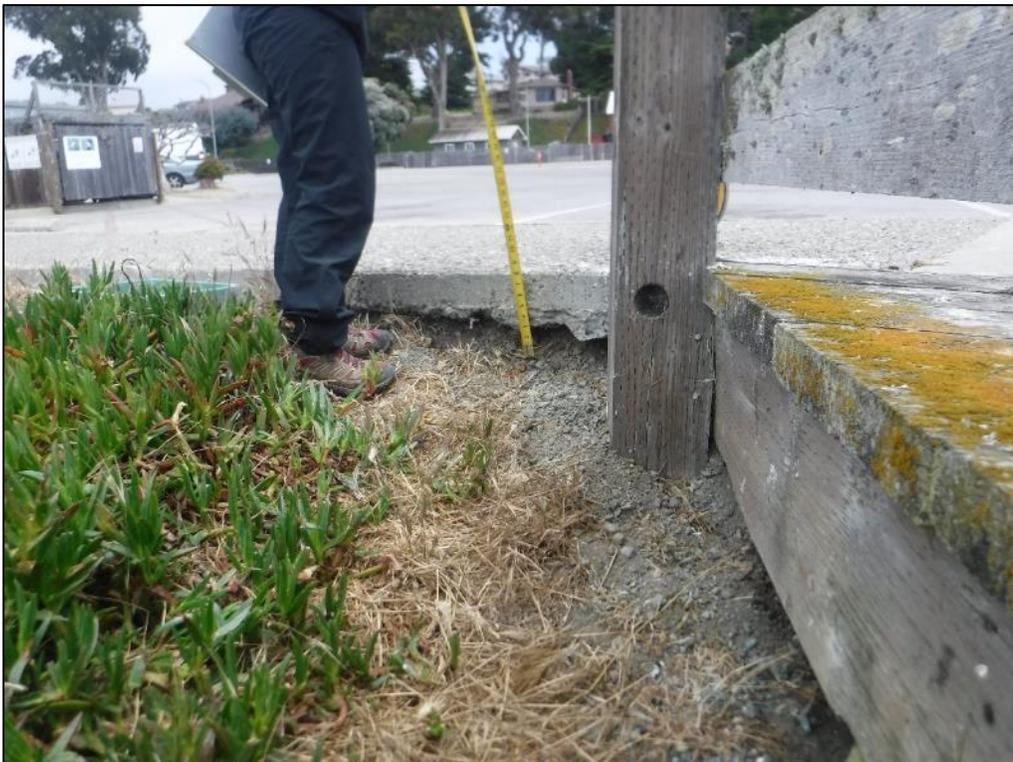
Photo 76. Revetment 12 STA 13+40 Erosion in front of the concrete sidewalk results in a 3-in high void.

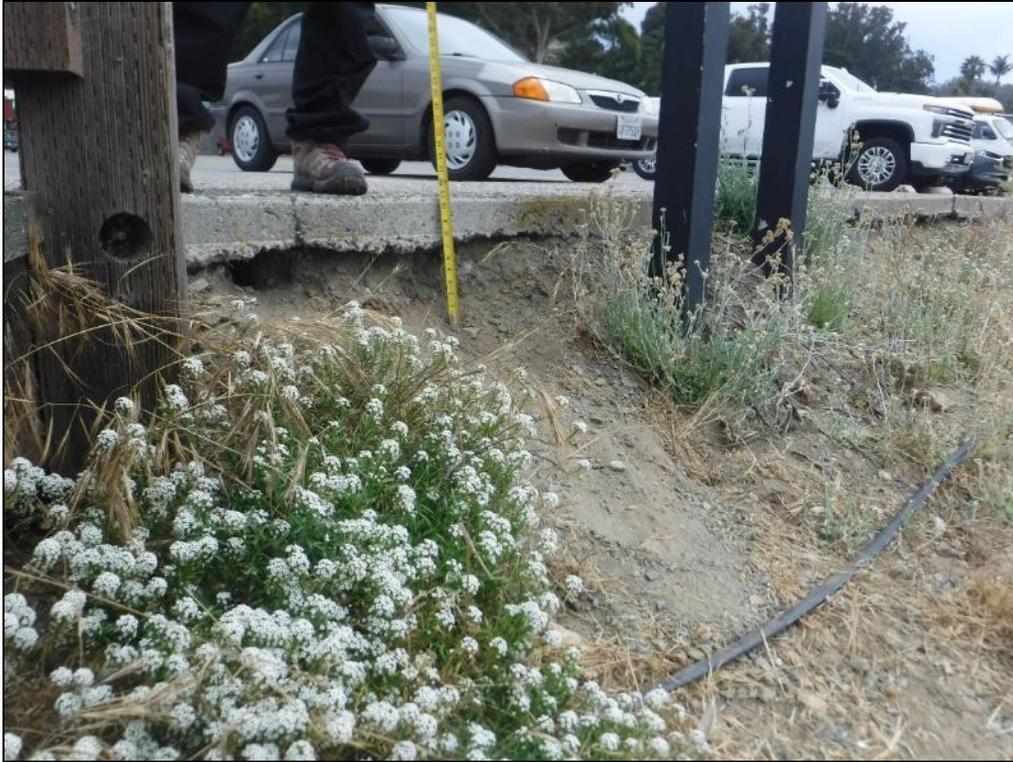
Photo 77. Revetment 12 STA 14+00 A 20 ft long section of sidewalk is undermined.
