Appendix D: GEOTECHNICAL DATA REPORT

Project No.
25170.000.001

October 10, 2024

Subject: Inspection and Assessment of Revetments and Seawalls
Morro Bay, California

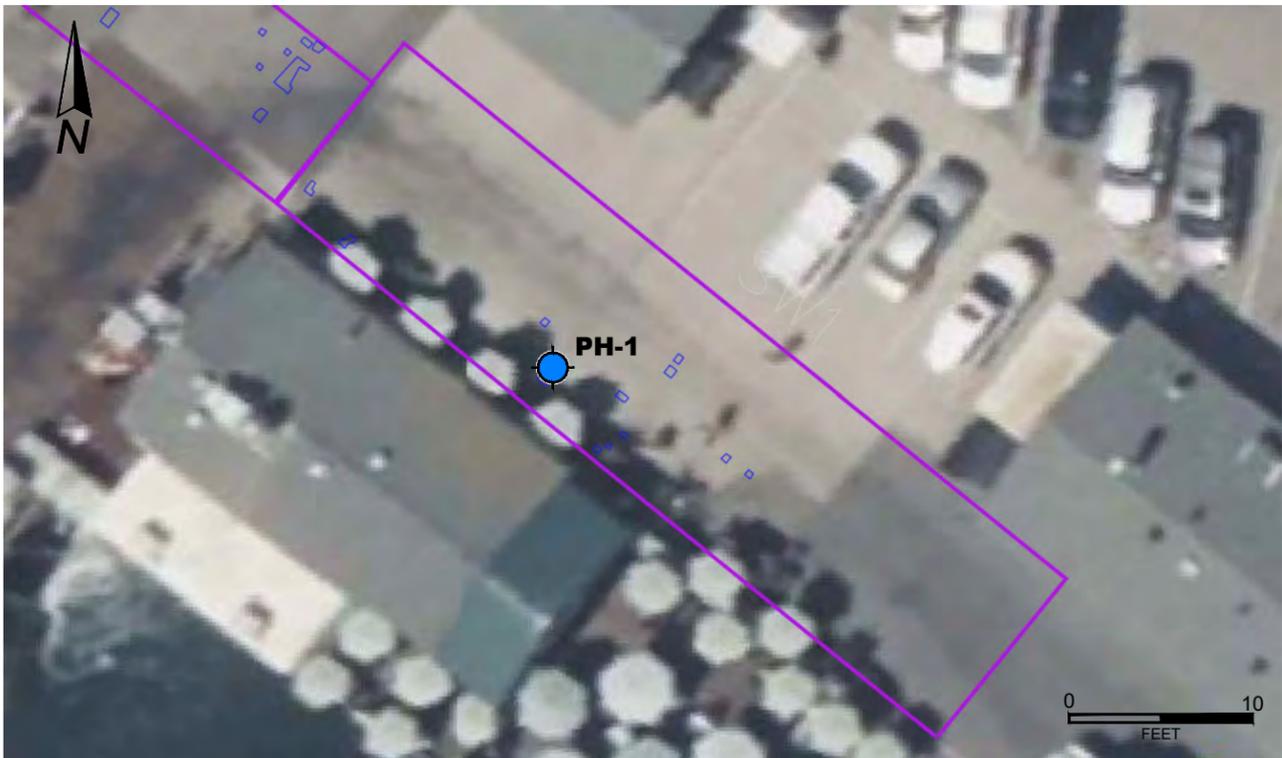
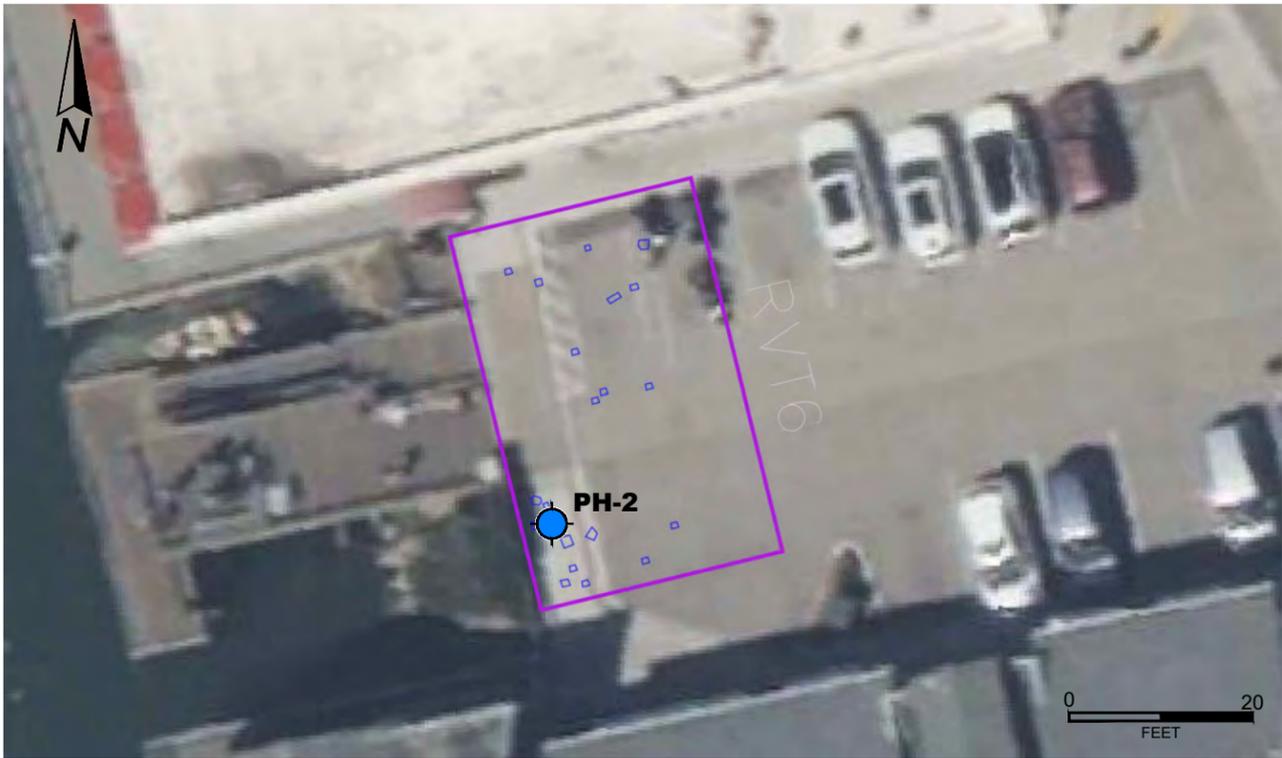
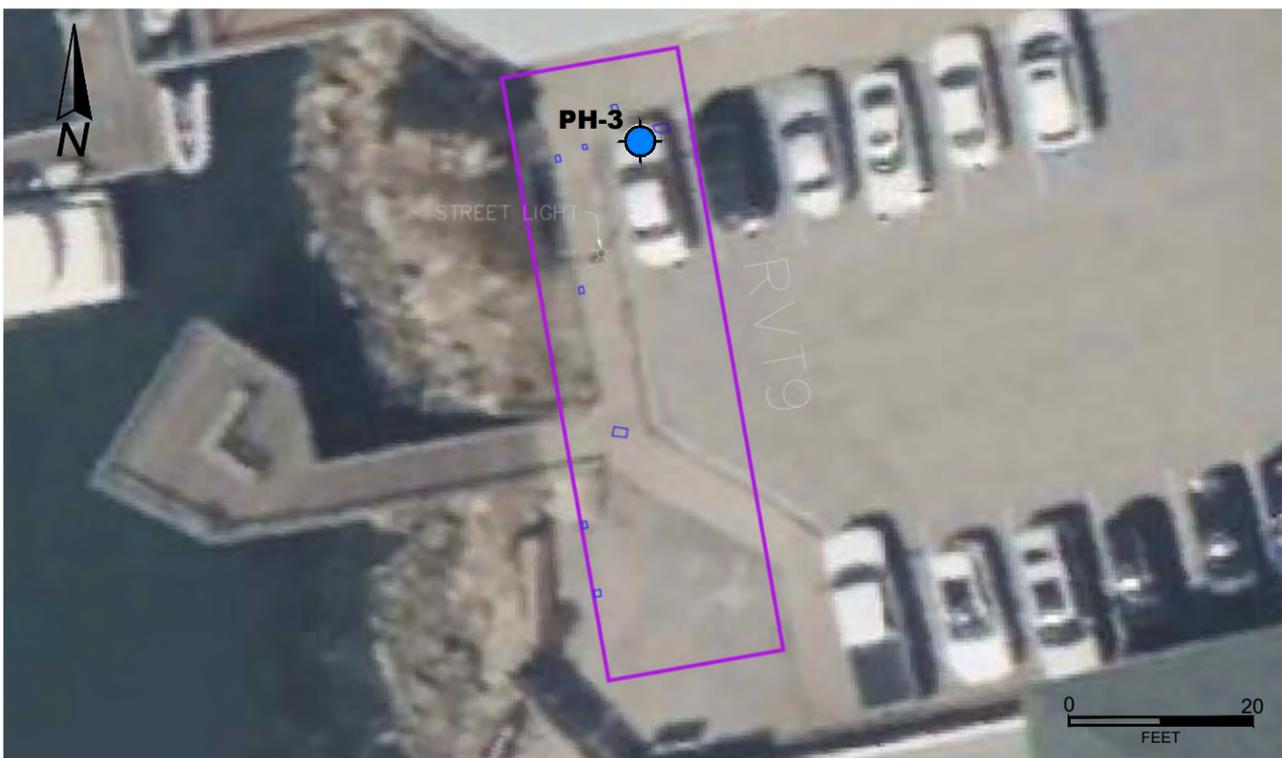
We performed pothole PH-1 at Seawall 1, as shown in Figure 2A. We observed 5-inch-thick concrete slab and large rock pieces at a depth of 1 foot below the ground surface. We did not observe any void between the concrete slab and the subgrade. We terminated the pothole at a depth of approximately 2¼ feet due to the rock. The anomalies identified by GeoVision may be small voids within the observed rock.

We performed pothole PH-2 at Revetment 6, as shown in Figure 2A. We observed a 4-inch-thick concrete slab and large rock pieces directly under the concrete slab. We did not observe a void between the concrete and the subgrade. We terminated the pothole at a depth of approximately 1¼ feet due to the rock. The anomalies identified by GeoVision may be small voids within the observed rock.

We performed pothole PH-3 at Revetment 9, as shown in Figure 2A. We observed 3½ inches of asphalt pavement, poorly graded sand, and multiple communications conduits at a depth of approximately 2 feet. We did not observe a void between the pavement and the subgrade. We terminated the pothole when the conduit was observed.

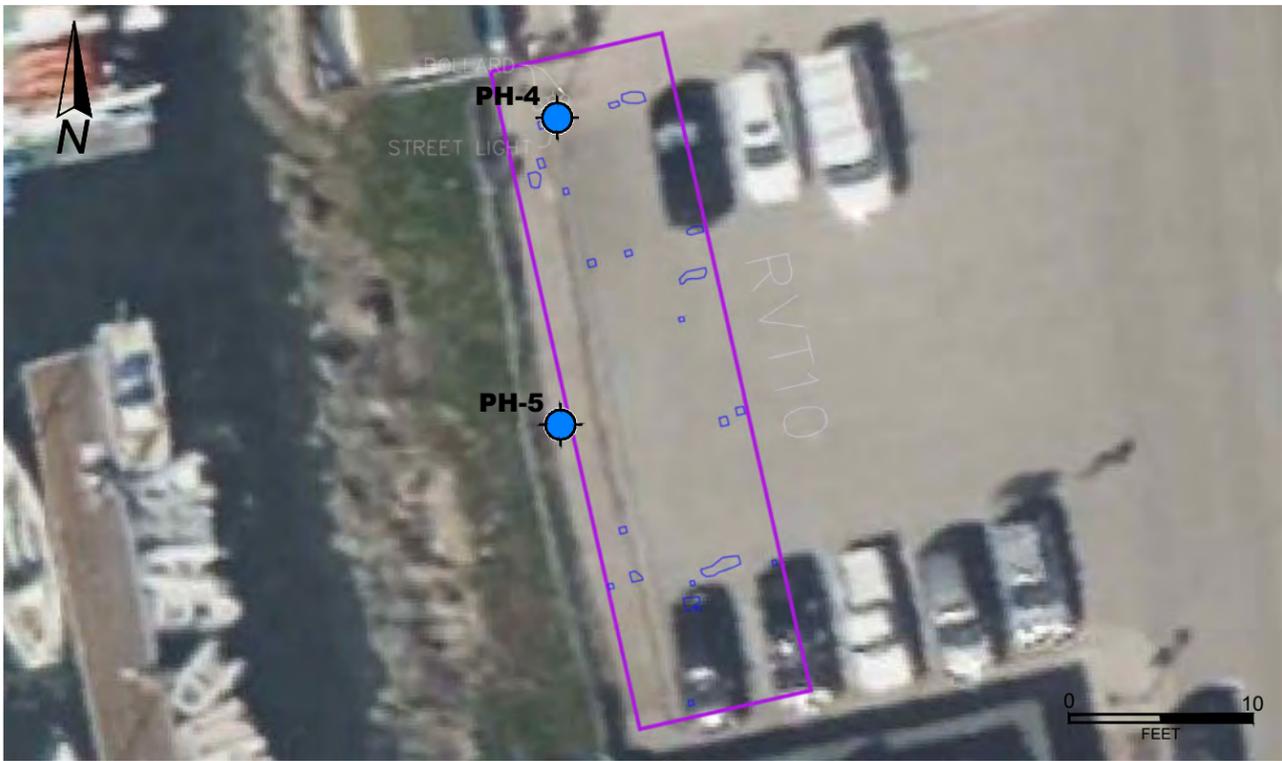
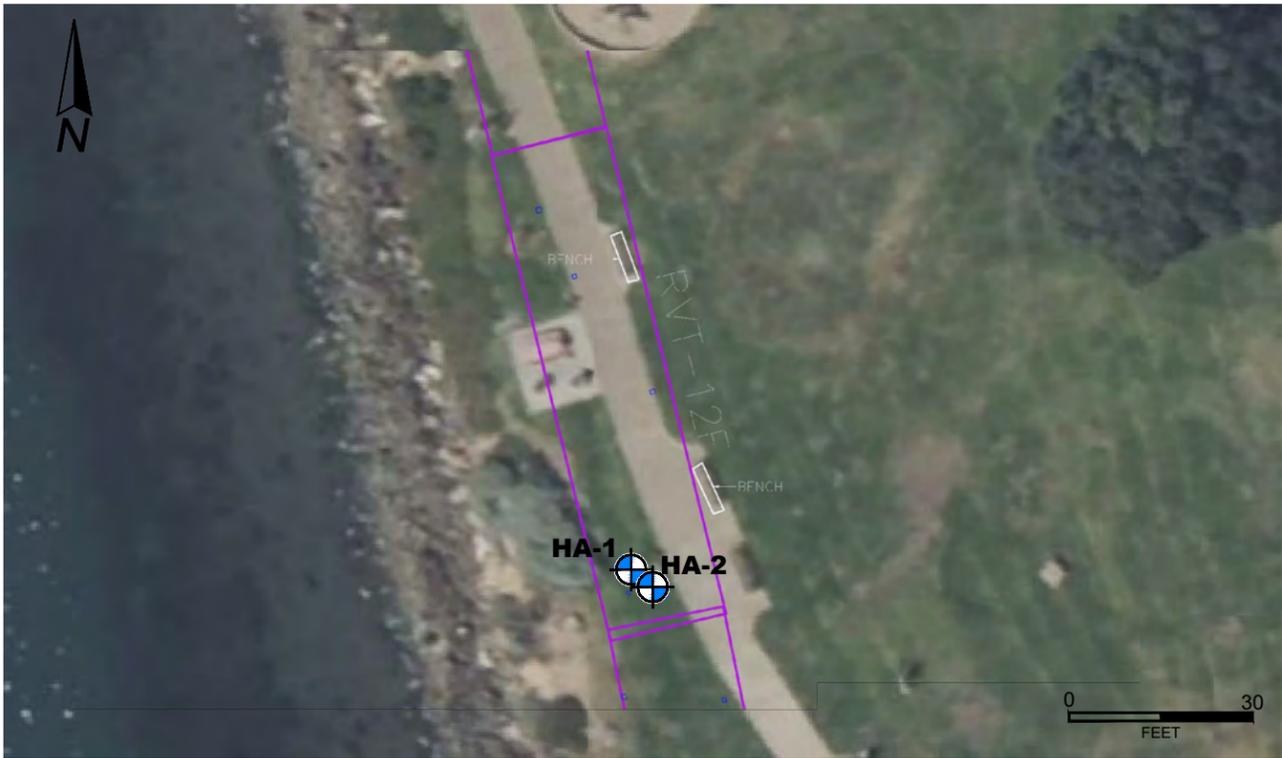
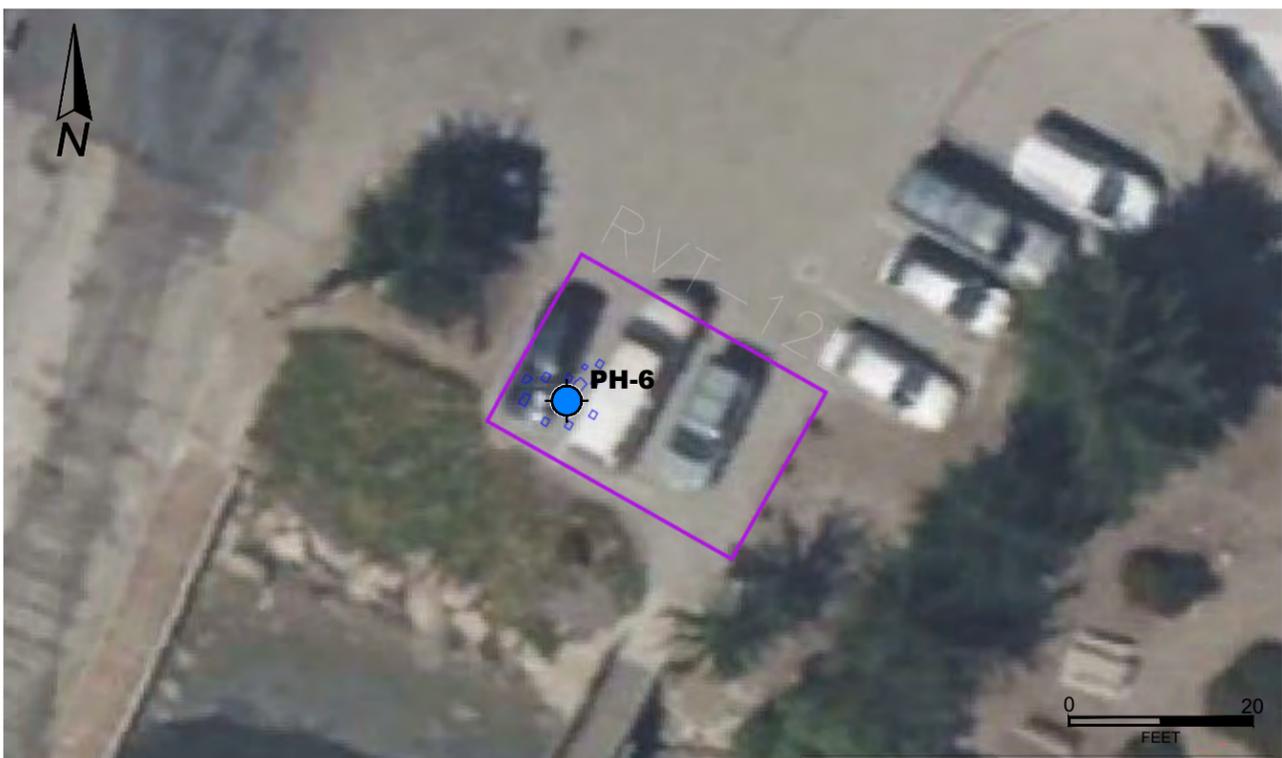
As shown in Figure 2B, we performed hand augers HA-1 and HA-2 at Revetment 12 within Tidelands Park. At both HA-1 and HA-2, we encountered poorly graded sand to silty sand with variable amounts of shells. We encountered an approximately 3-inch-thick layer of clay a depth of about 4 feet in HA-1. We encountered practical refusal in HA-1 at a depth of about 5 feet and HA-2 at about 7 feet, due to what felt like gravel or shells. No voids were observed during hand auguring.

We performed pothole PH-4 at the northern end of Revetment 10, as shown in Figure 2B. We observed 2½ inches of asphalt pavement over very loose poorly graded sand with shells. We did not observe a void between the pavement and the subgrade, nor in the sidewall of the excavation. We terminated the pothole at a depth of approximately 6½ feet below the ground surface.

We performed pothole PH-5 towards the middle of Revetment 10, as shown in Figure 2B. BRADY had noted a tilted railing and movement of the concrete sidewalk. We observed 5 inches of concrete over very loose poorly graded sand with shells. We did not observe a void between the pavement and the subgrade. We terminated the pothole at a depth of approximately 3¼ feet below the ground surface due to the sidewalls collapsing.

We performed pothole PH-6 at the southern end of Revetment 12, as shown in Figure 2B. We observed 5 inches of asphalt pavement and 13 inches of aggregate base over large rock pieces. We did not observe a void between the pavement and the subgrade. We terminated the pothole at a depth of 2½ feet due to the rock. The anomalies identified by GeoVision may be small voids within the observed rock.
