ACG Job No. I1612-1202

Subject: Post-removal Inspection – Former Hose-shed Locations

Site: Former US Navy Jet Fuel Storage Site, 3300 Panorama Road, Morro Bay, California

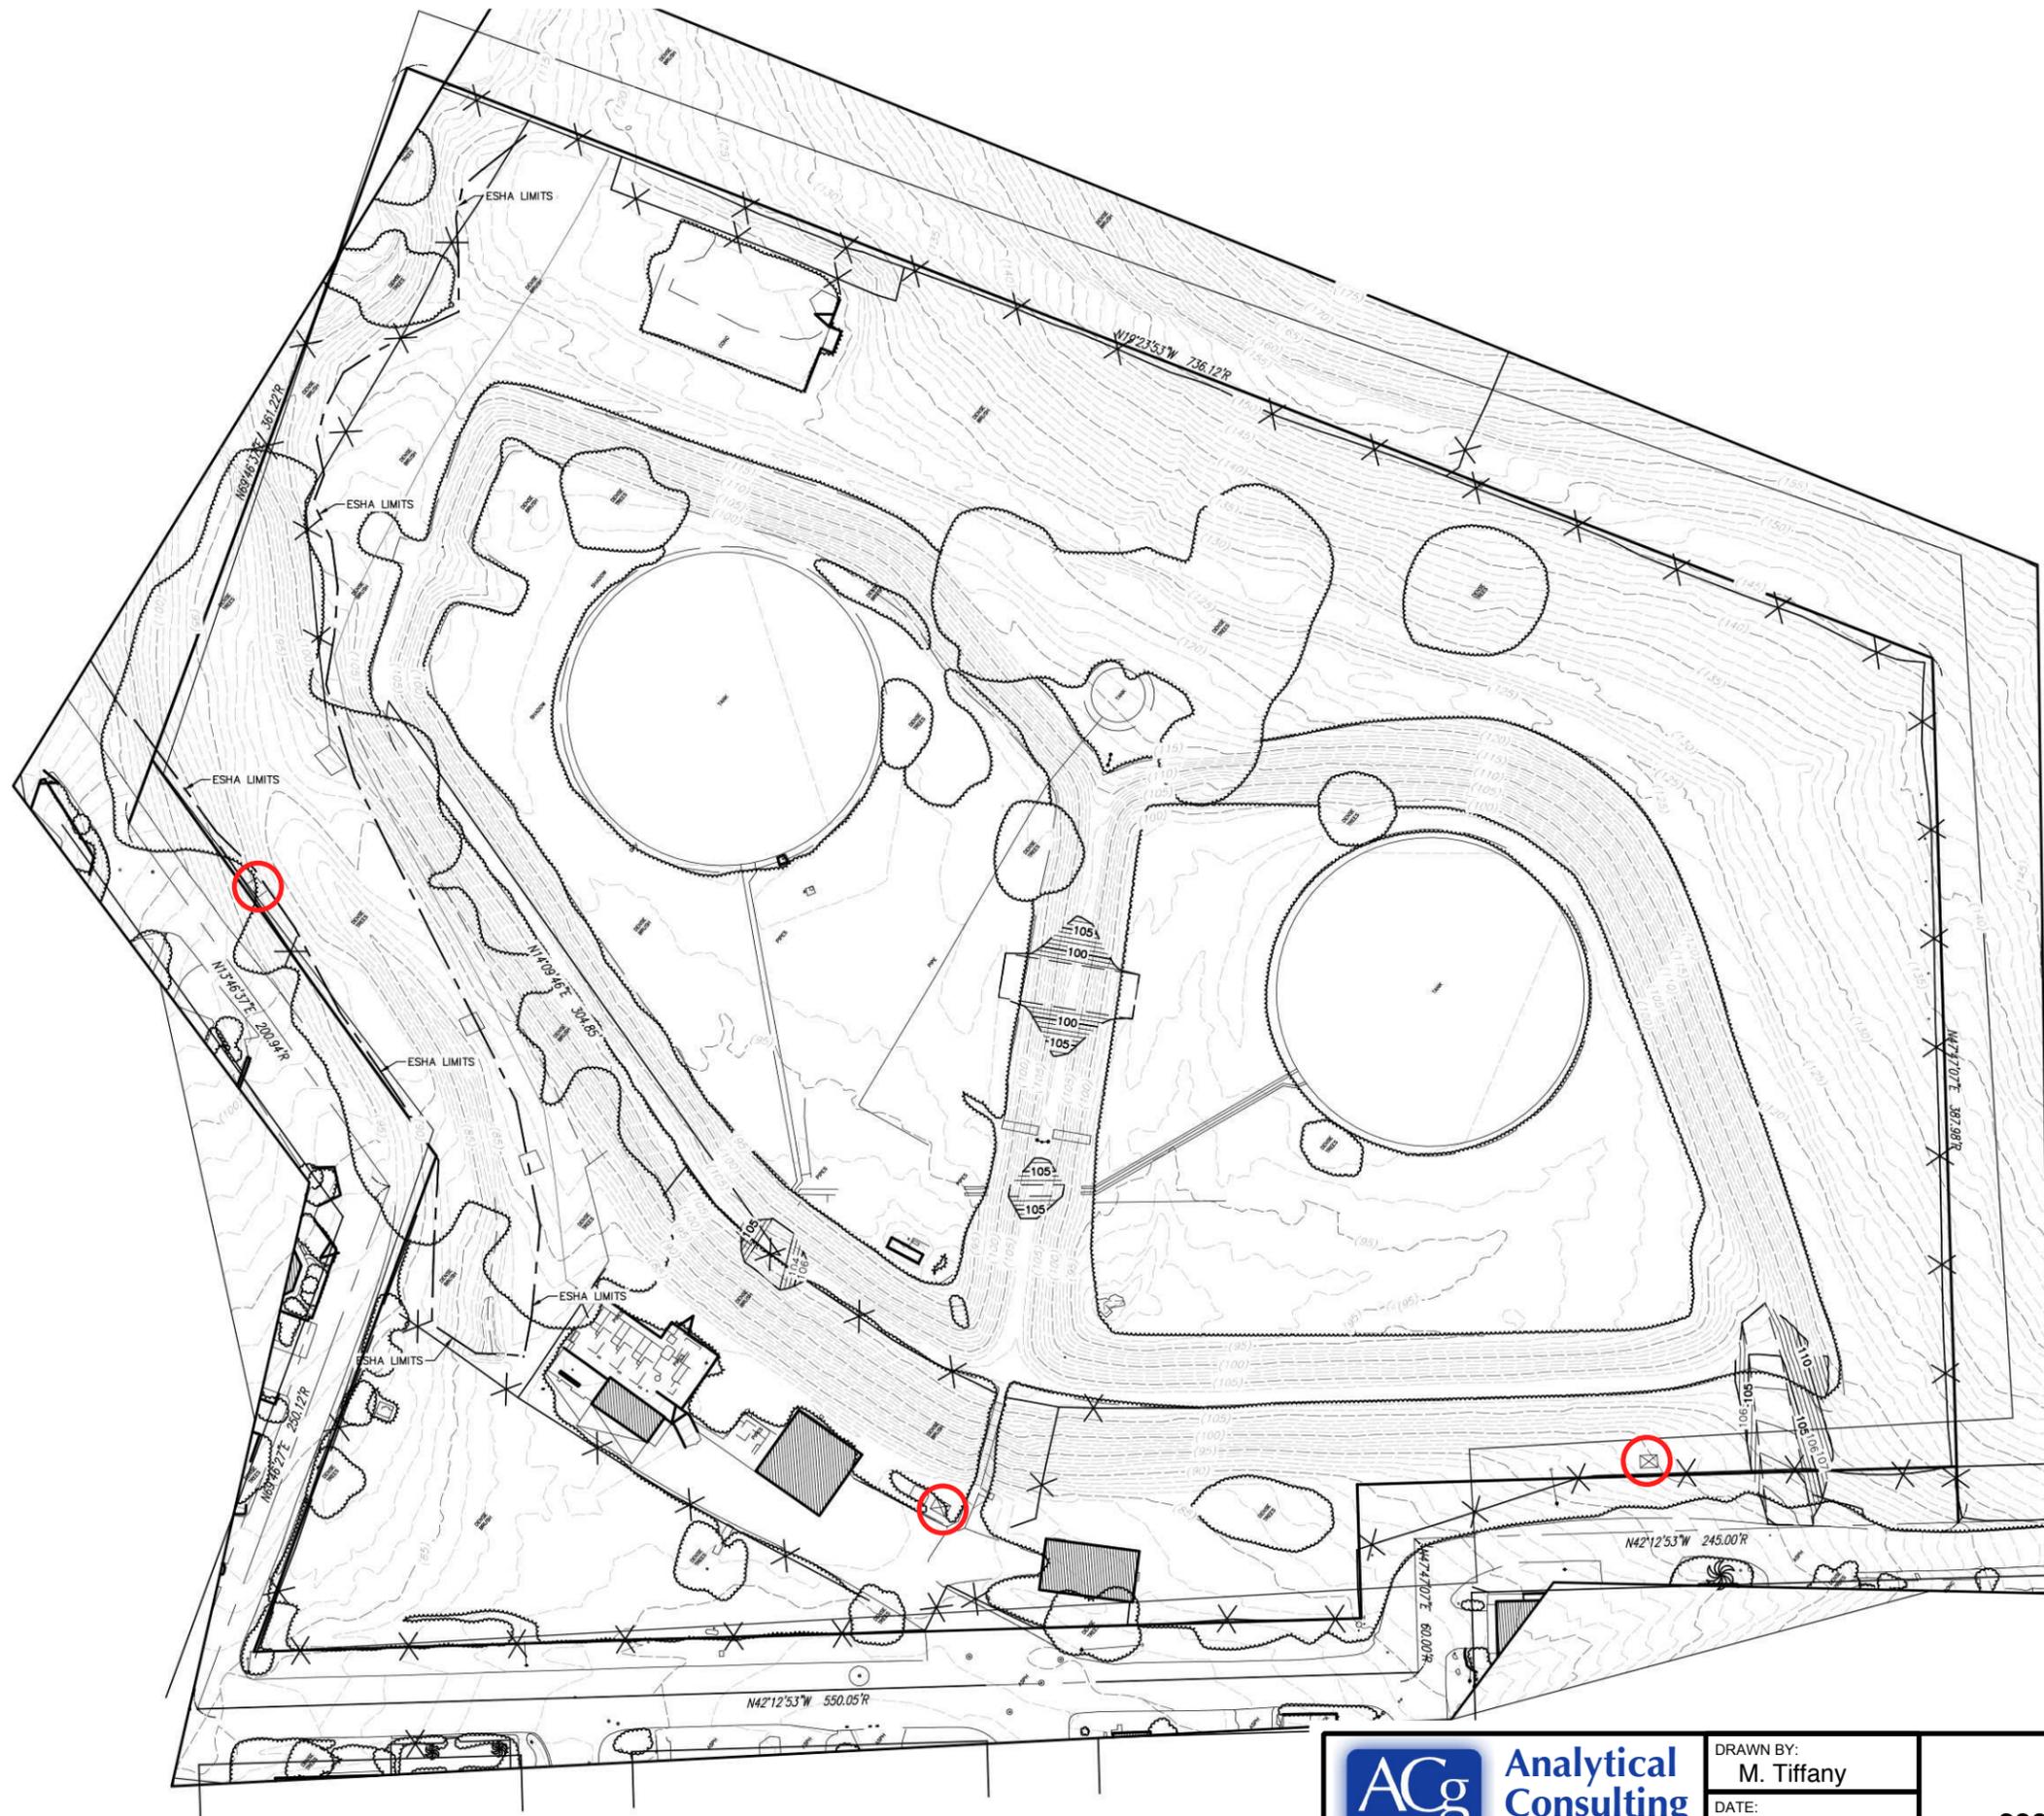
Locations of Fire Hose Sheds

- Figure: Hose Shed Locations
- Forensic Analytical Laboratory Reports
