# **CITY OF MORRO BAY**

## **PUBLIC WORKS ADVISORY BOARD**

**SUBJECT: Streets Summit: A Review of the 2012 Activities and an Update on Pavement Management, Streets Maintenance Programs and Recommendations for Future Work**

PAVEMENT MANAGEMENT PLAN (PMP)  
FOR  
THE CITY OF MORRO BAY

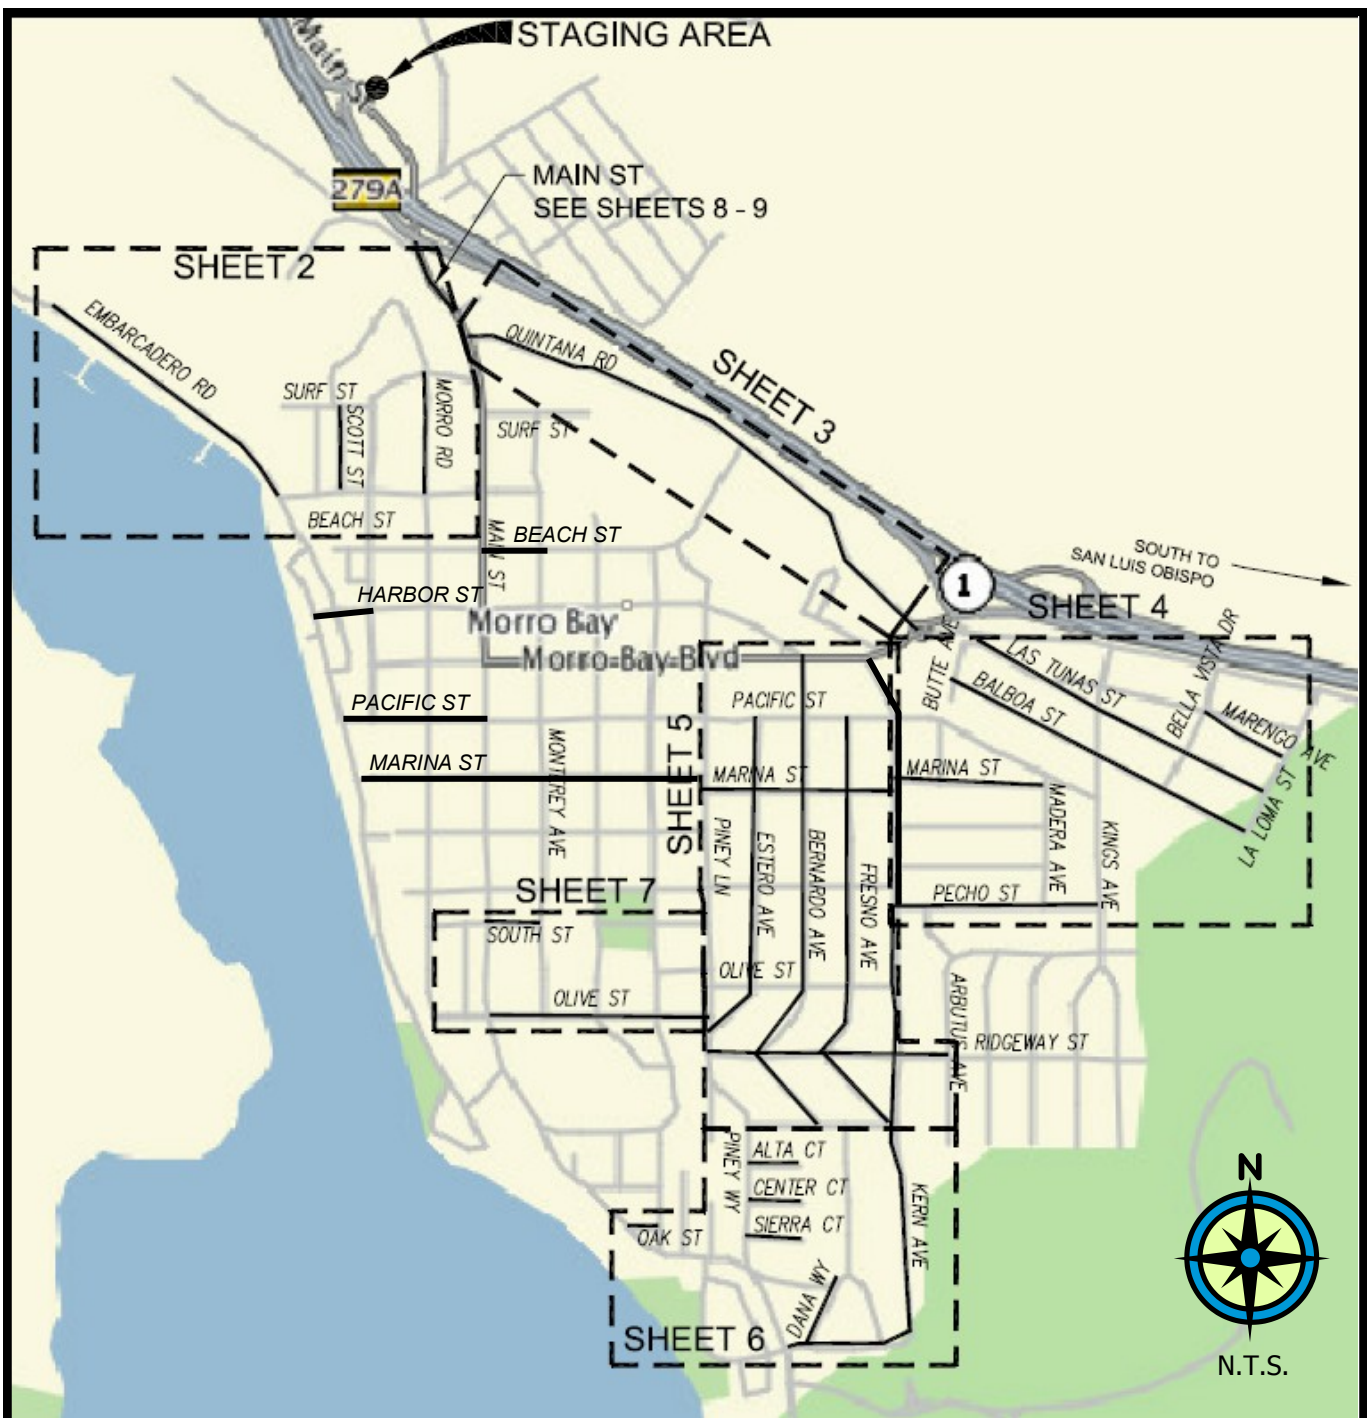
### **ATTACHMENT 3: 2012 Street Rehabilitation Project Location Map**

## CITY OF MORRO BAY 2012 STREET REHABILITATION PROGRAM

*STREETS REHABILITATED ARE SHOWN AS SOLID BLACK LINES  
NOT SHOWN: TIDE AND MIMOSA STREETS*
